12981 Proposed Alternative Method Permit or Closure Plan Application

BELOW-GRADE TANK CLOSURE PLAN

Gallegos Canyon Unit 214E

API No. 3004526326

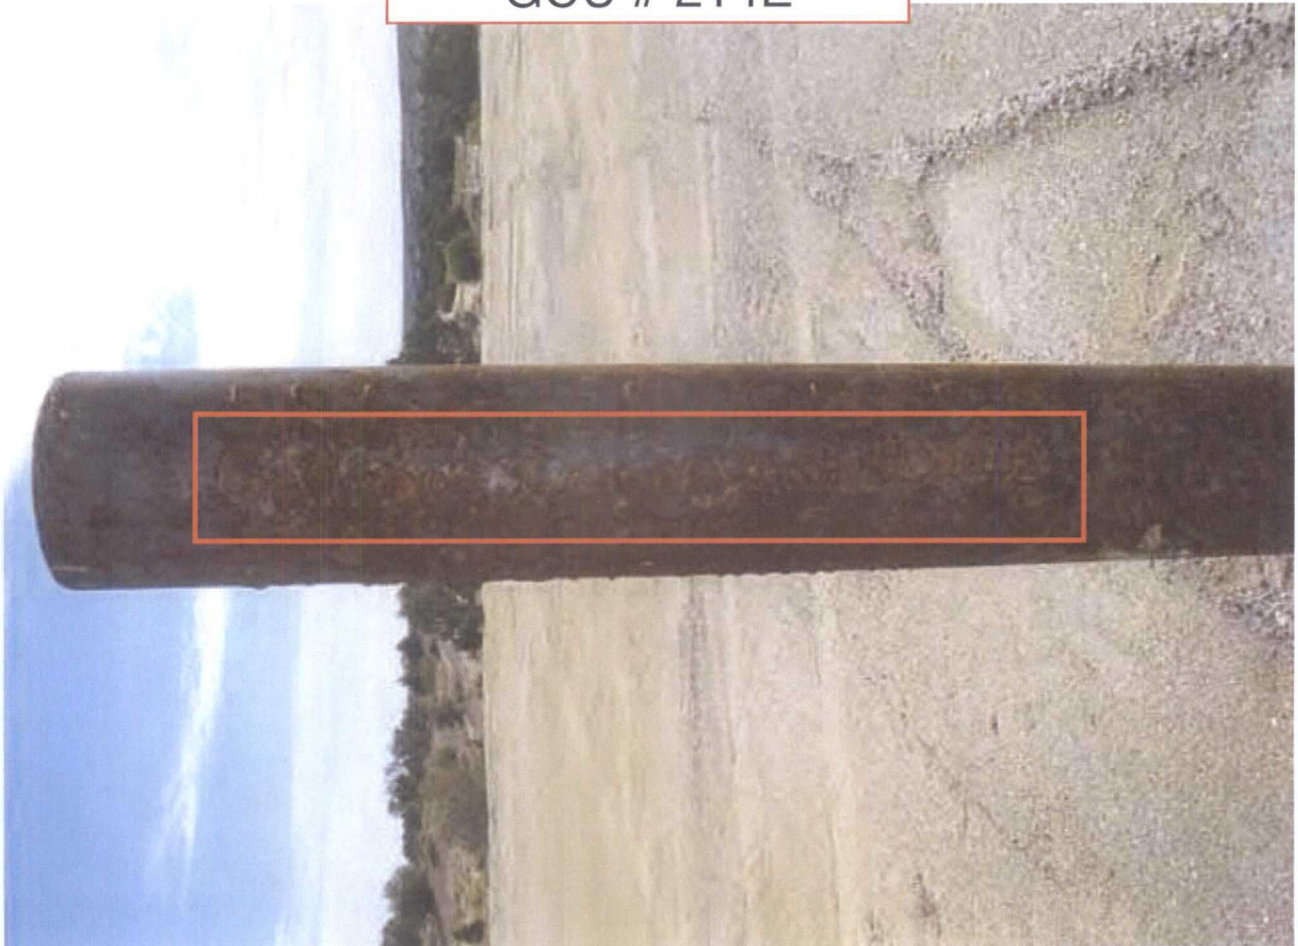
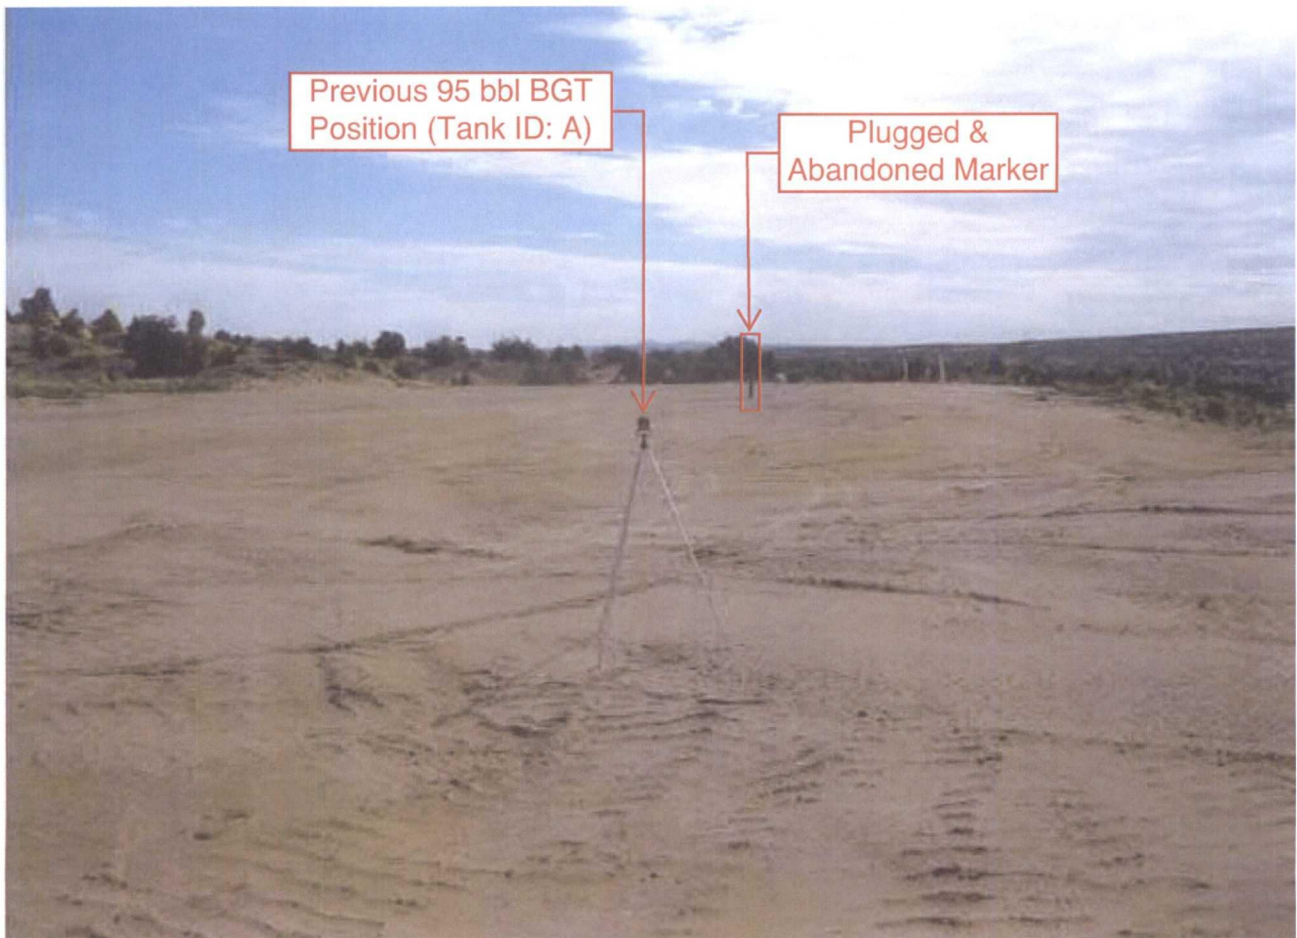
GCU # 214E

Previous 95 bbl BGT  
Position (Tank ID: A)

Plugged &  
Abandoned Marker

**The area under the BGT was backfilled with clean soil. This area will be reclaimed since the well has been plugged and abandoned.**
10. BP shall reclaim the BGT location and all areas associated with the BGT including associated access roads to a safe and stable condition that blends with the surrounding undisturbed area. BP shall substantially restore the impacted surface area to the condition that existed prior to oil and gas operations by placement of the soil cover as provided in Subsection H of 19.15.17.13 NMAC, re-contour the location and associated areas to a contour that approximates the original contour and blends with the surrounding topography and re-vegetate according to Subsection I of 19.15.17.13 NMAC.
