13107 Proposed Alternative Method Permit or Closure Plan Application

Burlington Resources Oil Gas Company, LP
San Juan Basin
Below Grade Tank Closure Report
(Without Reclamation)

Lease Name: SUNRAY D #1

API No.: 30-045-09295

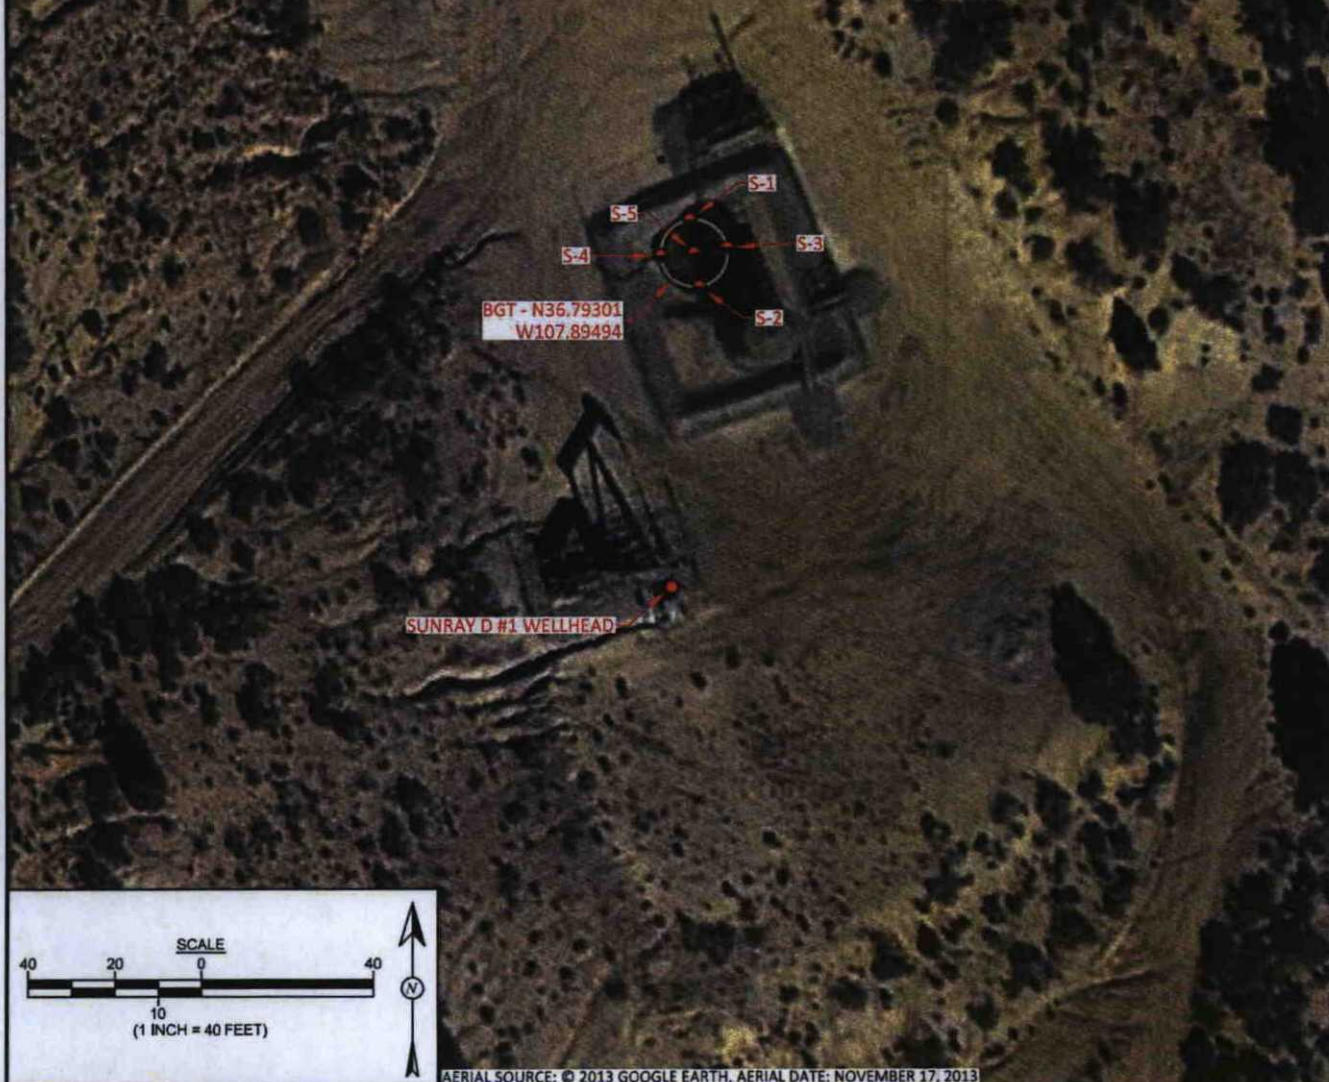
Sample ID	Date	Benzene (mg/kg)	Total BTEX (mg/kg)	TPH - GRO (mg/kg)	TPH - DRO (mg/kg)	Chlorides (mg/kg)
NMOCD ACTION LEVEL		0.2	50	100		250
SC-1	1/17/14	<0.038	<0.191	NA	NA	30

SAMPLE WAS ANALYZED PER EPA METHOD 8021B AND 300.0.

NMOCD action levels for BGT closures are specified in New Mexico Administrative Code (NMAC) 19.15.17.13E. Field TPH concentrations were below the NMOCD action level of 100 mg/kg, with the highest concentration reported in S-4 with 65.7 mg/kg. Benzene and total BTEX concentrations in SC-1 were below the NMOCD action levels of 0.2 mg/kg and 50 mg/kg, respectively. Chloride concentrations in SC-1 were below the NMOCD action level of 250 mg/kg. Based on field screening and laboratory analytical results for benzene, total BTEX, TPH, and chlorides, no further work is recommended at Sunray D #1.
