Pit, Below-Grade Tank, or  
Proposed Alternative Method Permit or Closure Plan Application

1.  
Operator: D.J. SIMMONS INC. \_\_\_\_\_ OGRID #: 005578 \_\_\_\_\_  
Address: 1009 RIDGEWAY PLACE - SUITE 200, FARMINGTON, NM 87401 \_\_\_\_\_  
Facility or well name: SIMMONS #12 (PC) \_\_\_\_\_  
API Number: 30-045-11870 \_\_\_\_\_ OCD Permit Number: N/A \_\_\_\_\_  
U/L or Qtr/Qtr O Section 29 Township 29N Range 9W County: SAN JUAN COUNTY, NM \_\_\_\_\_  
Center of Proposed Design: Latitude 36.692462 Longitude -107.800247 NAD:  1927  1983  
Surface Owner:  Federal  State  Private  Tribal Trust or Indian Allotment

# CLOSURE REPORT

API: 30-045-11870

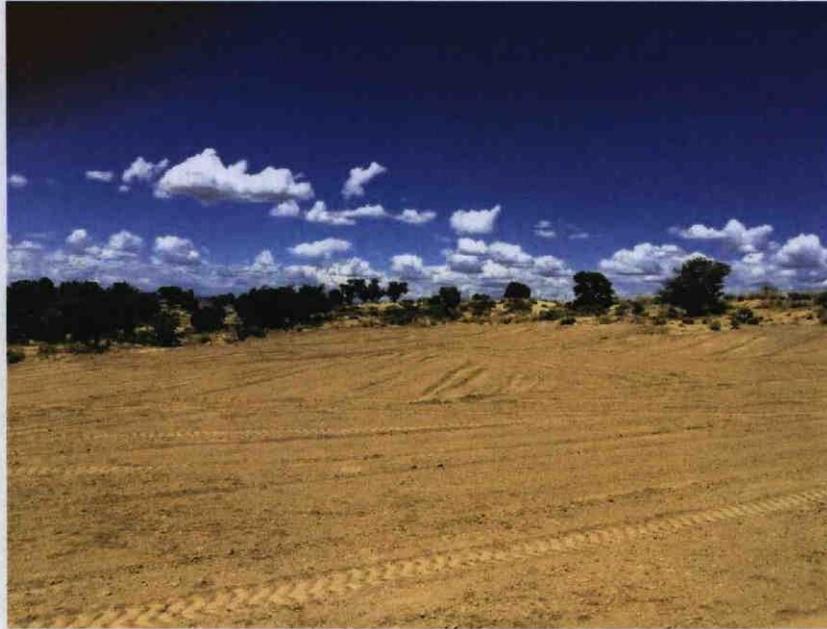
Looking north at recontoured remediation area.

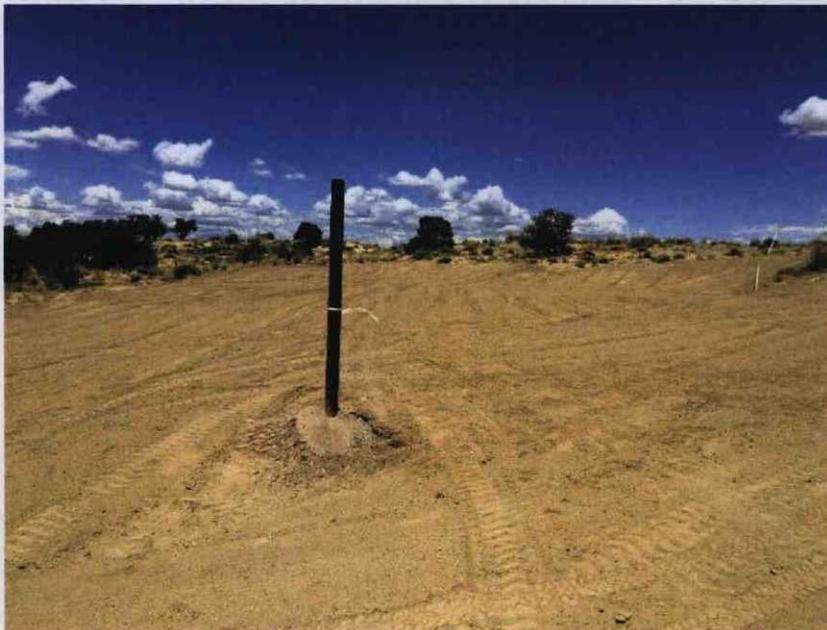
Looking north passed P&A marker at recontoured remediation area.

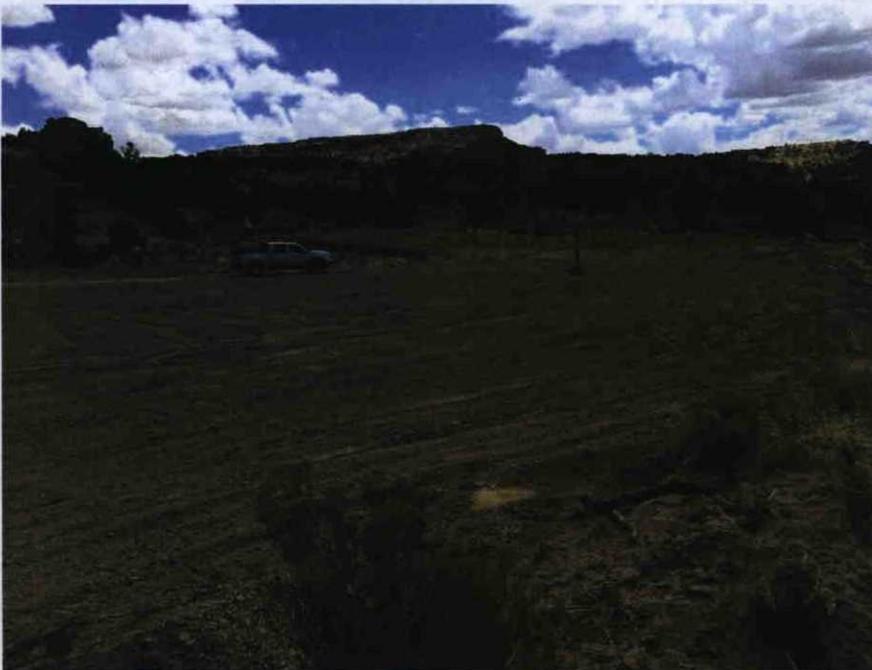
Looking southwest at recontoured remediation area.

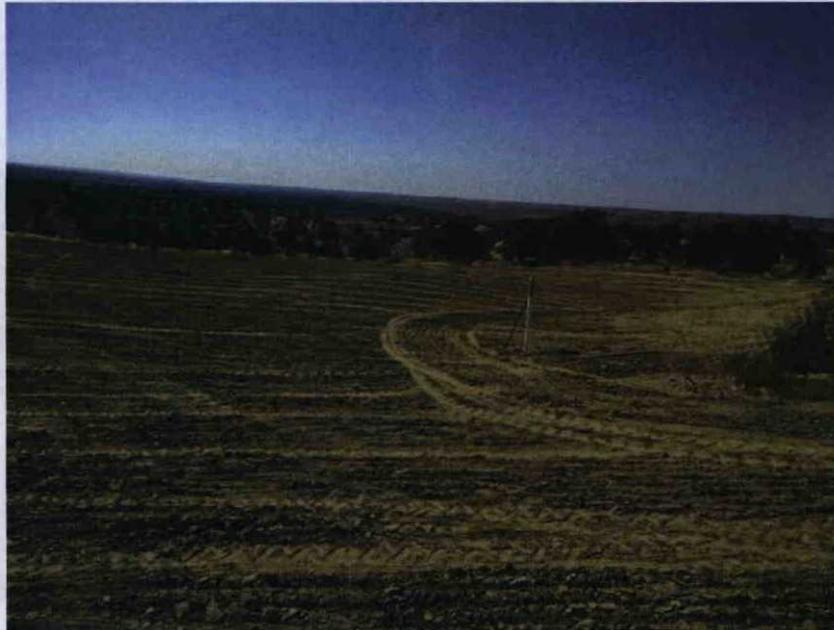
Looking west at the recontoured and reseeded remediation area.

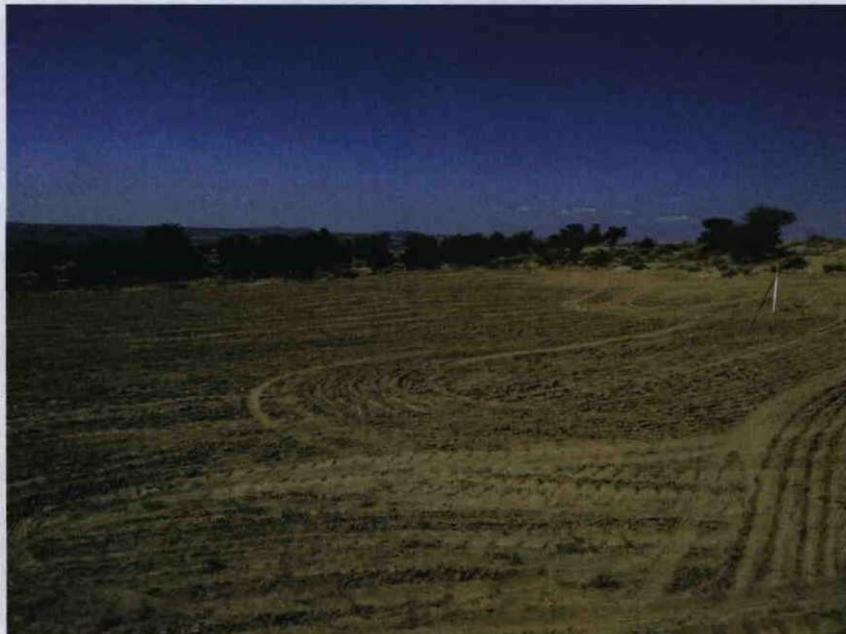
Looking north at recontoured and reseeded remediation area.

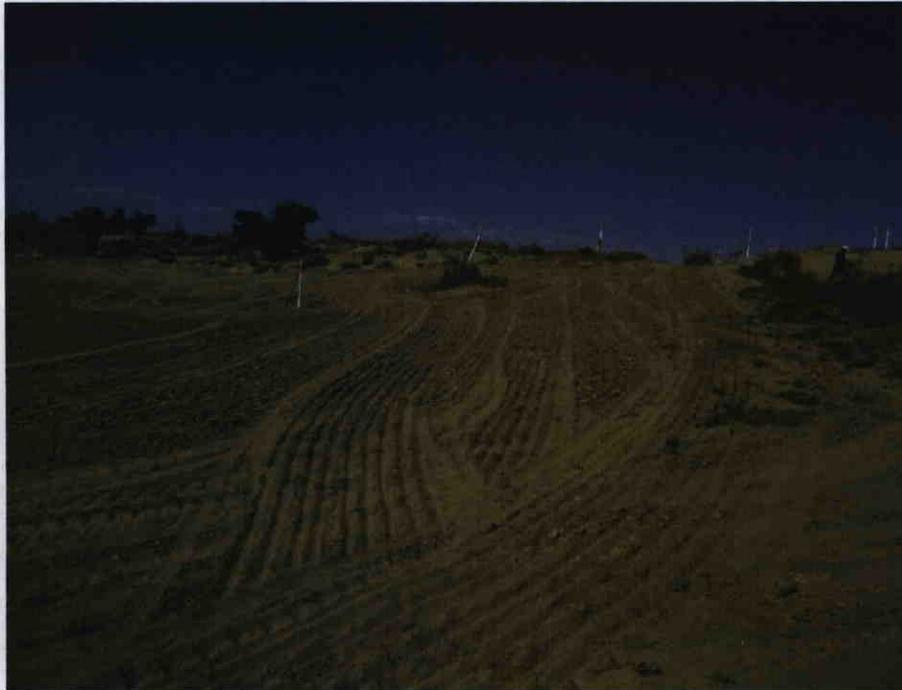
Another view looking north at the recontoured and reseeded remediation area.

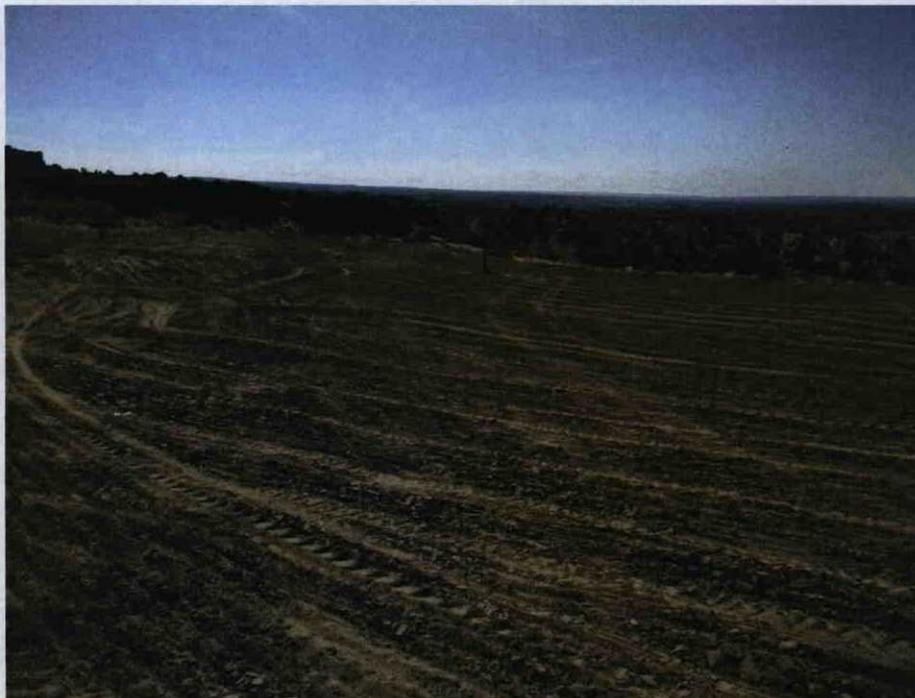
Looking southwest at recontoured and reseeded remediation area.
