13067 Pit, Below-Grade Tank, or
Proposed Alternative Method Permit or Closure Plan Application

Burlington Resources Oil Gas Company, LP
San Juan Basin
Below Grade Tank Closure Report

Lease Name: Rhodes B 100

API No.: 30-045-29217

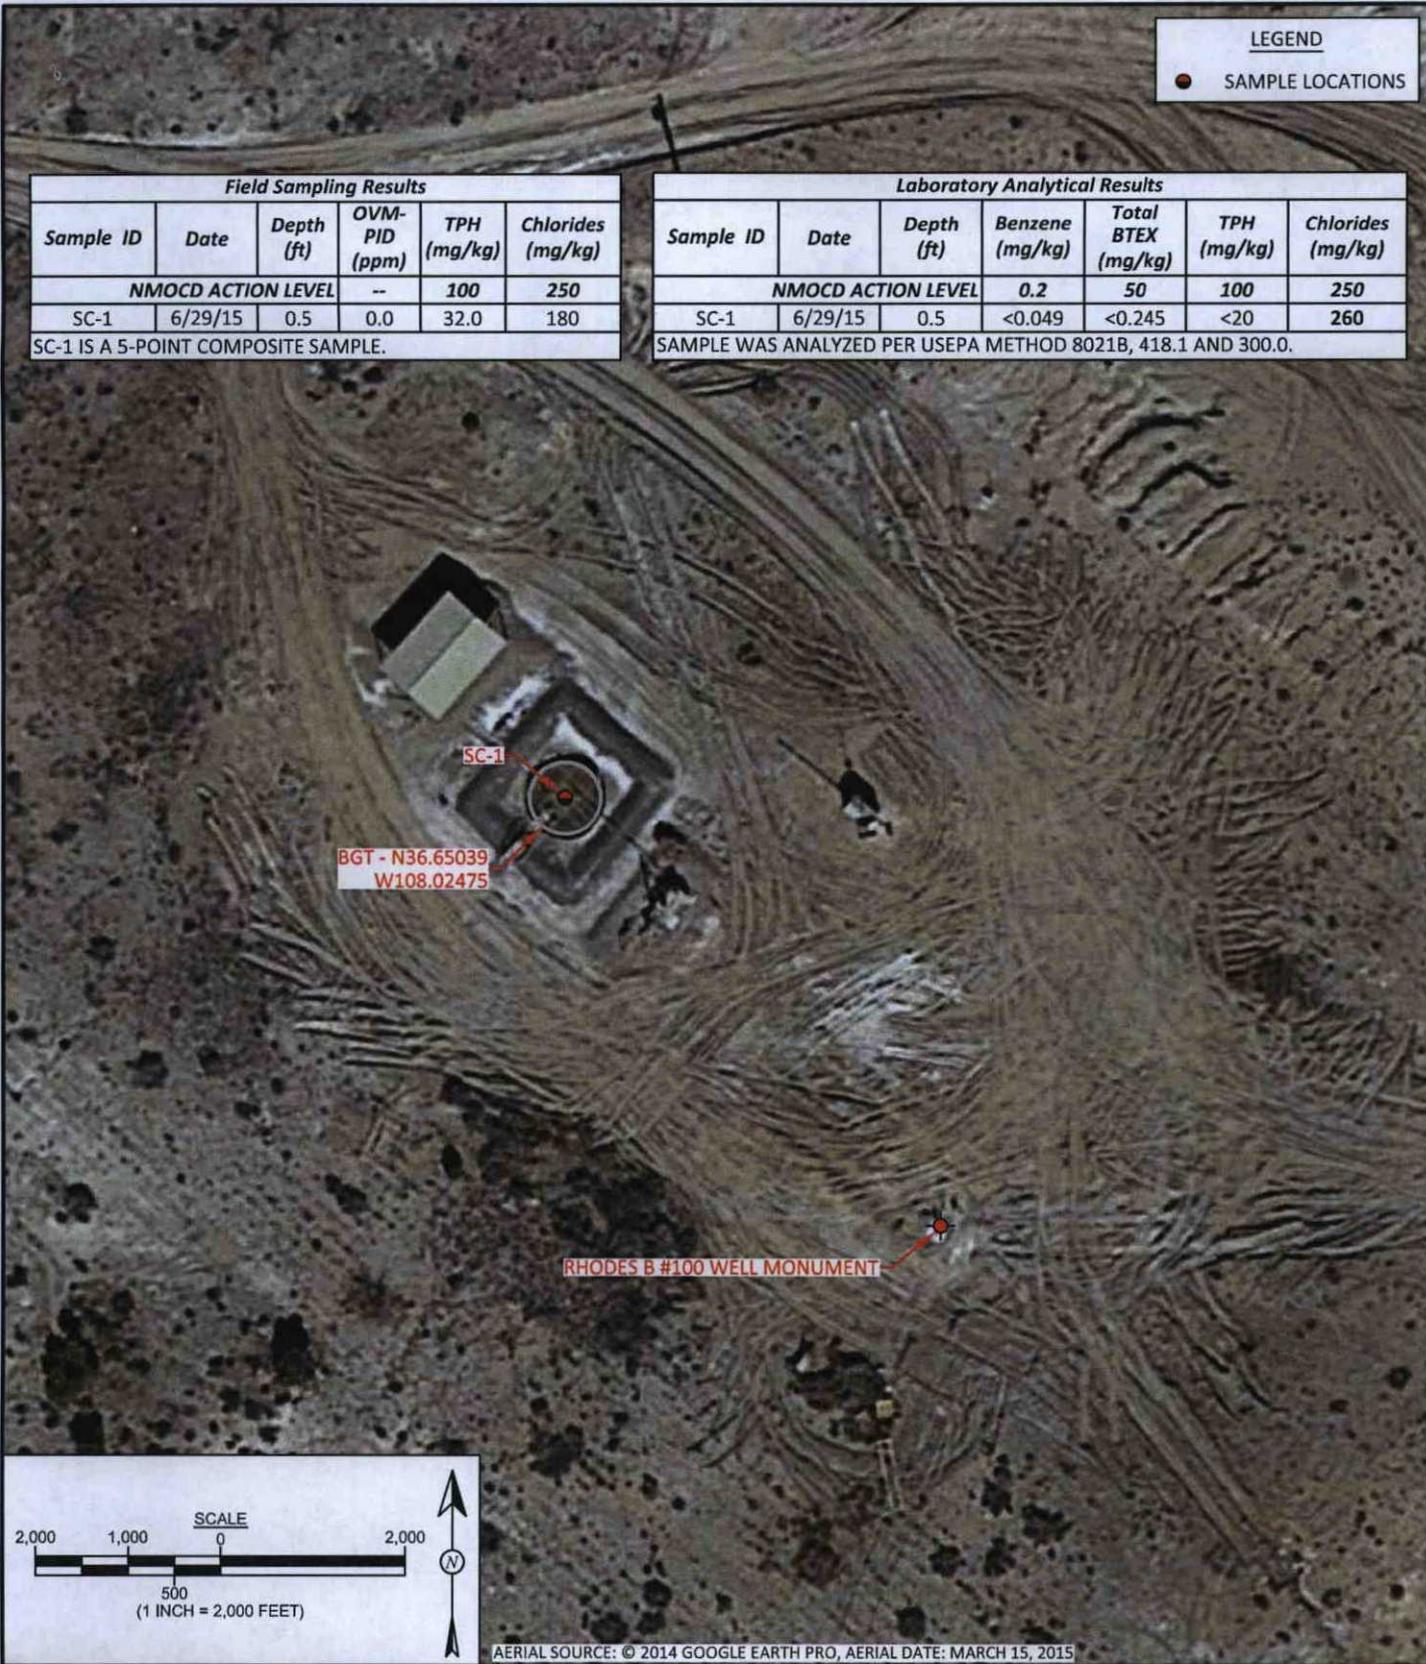
Laboratory Analytical Results						
Sample ID	Date	Depth (ft)	Benzene (mg/kg)	Total BTEX (mg/kg)	TPH (mg/kg)	Chlorides (mg/kg)
NMOC D ACTION LEVEL			0.2	50	100	250
SC-1	6/29/15	0.5	<0.049	<0.245	<20	260

SAMPLE WAS ANALYZED PER USEPA METHOD 8021B, 418.1 AND 300.0.

NMOCD action levels for BGT closures are specified in New Mexico Administrative Code (NMAC) 19.15.17.13E. Field TPH concentrations in SC-1 were below the NMOCD action level of 100 mg/kg, with a concentration reported at 32.0 mg/kg. Benzene and total BTEX concentrations were below the NMOCD action levels of 0.2 mg/kg and 50 mg/kg, respectively. In contrast, chloride concentrations in SC-1 exceeded the NMOCD action level of 250 mg/kg with 260 mg/kg. As per Cory Smith of the NMOCD, no further work is recommended for the Rhodes B #100.
