Release Notification and Corrective Action

Name of Company: BP	Contact: Steve Moskal
Address: 200 Energy Court, Farmington, NM 87401	Telephone No.: 505-326-9497
Facility Name: Heaton LS 4	Facility Type: Natural gas well

FIELD REPORT:

SITE NAME: HEATON LS 4

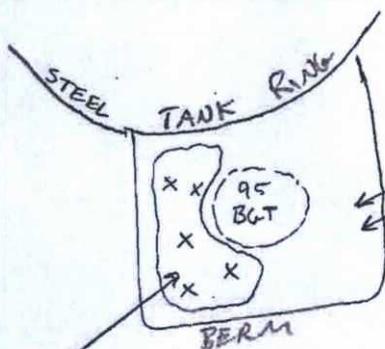
SITE SKETCH

OTHER: Sampled soils @ Ground surface (0"-3" Depth) IN Area @ West side of BGT where obvious STANDING Water from overflow was AT.

BGT Located: off / (on) site

A BGT Sidewalls Visible: Y (N)

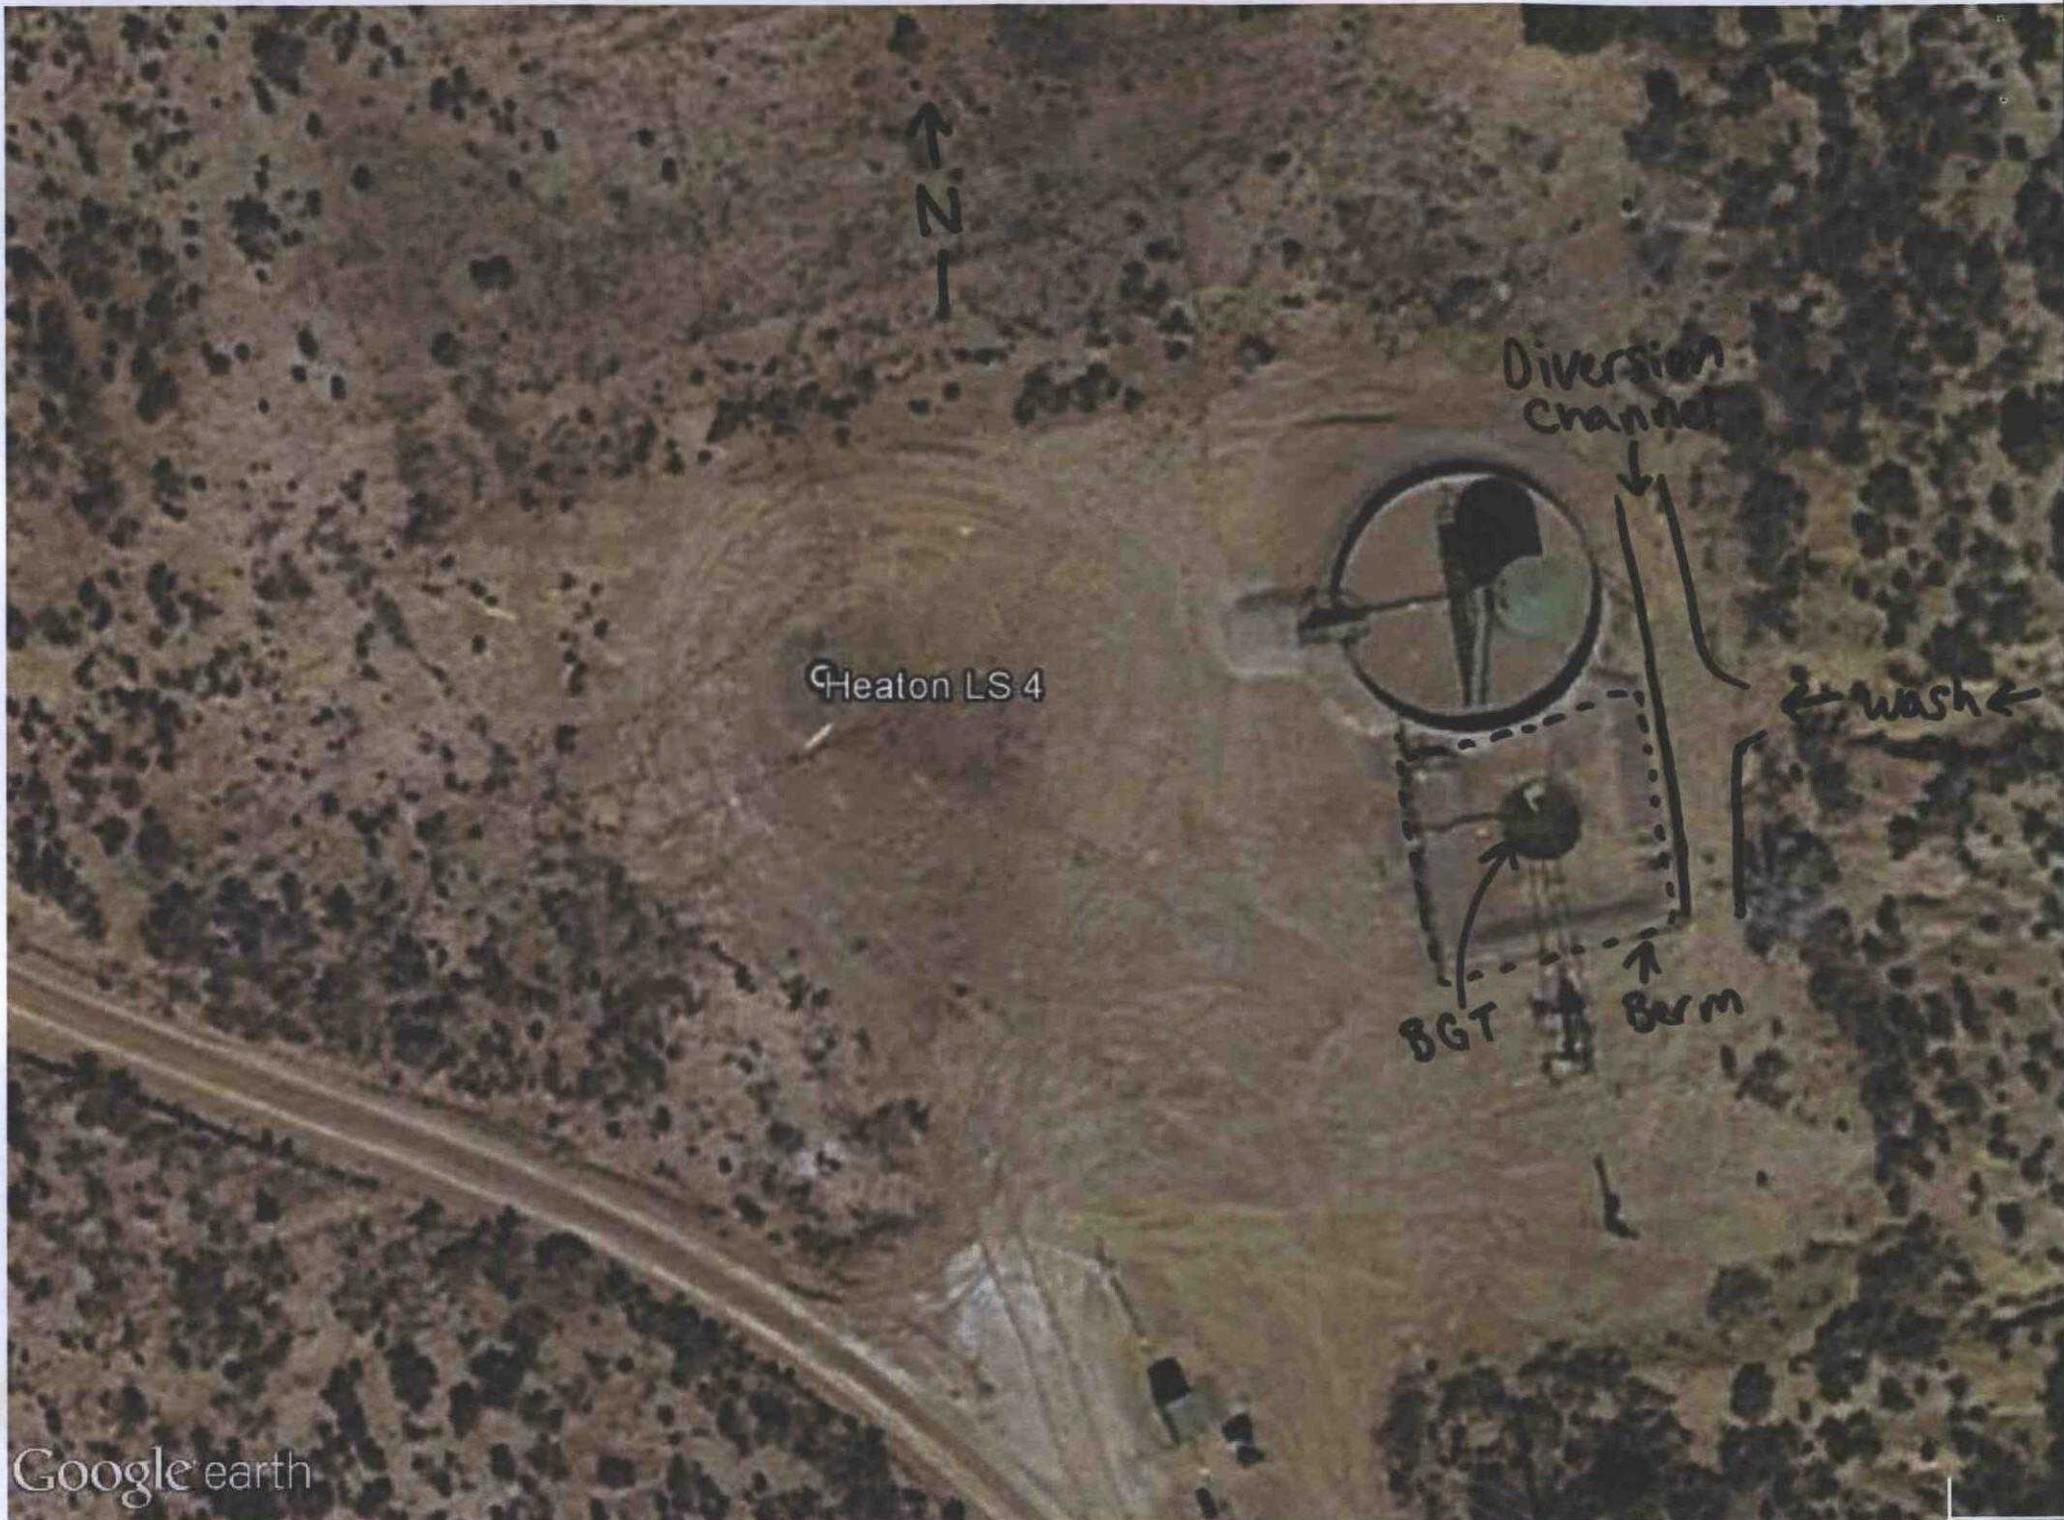
Heaton LS 4

Diversion channel

← wash ←

BGT

Berm
