Pit, Below-Grade Tank, or
Proposed Alternative Method Permit or Closure Plan Application

1.
Operator: Burlington Resources Oil & Gas Company, LP OGRID #: 14538
Address: PO BOX 4289, Farmington, NM 87499
Facility or well name: SAN JUAN 27-4 UNIT 116
API Number: 30-039-21007 OCD Permit Number: _____
U/L or Qtr/Qtr I Section 32 Township 27 N Range 4 W County: Rio Arriba
Center of Proposed Design: Latitude 36.5273 °N Longitude -107.26746 °W NAD: 1927 1983
Surface Owner: Federal State Private Tribal Trust or Indian Allotment

Topographic Map
 ConocoPhillips
 San Juan 27-4 Unit 116

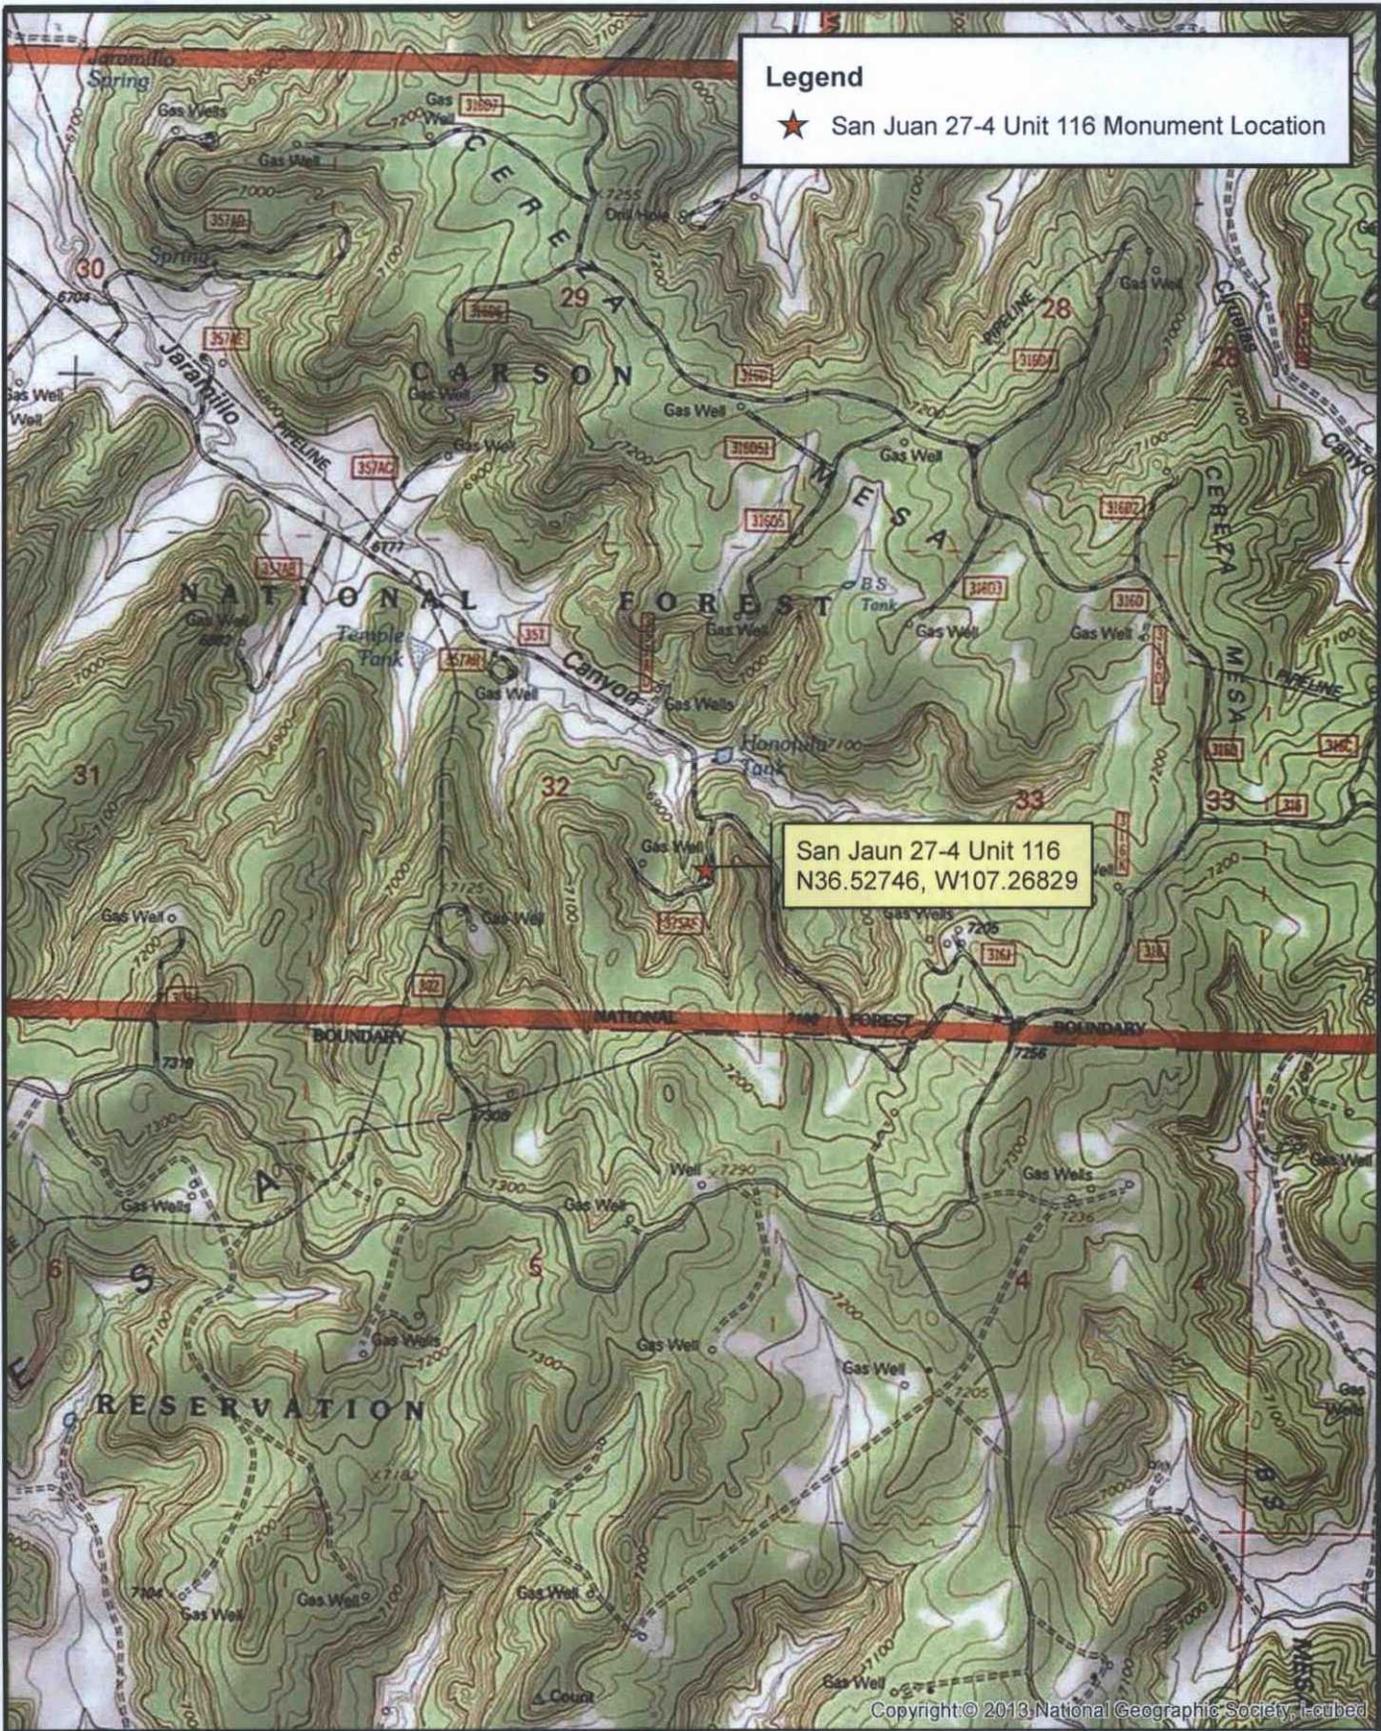
Date: 9/18/2015 File: 150729 San Juan 27-4 Unit 116 Topo Map Figure: 1

San Juan 27-4 Unit 116
 N36.52746, W107.26829

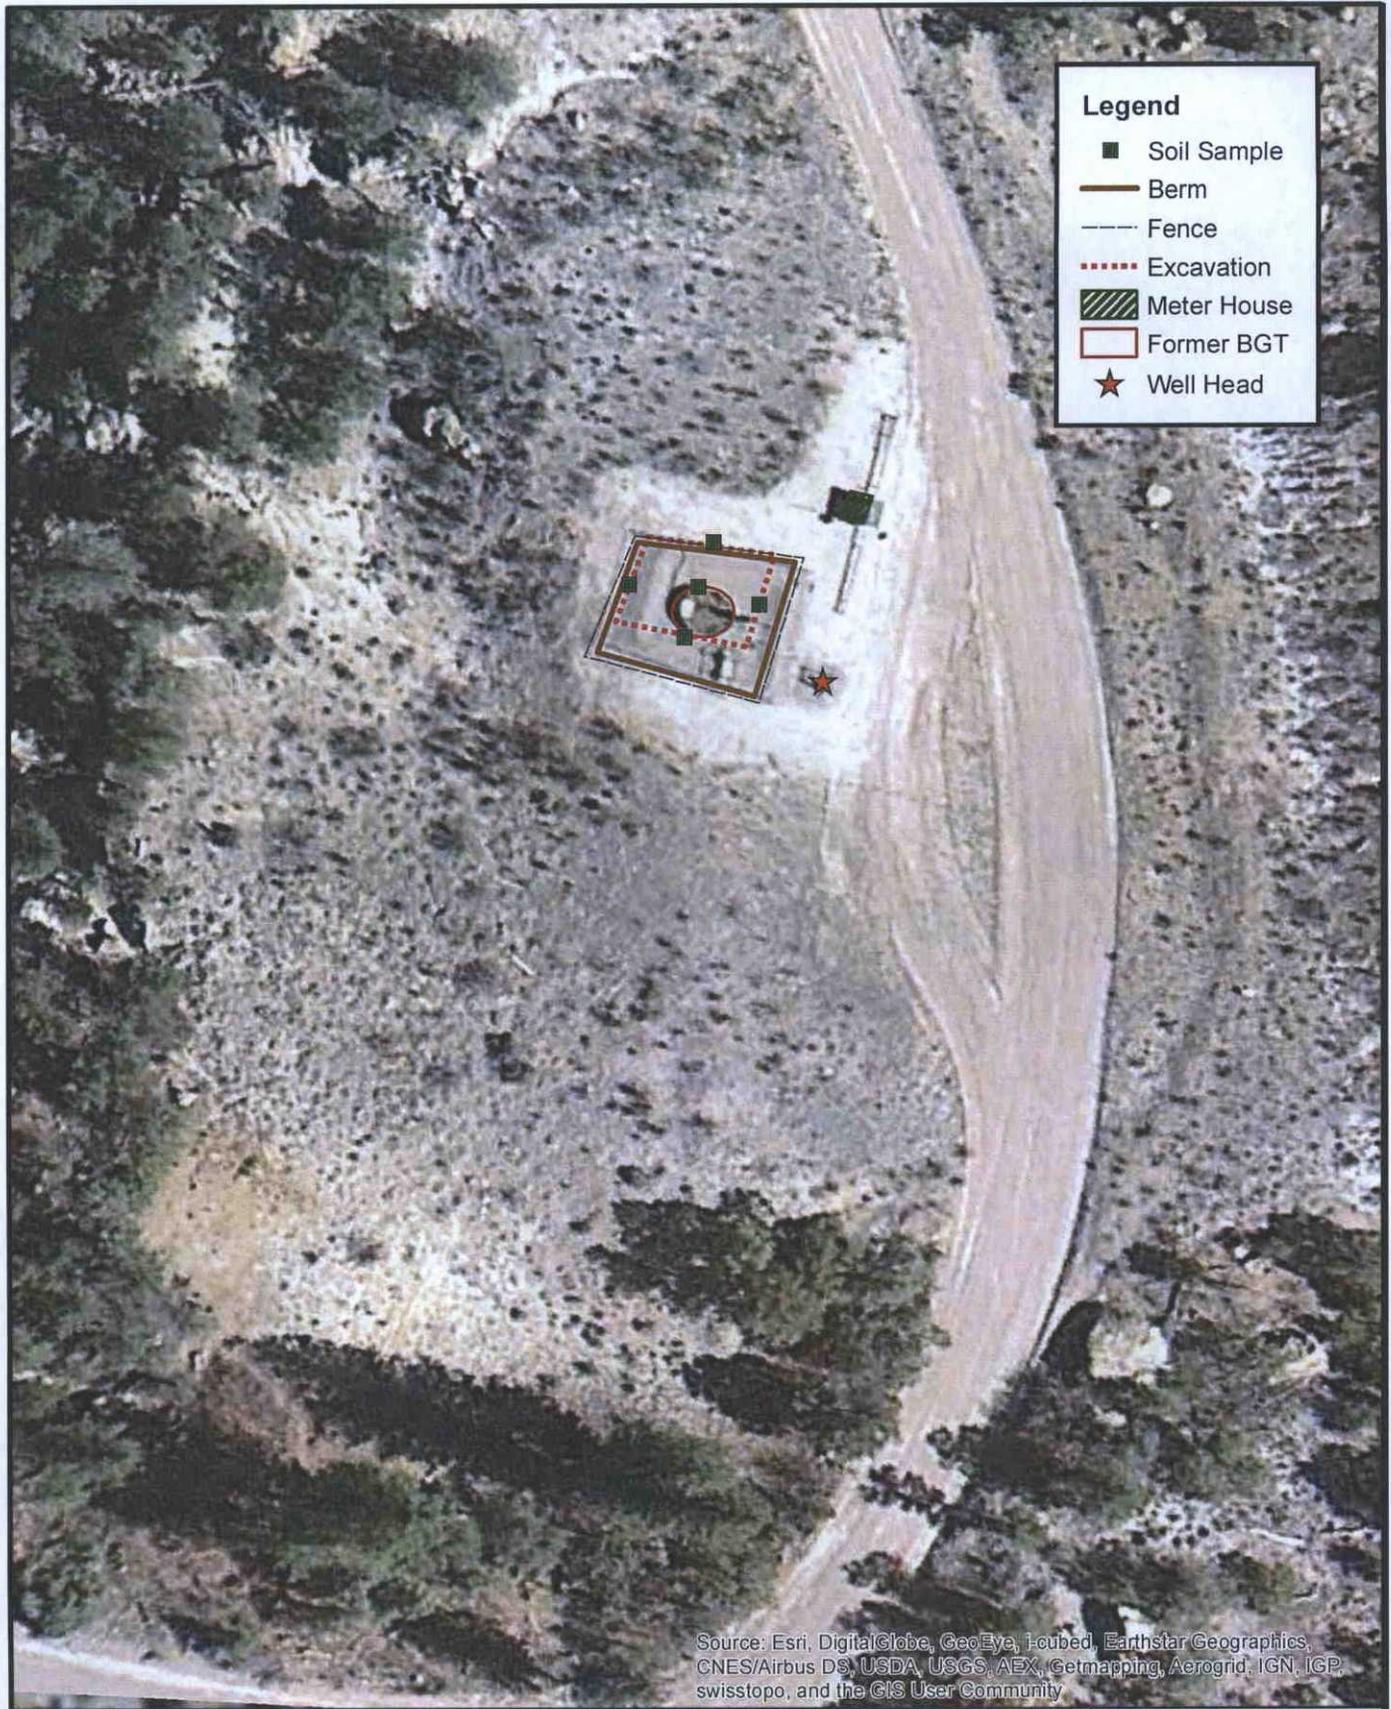
- Soil Sample
- Berm
- - - Fence
- ⋯ Excavation
- ▨ Meter House
- Former BGT
- ★ Well Head

SC-5	3.0'-4.5'
VOCs	1,221
TPH (418.1)	486
Benzene	0.16
BTEX	2.2
GRO	260
DRO	110

Excavation: 21' x 23' x 3.0-4.5' in depth

Field VOCs from the excavation were reported below the NMOCD action level of 100 ppm in all samples, except SC-5 with 1,221 ppm. Laboratory analytical results for soil confirmation samples (SC-1 through SC-5) reported benzene and total BTEX concentrations below the NMOCD action levels of 10 mg/kg and 50 mg/kg, respectively. All soil confirmation samples reported field and laboratory TPH concentrations below the NMOCD action level of 1,000 mg/kg. Based on laboratory analytical results, no further work is recommended.
