Release Notification and Corrective Action

Pierce SRC #1A Release Report

Unit Letter O, Section 30, Township 31 North, Range 10 West
N36.86511, W107.91994
San Juan County, New Mexico

ConocoPhillips Pierce SRC #1A Release Report

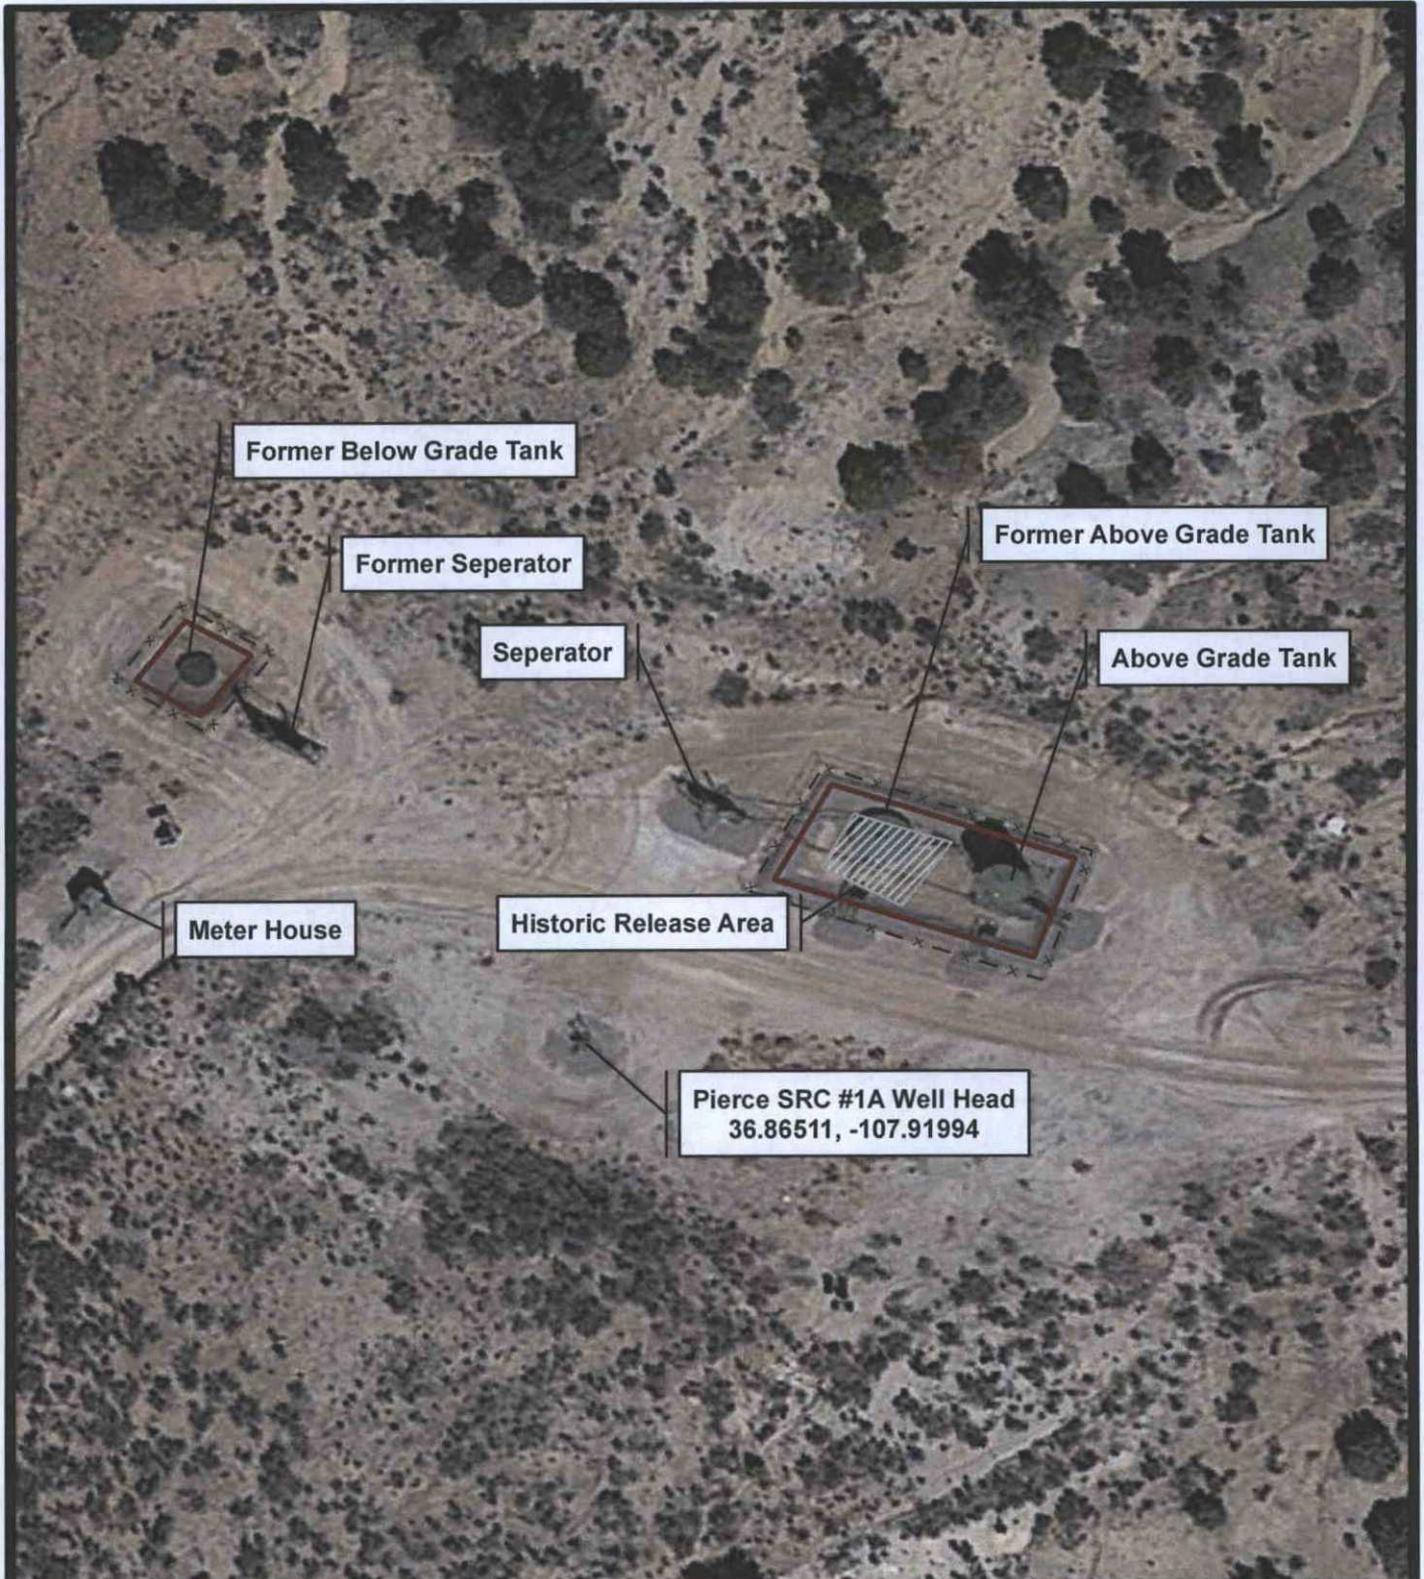
Figure 2

Historic Release Area
-

Aerial Site Map

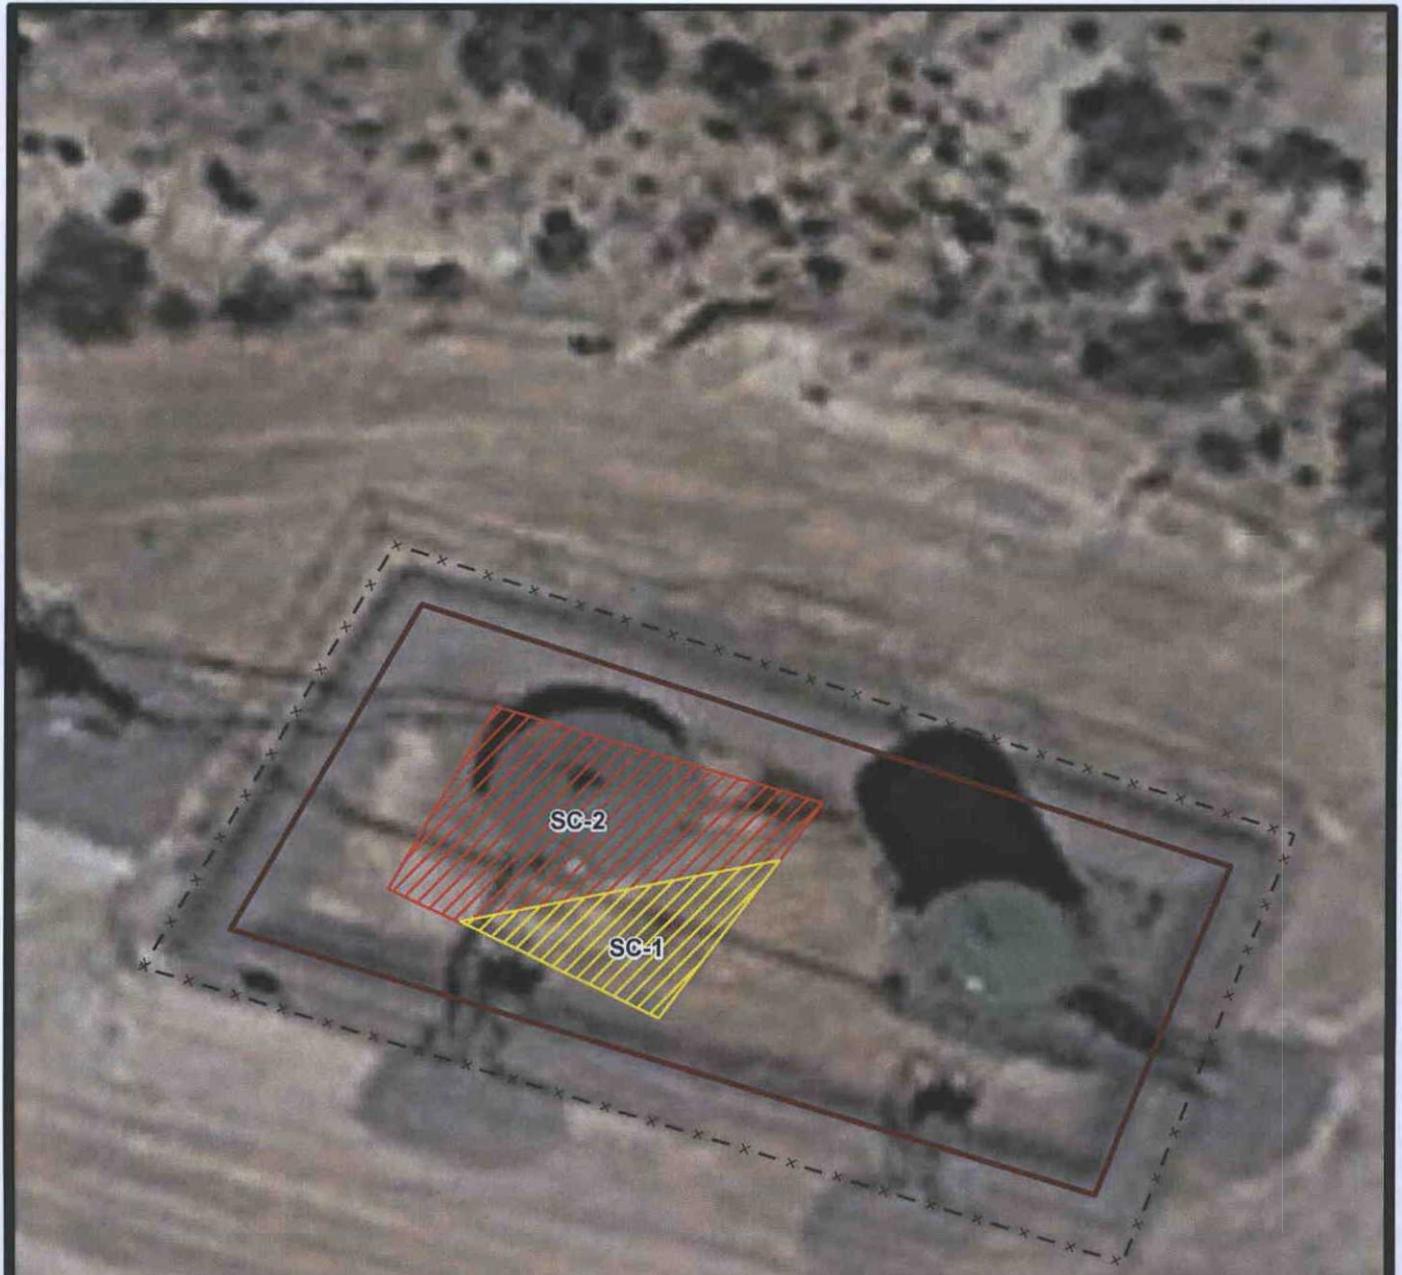
Excavation Closure Map
 ConocoPhillips
 Pierce SRC #1A
 API: 30-045-21796
Figure 3
 O-S30-T31N-R010W
 N36.86511, W107.91994
 San Juan County, New Mexico

On September 24, 2015, Rule Engineering, LLC (Rule) personnel conducted a visual inspection of the excavation completed during the facility upgrade activities. Soil and rock discoloration and hydrocarbon odor was observed. Rule personnel collected two composite samples (SC-1 and SC-2) from the base and sidewalls of the excavation. Approximately 20 cubic yards of discolored soil and rock were removed from the excavation measuring approximately 26 feet by 21 feet, with an upper shelf approximately 3 feet deep and a lower base approximately 6 feet deep. A depiction of the excavation with sample locations and summary of analytical results is included as Figure 3.

Laboratory analytical results for confirmation samples SC-1 and SC-2 reported benzene concentrations below the laboratory reporting limit, which is below the NMOCD action level of 10 mg/kg. Laboratory analytical results reported total BTEX concentrations ranging from below the laboratory reporting limit to 0.23 mg/kg, which are below the NMOCD action level of 50 mg/kg. Laboratory analytical results reported TPH (GRO/DRO) concentrations ranging 6.3 mg/kg and 87 mg/kg, which are below the applicable NMOCD action level of 1,000 mg/kg for a site with a ranking of 10. Laboratory analytical results are summarized in Table 2 and presented on Figure 3.

Sample ID	Date	Sample Type	Sample Depth (ft)	Laboratory Analytical Results						
				Benzene (mg/kg)	Toluene (mg/kg)	Ethyl-benzene (mg/kg)	Xylenes (mg/kg)	Total BTEX (mg/kg)	TPH-GRO (mg/kg)	TPH-DRO (mg/kg)
NMOCD Action Levels				10	--	--	--	50	1,000	
SC-1	9/24/15	Composite	0.5 to 3	<0.032	<0.032	0.073	0.16	0.23	43	44
SC-2	9/24/15	Composite	0.5 to 5	<0.035	<0.035	<0.035	<0.070	ND	6.3	<9.7

NOTE: SC-1 and SC-2 are five point composites

Based on laboratory analytical results of the confirmation soil samples, no further work is recommended.
