**Release Notification and Corrective Action**

Name of Company: BP	Contact: Steve Moskal
Address: 200 Energy Court, Farmington, NM 87401	Telephone No.: 505-326-9497
Facility Name: Hughes 003E	Facility Type: Natural gas well
Surface Owner: Federal	Mineral Owner: Federal
API No. 3004524999

# BP America: Hughes 3E

## Summary Record of Impact Remediation

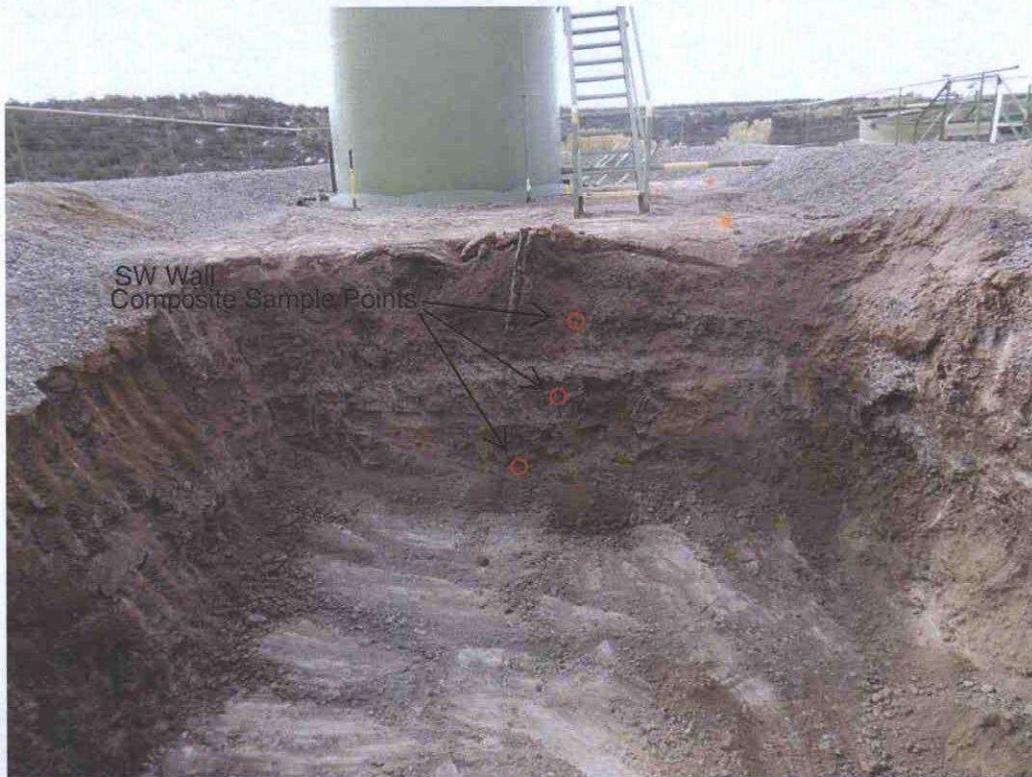
December 10, 2015 Initiate and complete remediation of site by excavation of impacts with trackhoe. Final excavation size 18' x 18' x 7.5' deep. Collect 3-point composite samples of NW, NW, SW and SE sidewalls and 5-point composite sample of base. Entire excavation in soft, purple colored shalestone.

95 BGT Excavation on December 10, 2015  
18' x 18' x 7.5' Deep
