13970 Proposed Alternative Method Permit or Closure Plan Application

1.
Operator: WPX Energy Production, LLC OGRID #: 120782
Address: PO Box 640/721 S Main Aztec, NM 87410
Facility or well name: Schalk 32 #3H
API Number: 30-039-31108 OCD Permit Number: _____
U/L or Qtr/Qtr L Section 32 Township 31N Range 04W County: Rio Arriba
Center of Proposed Design: Latitude N36.85462 Longitude W107.28529 NAD: 1927 1983
Surface Owner: Federal State Private Tribal Trust or Indian Allotment

Photograph Log
Schalk 32 #3H Reserve Pit Closure
WPX Energy Production, LLC

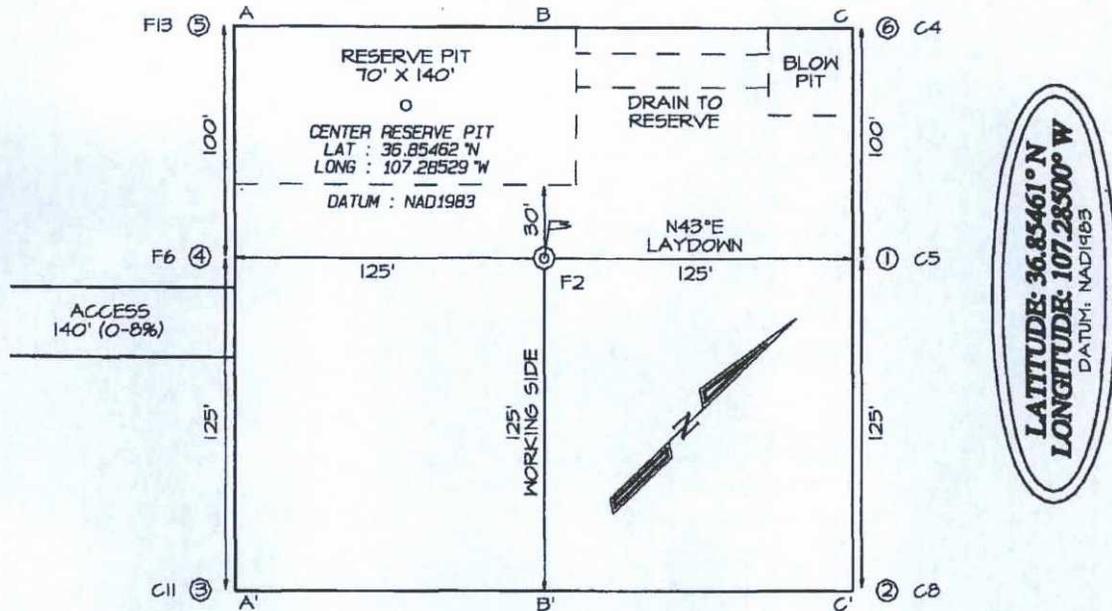
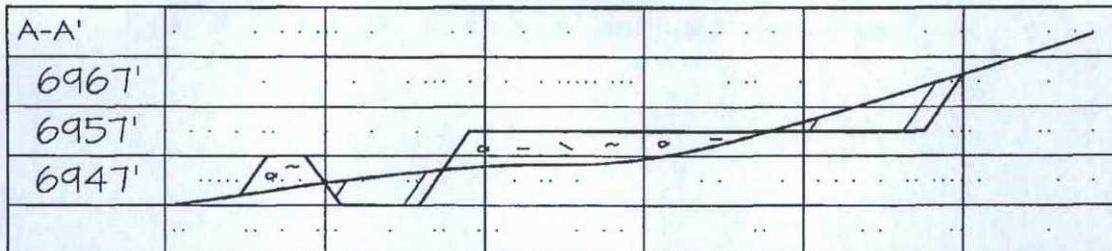
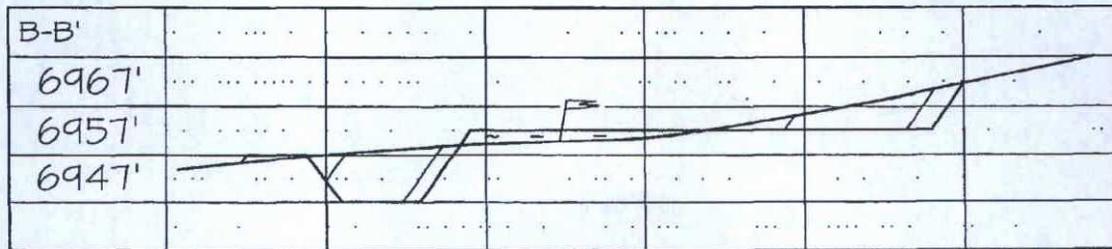
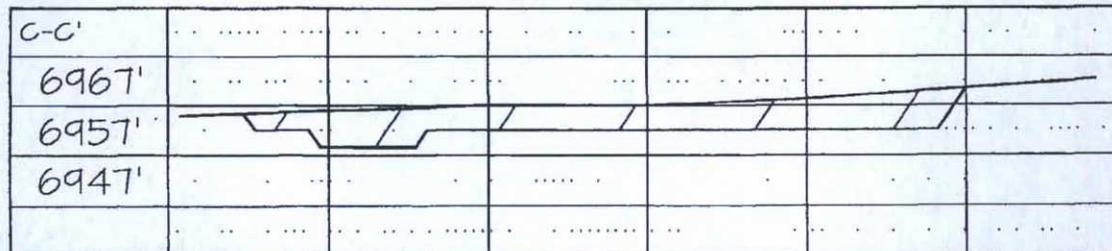
**WILLIAMS PRODUCTION COMPANY SCHALK 32 #2A
2070' FSL & 660' FWL, SECTION 32, T31N, R4W, NMPM
RIO ARRIBA COUNTY, NEW MEXICO ELEVATION: 6955'**

Steel T-Posts have been set to define the Edge of Disturbance limits which are 50' offset from the edge of the staked wellpad.

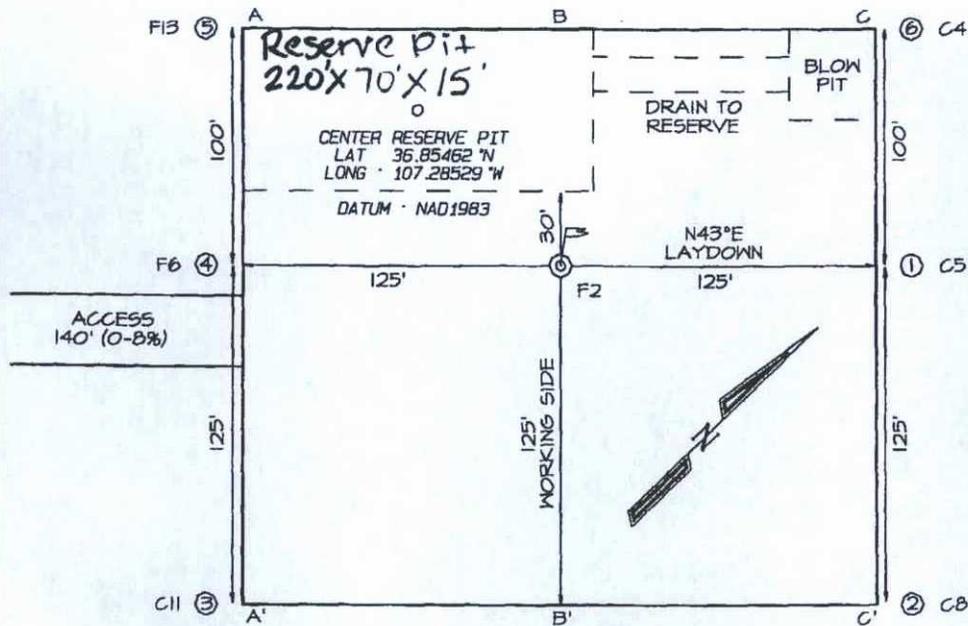
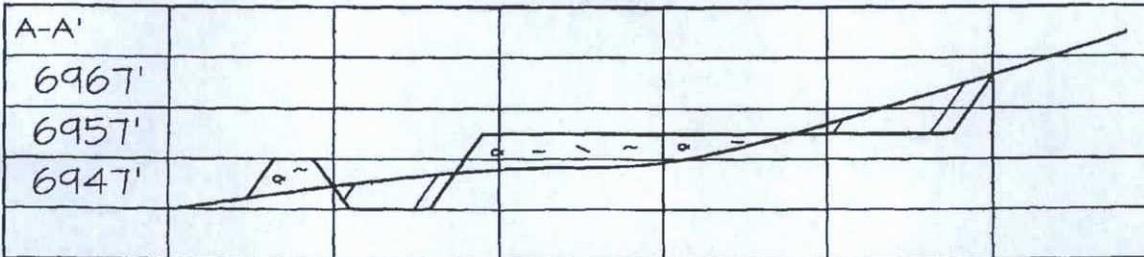
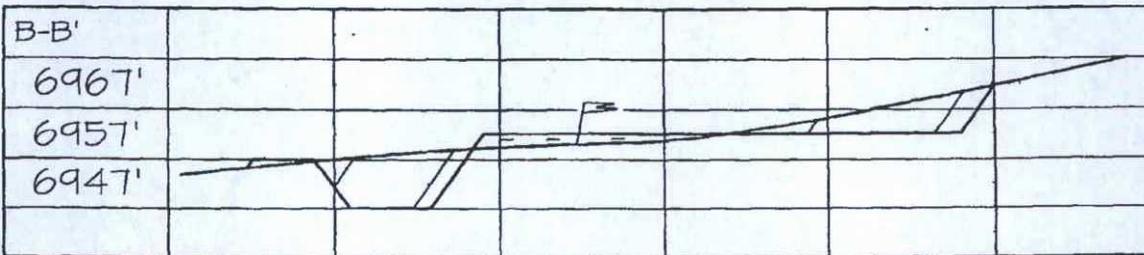
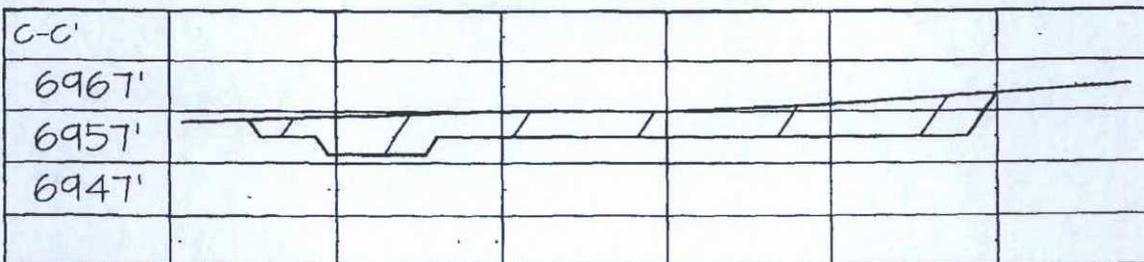
WILLIAMS PRODUCTION COMPANY SCHALK 32 #2A
2070' FSL & 660' FWL, SECTION 32, T31N, R4W, NMPM
RIO ARriba COUNTY, NEW MEXICO ELEVATION: 6955'

Steel T-Posts have been set to define the Edge of Disturbance Limits which are 50' offset from the edge of the staked wellpad.

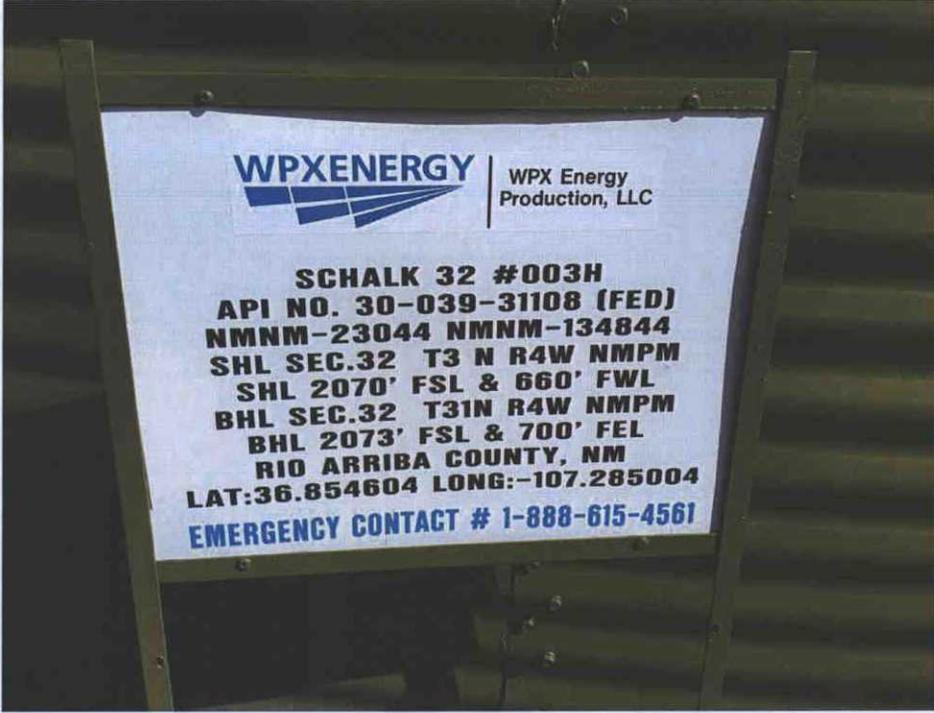
| <p>Photograph 1</p> | |

| <p>Photo Taken by: Glenn Shelby</p> | <p>Description: Schalk 32 #003H.</p> |

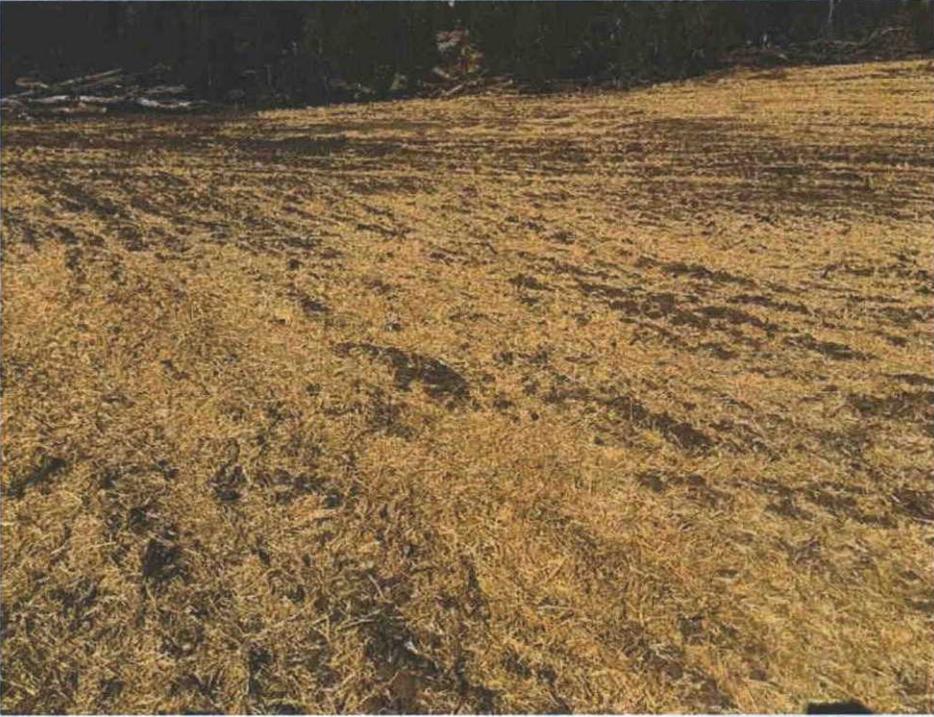
| <p>Photograph 2</p> | |

| <p>Photo Taken by: Glenn Shelby</p> | <p>Description: Facing NW, location of former reserve pit.</p> |

Upon completion of solidification and testing, the pit area was backfilled with non-waste earthen material compacted to native conditions. A minimum of four feet of cover to the extent practical was achieved and the cover included just over a foot of topsoil suitable to establish vegetation.

Following cover, WPX reestablished drainage and contours to approximately match previous topography meeting the Conditions of Approval in the APD and the direction offered by a BLM/USFS inspector. Cover and re-contouring were completed (October 20, 2015).

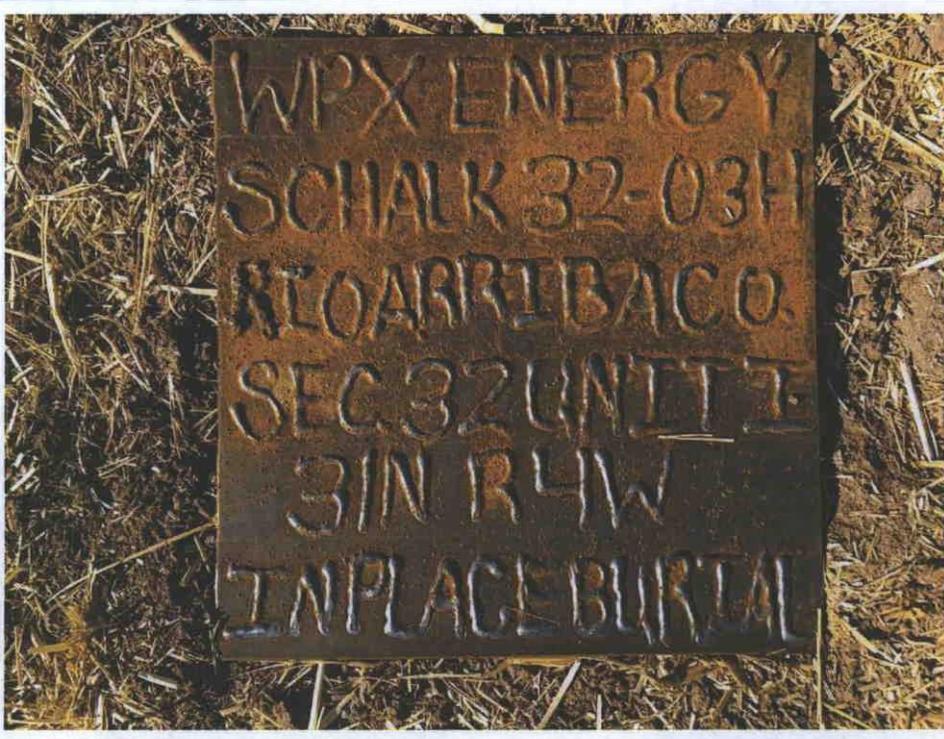
| <p>Photograph 3</p> | |

| <p>Photo Taken by: Glenn Shelby</p> | <p>Description: Steel marker set marking location of buried reserve pit.</p> |
