Proposed Alternative Method Permit or Closure Plan Application

BELOW-GRADE TANK CLOSURE PLAN

Valentine GC 001A

API No. 3004521881

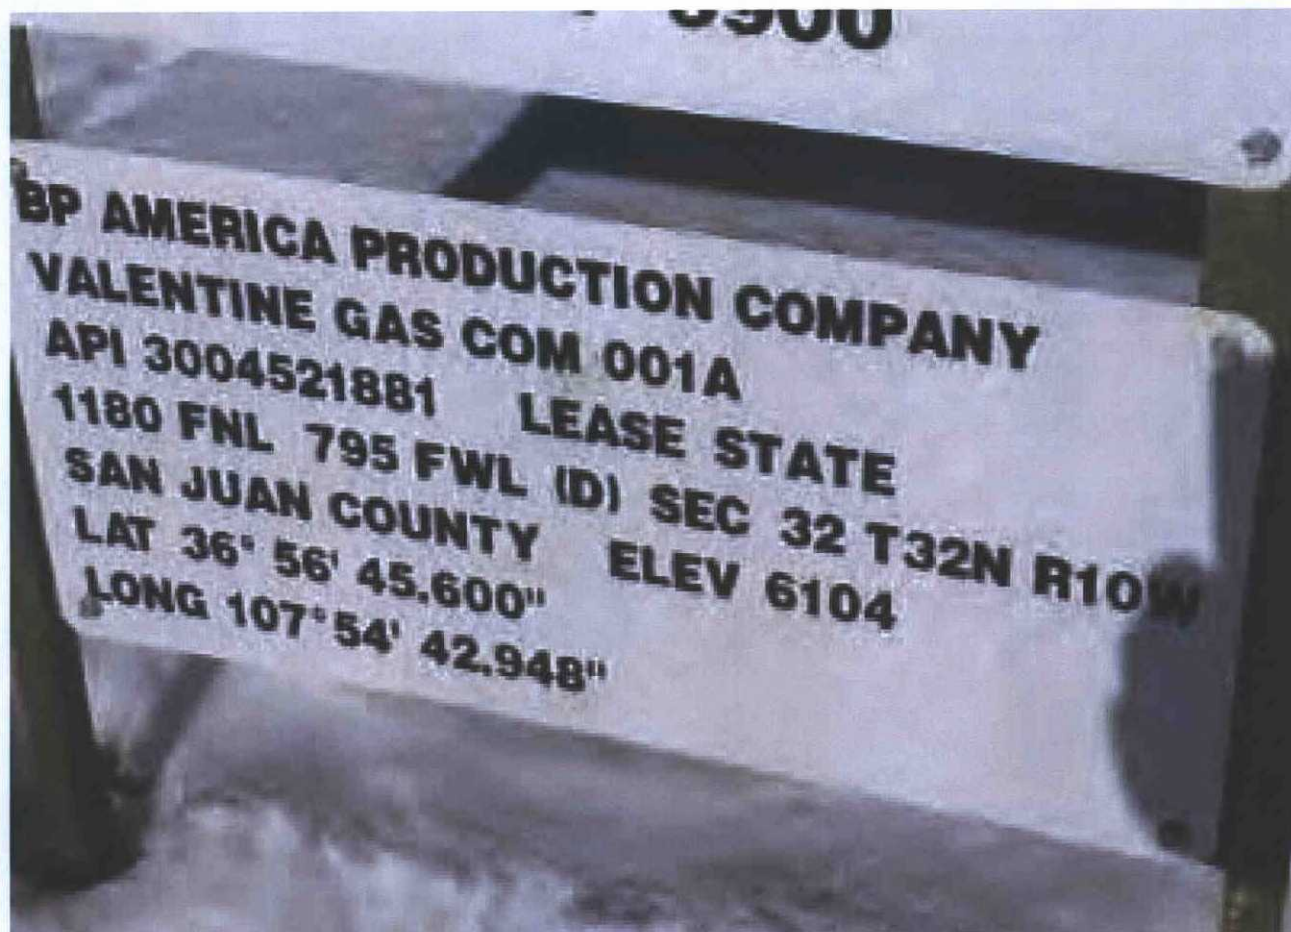
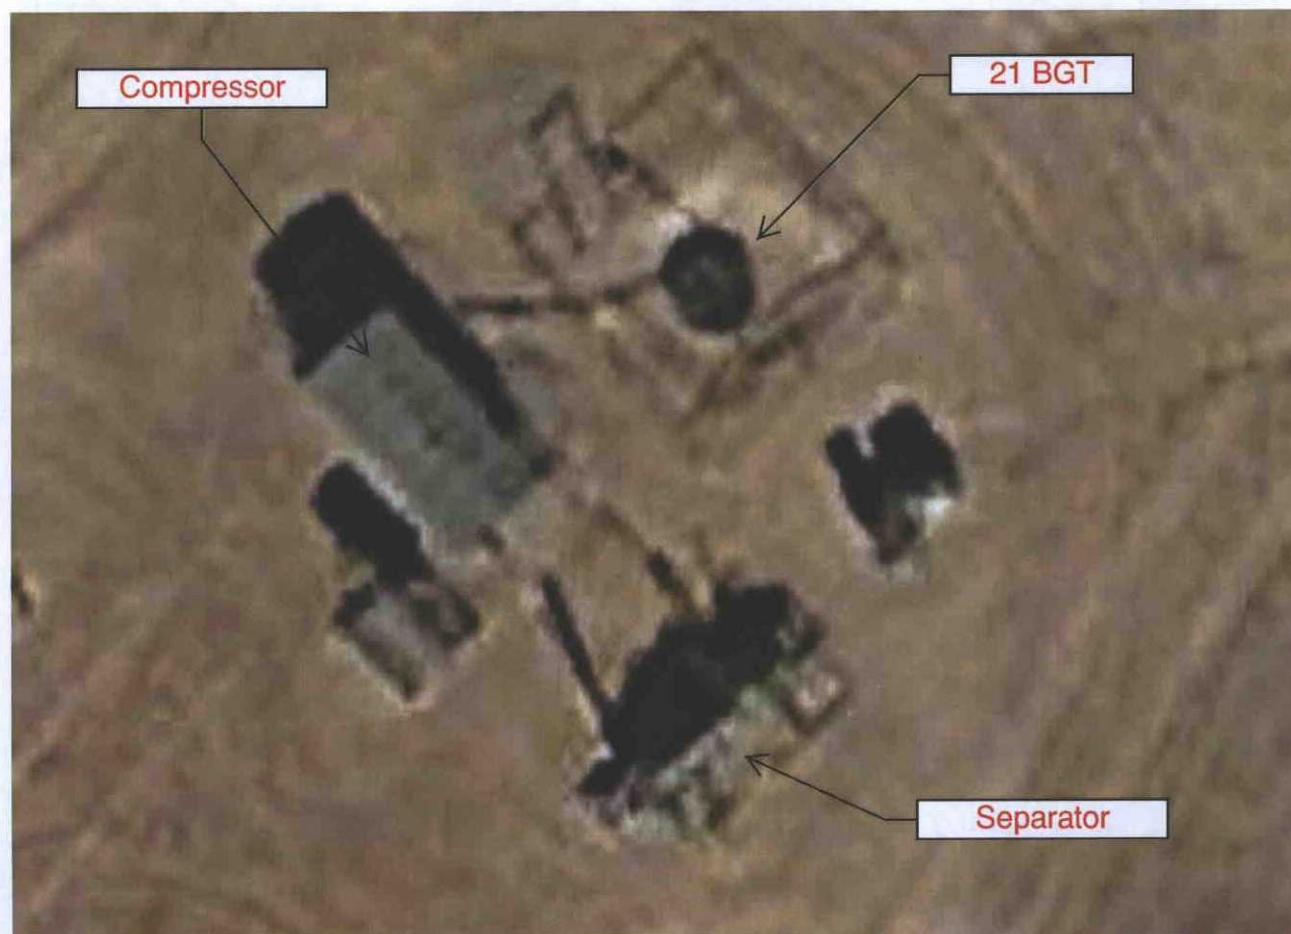
1. **January 26, 2016:** Impacted soils discovered during confirmation sampling of 21 barrel below-grade tank. Preliminary investigation conducted with the advancement of four (4) test holes (see Field Report - page 1 of 3 for locations).
2. **January 29, 2016:** Remediation via excavation initiated. New Mexico Oil Conservation Division (NMOCD) representative from the District III Aztec office was present during the sample collection (see Field Report - page 2 of 3).
3. **February 02, 2016:** Subsequent sampling of expanded southwest sidewall conducted (see Field Report - page 3 of 3).
4. **February 10, 2016:** Final excavation measurements (in feet) approximately 15 x 15 x 9.5 average depth below grade. Total volume transported to JFJ Landfarm = 95 cubic yards (Form C-138 attached).

<b>SITE OBSERVATIONS:</b>	LOST INTEGRITY OF EQUIPMENT: YES <u>NO</u> EXPLANATION -
APPARENT EVIDENCE OF A RELEASE OBSERVED AND/OR OCCURRED: <u>YES</u> NO EXPLANATION: <b>DISCOLORED SOILS DIRECTLY BENEATH BGT.</b>	EQUIPMENT SET OVER RECLAIMED AREA: YES <u>NO</u> EXPLANATION -
OTHER: <b>APPEARS THAT SANDSTONE WAS CARVED OUT TO INSTALL 21 BGT. BEDROCK WAS OBSERVED AS SHALLOW AS 2 FEET (FT.) BELOW GRADE &lt; 10 FT. FROM BGT (NW QUADRANT). BEDROCK SANDSTONE DISCOLORATION PHASED INTO OLIVE GRAY TO A PALE YELLOWISH ORANGE.</b>	
SOIL IMPACT DIMENSION ESTIMATION: <b>10</b> ft. X <b>10</b> ft. X <b>1</b> ft.	IMPACTED SOIL ESTIMATION (Cubic Yards): <b>3 - 5 (±)</b>
DEPTH TO GROUNDWATER: <b>&gt;100'</b>	NEAREST WATER SOURCE: <b>&gt;1,000'</b> NEAREST SURFACE WATER: <b>&lt;1,000'</b> NMOC DTPH CLOSURE STD: <b>1,000</b> ppm

Describe Area Affected and Cleanup Action Taken.\* The impacts found surrounding and below the BGT were excavated and transported off site for landfarming. Approximately 95 cubic yards were removed from the site. Final laboratory analysis supported closure of the BGT location.
