Burlington Resources Oil & Gas Company, LP San Juan Basin Below Grade Tank Closure Report

Lease Name: Marshall 1 API No.: 30-045-06530

RE: Below Grade Tank Closure Report

Marshall #1

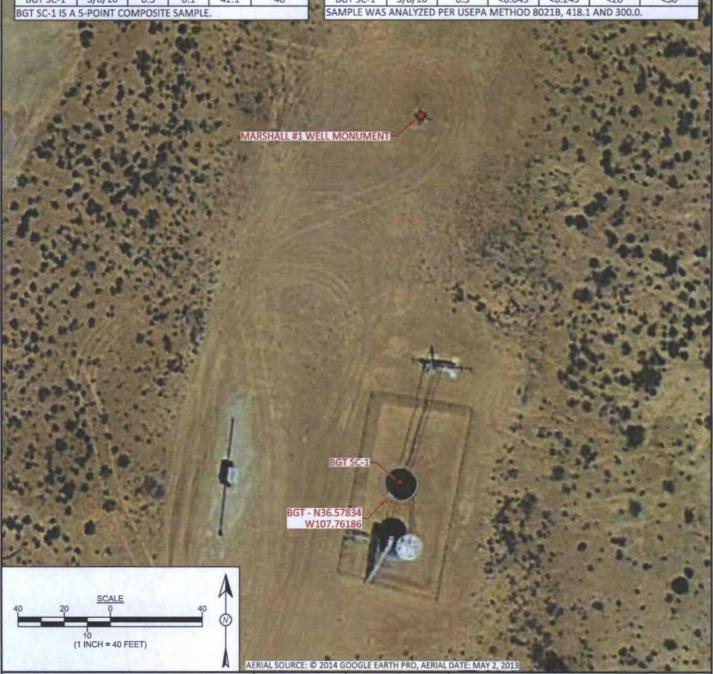
FIGURE 2

SAMPLE LOCATIONS

ALC: N	Fie	ld Samplin	ng Result	s	
Sample ID	Date	Depth (ft)	OVM- PID (ppm)	TPH (mg/kg)	Chlorides (mg/kg)
NN	OCD ACTI		100	250	
BGT SC-1	3/8/16	0.5	0.1	42.1	40

Laboratory Analytical Results									
Sample ID	Date	Depth (ft)	Benzene (mg/kg)	Total BTEX (mg/kg)	TPH (mg/kg)	Chlorides (mg/kg)			
NMOCD ACTION LEVEL		0.2	50	100	250				
BGT SC-1	3/8/16	0.5	< 0.049	< 0.245	<20	<30			
SAMPLE WAS	ANALYZED	DER LISEDA	METHOD 8	021B 418 1	AND 300 0

AERIAL SITE MAP
BELOW GRADE TANK CLOSURE
MARCH 2016
ConocoPhillips
MARSHALL #1

On March 8, 2016, AES personnel conducted field sampling and collected one 5-point composite (BGT SC-1) from below the BGT. Soil was collected from approximately 0.5 feet below the former BGT. Soil sample BGT SC-1 was field screened for volatile organic compounds (VOCs), total petroleum hydrocarbon (TPH), and chloride, and was submitted for confirmation laboratory analysis. Soil sample locations are included on Figure 2.

Field screening readings for VOCs via OVM were measured at 0.1 ppm in SC-1. Field TPH concentrations were reported at 42.1 mg/kg and the field chloride concentration was 40 mg/kg. Field sampling results are summarized in Table 1 and presented on Figure 2. The AES Field Sampling Report is attached.

Laboratory analytical results reported benzene and total BTEX concentrations in BGT SC-1 as less than 0.049 mg/kg and 0.245 mg/kg, respectively. TPH concentrations were reported at less than 20 mg/kg. The laboratory chloride concentration was reported below the laboratory detection limit of 30 mg/kg. Laboratory analytical results are summarized in Table 2 and included on Figure 2. The laboratory analytical report is attached.
