Proposed Alternative Method Permit or Closure Plan Application

Facility or well name: SAN JUAN 30-5 UNIT 27

Burlington Resources Oil & Gas Company
San Juan Basin: New Mexico Assets
Below Grade Tank Closure Report

Lease Name: SAN JUAN 30-5 UNIT 27
API No.: 30-039-07792

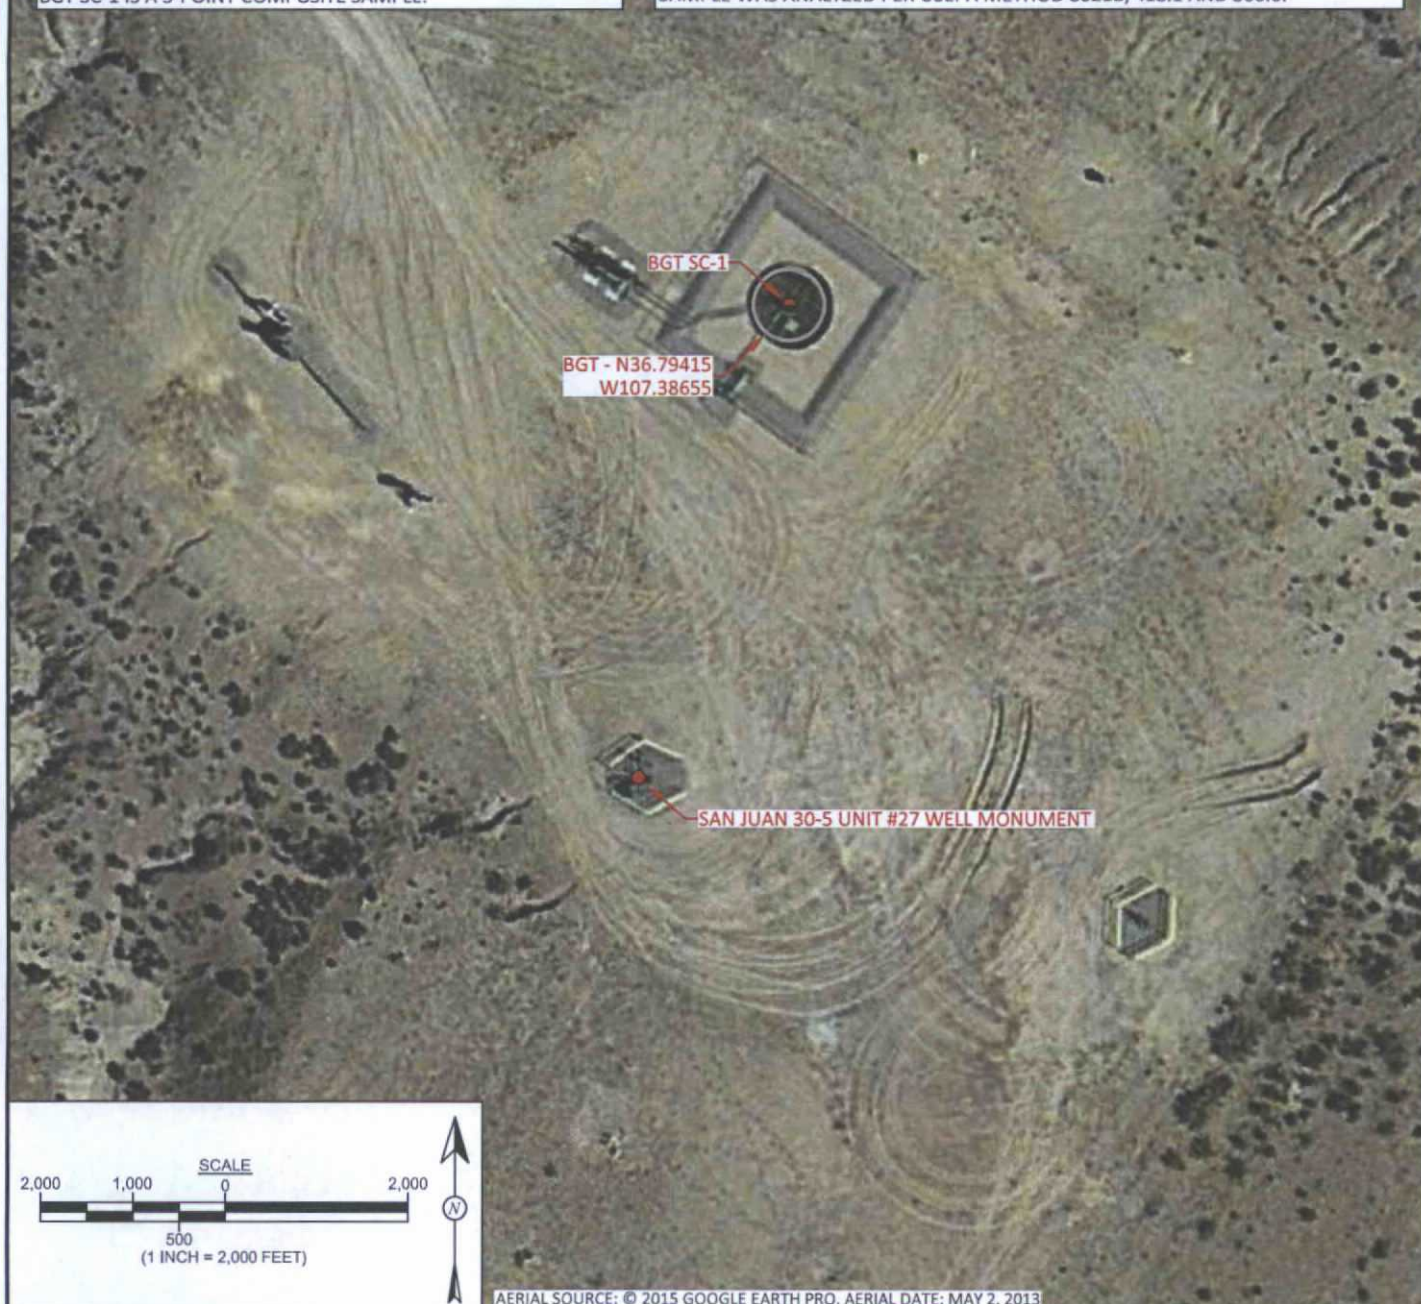
FIGURE 2

**AERIAL SITE MAP
BELOW GRADE TANK CLOSURE
APRIL 2016**
ConocoPhillips
SAN JUAN 30-5 UNIT #27
SW¼ SW¼, SECTION 20, T30N, R5W
RIO ARriba COUNTY, NEW MEXICO
N36.79388, W107.38665
