Release Notification and Corrective Action

Name of Company Burlington Resources Oil & Gas Co.	Contact Bobby Spearman
Address 3401 East 30th St, Farmington, NM	Telephone No. (505)-320-3045
Facility Name: San Juan 29-7 NP 509	Facility Type: Gas well

RE: COPC SJ 29 7 UNIT NP 509

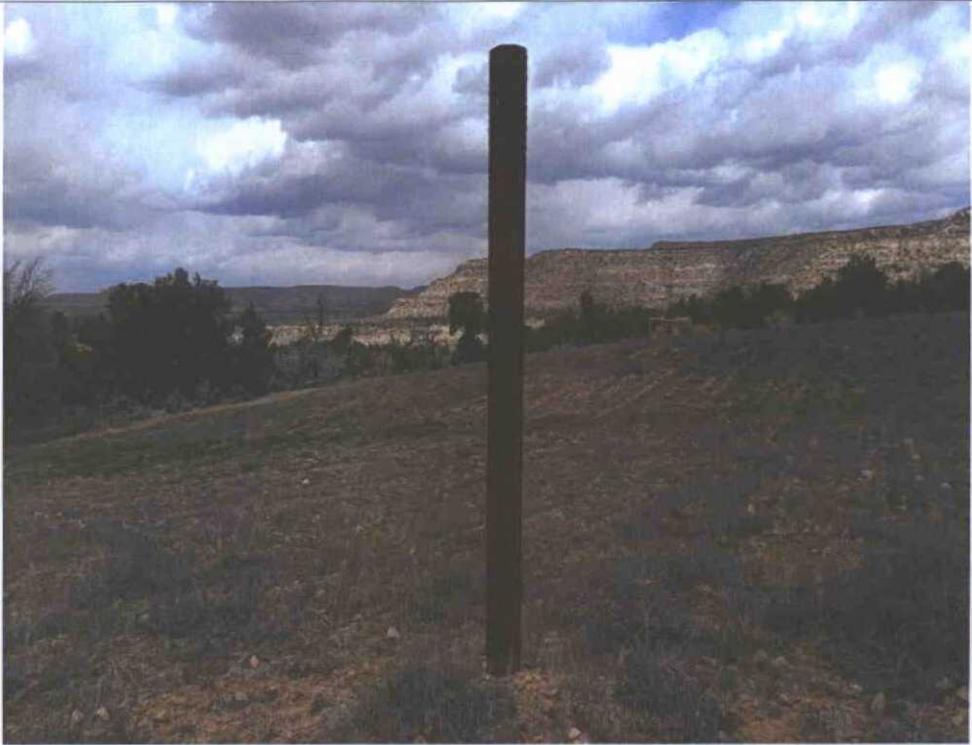
Photo #1

Client: ConocoPhillips	
Project Name: San Juan 29-7 Unit NP 509	
Rio Arriba County, NM	
Date Photo Taken: April 25, 2016	
BGT GPS and Location: 36.73112, -107.57112 NE¼ NE¼, Section 16, T29N, R7W	
Taken by: Delilah Dougi, AES	Subject: BGT sampling, April 2016
	Description: Facing N, overview of entire location.

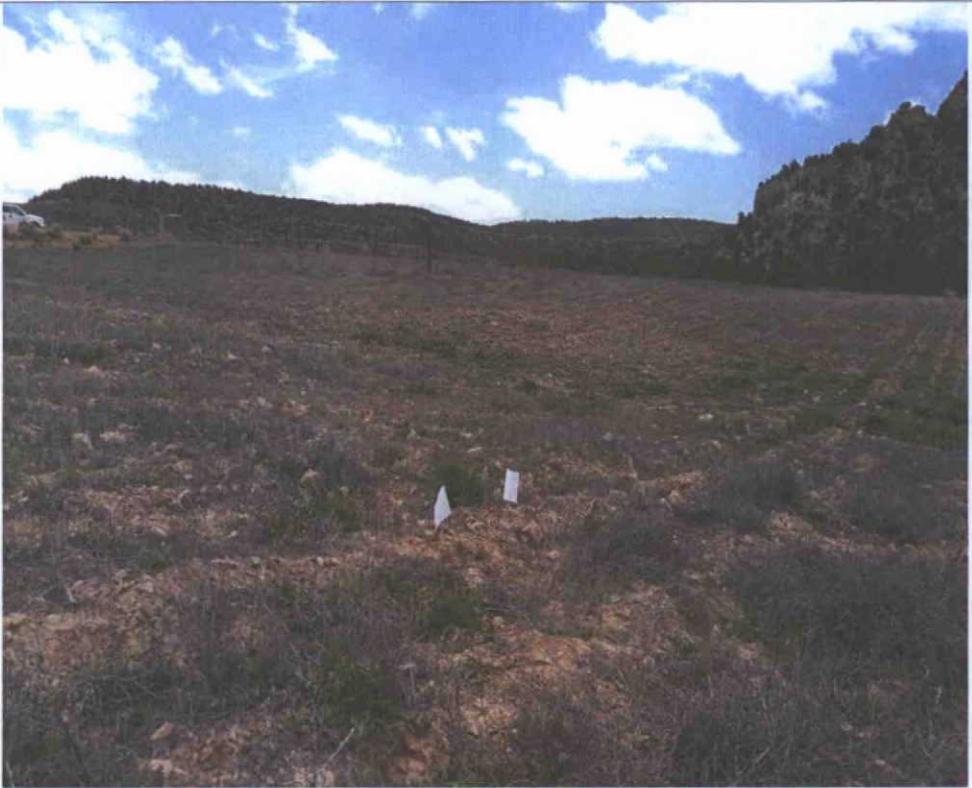
Photo #2

Client: ConocoPhillips	
Project Name: San Juan 29-7 Unit NP 509	
Rio Arriba County, NM	
Date Photo Taken: April 25, 2016	
BGT GPS and Location: 36.73112, -107.57112 NE¼ NE¼, Section 16, T29N, R7W	
Taken by: Delilah Dougi, AES	Subject: BGT sampling, April 2016
	Description: Facing S, sample location.
