Pit, Below-Grade Tank, or
Proposed Alternative Method Permit or Closure Plan Application

1.
Operator: Burlington Resources Oil & Gas Company, LP OGRID #: 14538
Address: PO BOX 4289, Farmington, NM 87499
Facility or well name: HUERFANO UNIT 55
API Number: 30-045-05691 OCD Permit Number: _____
U/L or Qtr/Qtr H Section 27 Township 26N Range 9W County: San Juan
Center of Proposed Design: Latitude _____°N Longitude _____°W NAD: 1927 1983
Surface Owner: Federal State Private Tribal Trust or Indian Allotment

- Figure 1. Topographic Site Location Map
- Figure 2. Aerial Site Map, June 2016
- AES Field Sampling Report 062116
- Hall Analytical Report 1606C22
- Hall Analytical Report 1608G58

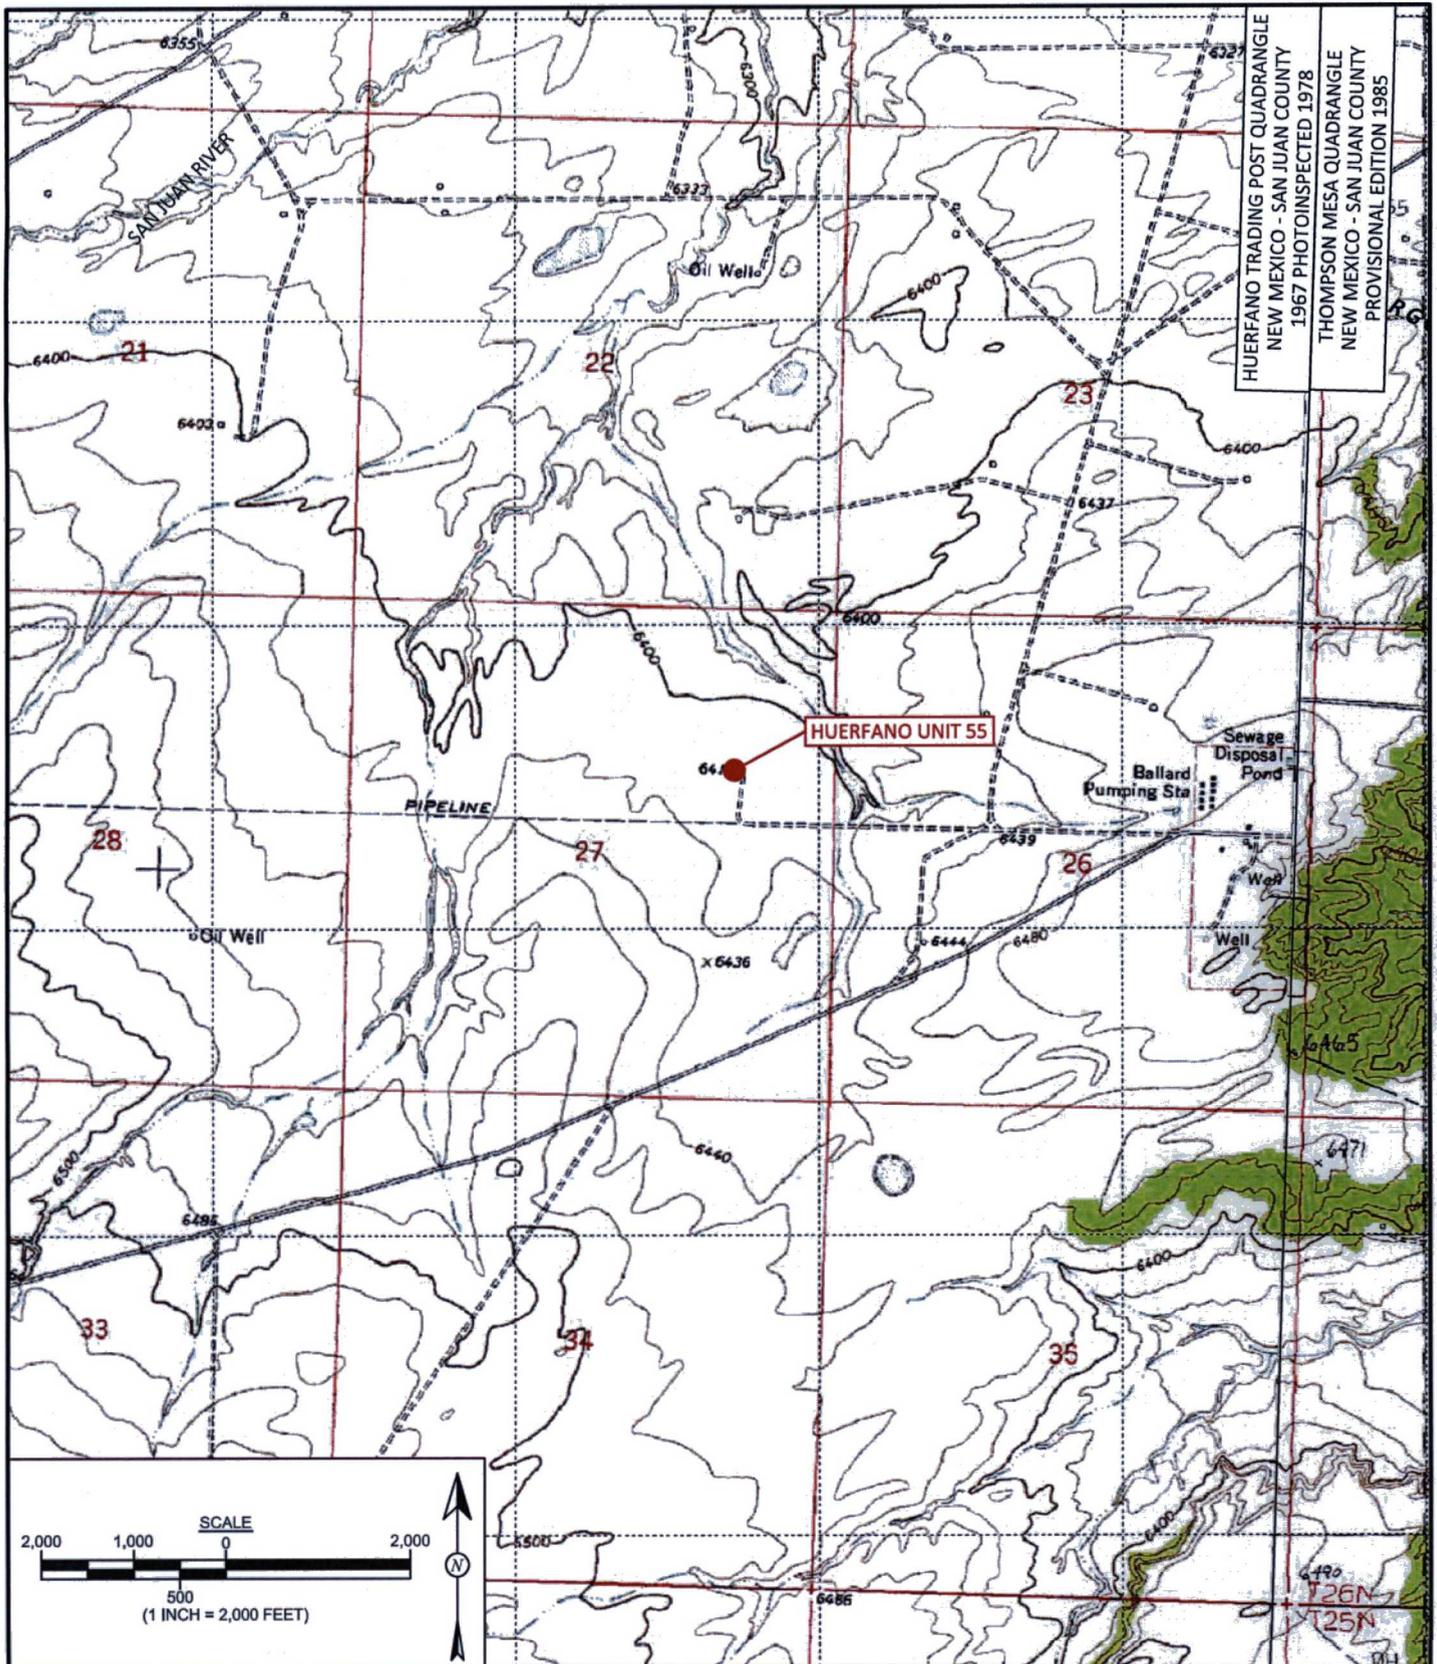
HUERFANO TRADING POST QUADRANGLE
 NEW MEXICO - SAN JUAN COUNTY
 1967 PHOTOINSPECTED 1978
 THOMPSON MESA QUADRANGLE
 NEW MEXICO - SAN JUAN COUNTY
 PROVISIONAL EDITION 1985

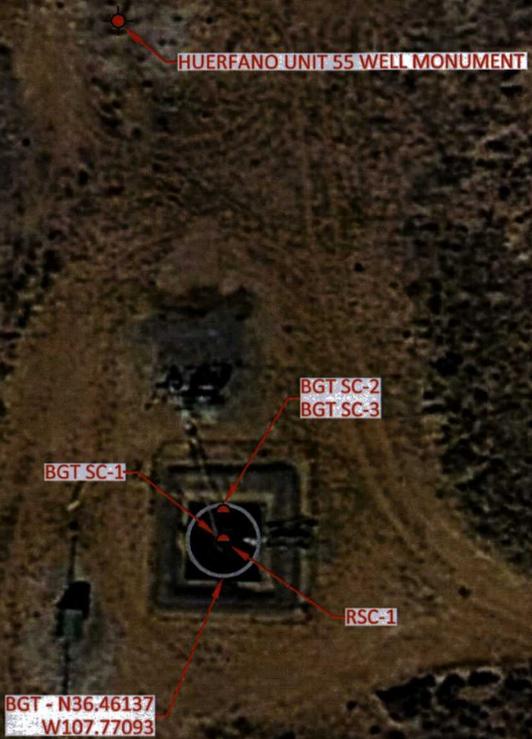
Laboratory Analytical Results									
Sample ID	Date	Depth Below BGT (ft)	Benzene (mg/kg)	Total BTEX (mg/kg)	TPH (mg/kg)	TPH-GRO (mg/kg)	TPH-DRO (mg/kg)	TPH-MRO (mg/kg)	Chlorides (mg/kg)
NMOC ACTION LEVEL			0.2/10*	50	100/5,000*	100/5,000*			250/NE*
BGT SC-1	6/21/16	0.5	<0.024	<0.216	18,000	<4.8	1,400	11,000	240
BGT SC-2	6/21/16	0.5	<0.023	<0.207	6,700	<4.6	880	7,100	<30
BGT SC-3	6/21/16	2.0	<0.024	<0.213	<18	<4.7	<9.4	<47	<30
RSC-1	8/26/16	6.0 ft bgs	<0.025	<0.225	NA	<5.0	170	1,700	NA
RSC-1	8/26/16	8.0 ft bgs	<0.025	<0.221	NA	<4.9	11	78	NA

BGT SC-1 THROUGH BGT SC-3 WERE ANALYZED PER USEPA METHOD 8021B, 418.1 AND 300.0. RSC-1 WAS ANALYZED PER USEPA METHOD 8021B AND 8015. NA - NOT ANALYZED, NE - NOT ESTABLISHED

AERIAL SOURCE: © 2015 GOOGLE EARTH PRO, AERIAL DATE: MARCH 16, 2016

Action levels for releases are determined by the NMOCD ranking score per *NMOCD Guidelines for Remediation of Leaks, Spills, and Releases* (August 1993), and the site was assigned a rank of 0. Benzene and total BTEX concentrations in all samples were below the NMOCD action levels of 10 mg/kg and 50 mg/kg, respectively. TPH concentrations, by USEPA Method 418.1 were above the action level of 5,000 mg/kg in SC-1 and SC-2, with 18,000 mg/kg and 6,700 mg/kg, respectively (June 2016), and TPH concentrations (analyzed by USEPA Method 8015) were reported as 1,400 mg/kg DRO and 11,000 mg/kg MRO in BGT SC-1 and 880 mg/kg DRO and 7,100 mg/kg MRO in BGT SC-2.
