Pit, Below-Grade Tank, or
Proposed Alternative Method Permit or Closure Plan Application

1.
Operator: Burlington Resources Oil & Gas Company, LP OGRID #: 14538
Address: PO BOX 4289, Farmington, NM 87499
Facility or well name: SAN JUAN 29-4 UNIT 21 - TANK 2 (WEST)
API Number: 30-039-21453 OCD Permit Number: _____
U/L or Qtr/Qtr K Section 5 Township 29N Range 4W County: Rio Arriba
Center of Proposed Design: Latitude 36.75171 °N Longitude -107.27923 °W NAD: 1927 1983
Surface Owner: Federal State Private Tribal Trust or Indian Allotment

ConocoPhillips Company
San Juan Basin: New Mexico Assets
Below Grade Tank Closure Report

Lease Name: San Juan 29-4 Unit 21 - Tank 2
API No.: 30-039-21453

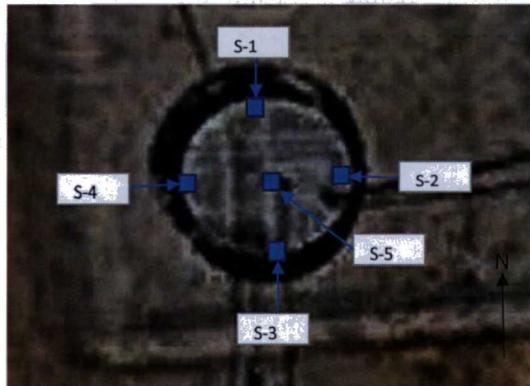
Observations: Moisture present below liner similar to surrounding area due to recent precipitation.

SC-1 West Tank is a 5-point composite of S-1 through S-5, collected 0.5 ft below BGT.

Sample SC-1 West Tank was laboratory analyzed for TPH (8015 and 418.1), BTEX (8021) and chlorides (300.0).
