Pit, Below-Grade Tank, or
Proposed Alternative Method Permit or Closure Plan Application

1.
Operator: BP America Production Company OGRID #: 778
Address: 200 Energy Court, Farmington, NM 87401
Facility or well name: Decker LS 001A
API Number: 3004524325 OCD Permit Number: _____
U/L or Qtr/Qtr E Section 17 Township 32N Range 10W County: San Juan
Center of Proposed Design: Latitude 36.987941 Longitude -107.911607 NAD: ☐ 1927 ☒ 1983
Surface Owner: ☐ Federal ☐ State ☒ Private ☐ Tribal Trust or Indian Allotment

3.
☒ **Below-grade tank:** Subsection I of 19.15.17.11 NMAC TANK A
Volume: 95 bbl Type of fluid: Produced water
Tank Construction material: Steel
☐ Secondary containment with leak detection ☐ Visible sidewalls, liner, 6-inch lift and automatic overflow shut-off
☐ Visible sidewalls and liner ☐ Visible sidewalls only ☐ Other Single wall/ Double bottom; no visible sidewalls
Liner type: Thickness _____ mil ☐ HDPE ☐ PVC ☐ Other _____

☒ Closure Completion Date: 3/13/2017

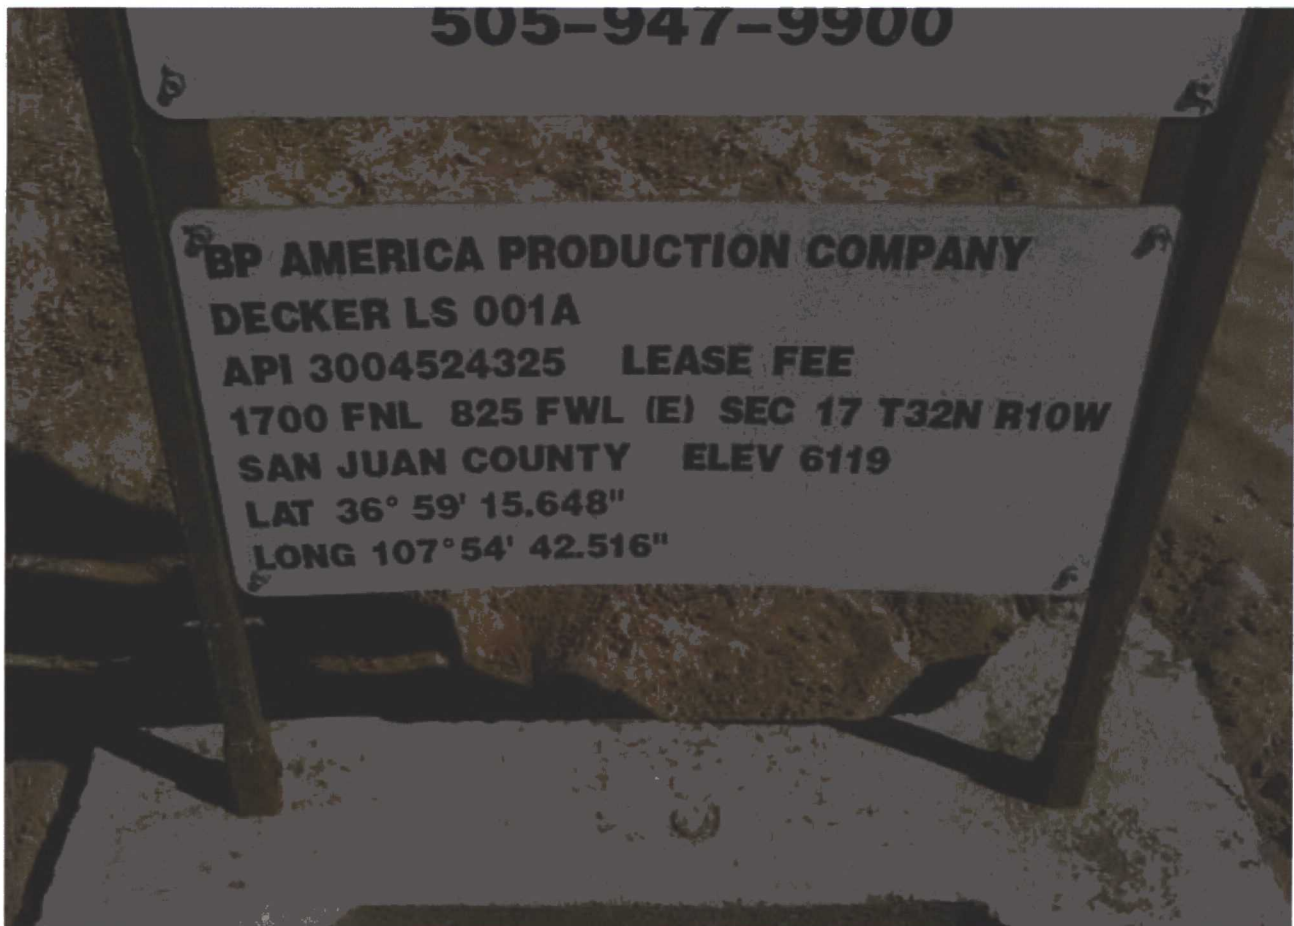
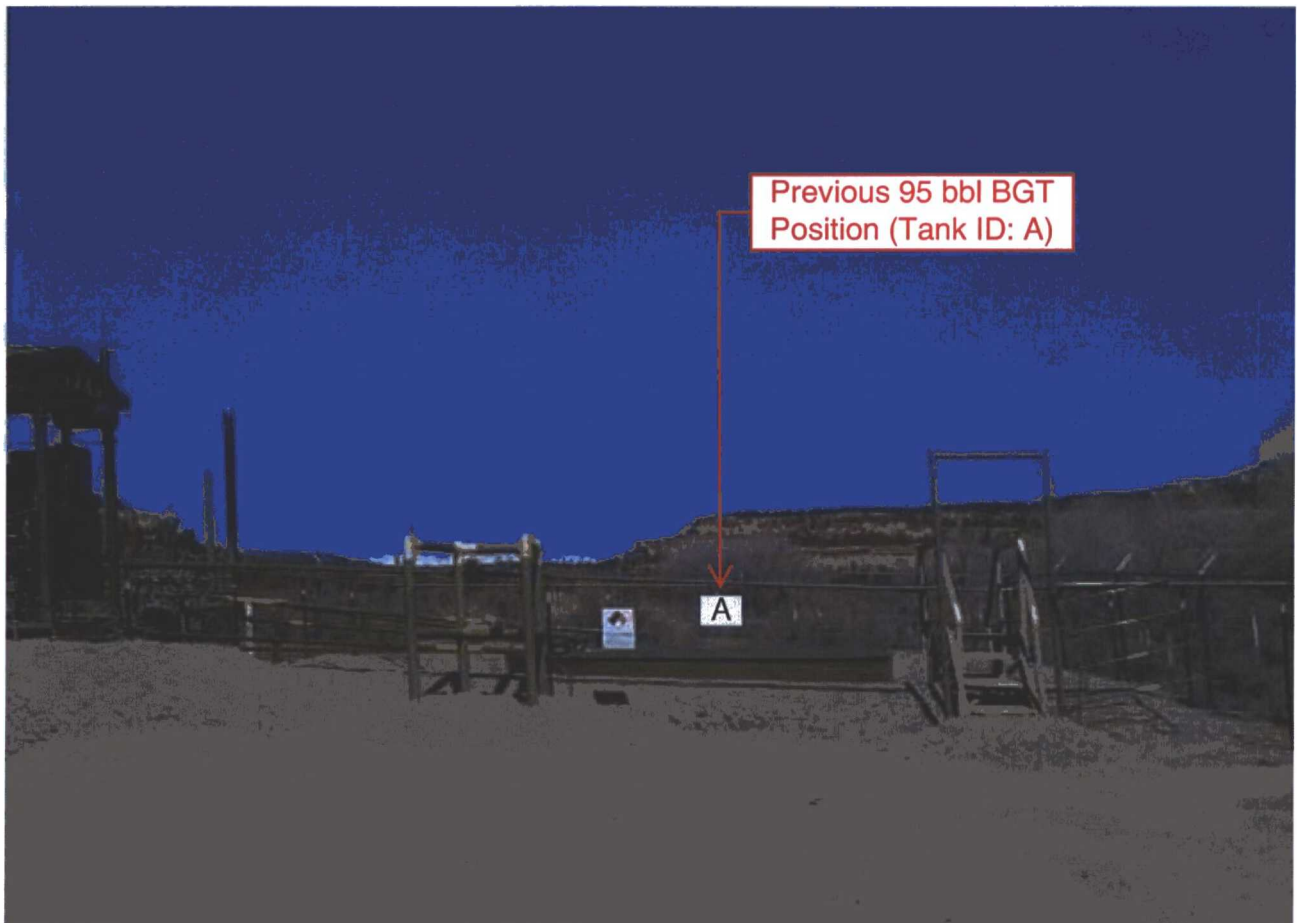
Closure report on C-144 form is included including photos of reclamation completion.
