Pit, Below-Grade Tank, or  
Proposed Alternative Method Permit or Closure Plan Application

BELOW-GRADE TANK CLOSURE PLAN

Neil A 002A

API No. 3004522735

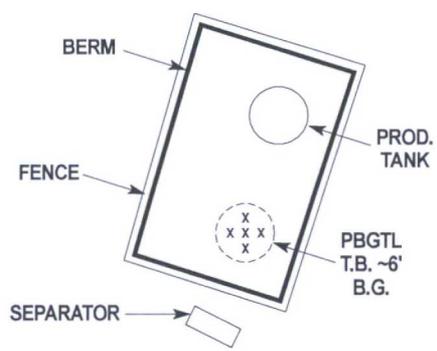
DISCOLORATION/STAINING OBSERVED:  YES /  NO EXPLANATION - **VARYING GRAYS TO BLACK SAND & SANDSTONE.**

APPARENT EVIDENCE OF A RELEASE OBSERVED AND/OR OCCURRED:  YES /  NO EXPLANATION: **WATER FROM BGT BOTTOM ESCAPING & DISCOLORATION.**

**SCRAPED BEDROCK ~ 2 FT. BELOW BGT BOTTOM & COLLECTED GRAB SAMPLE NOTED.**
