Pit, Below-Grade Tank, or
Proposed Alternative Method Permit or Closure Plan Application
Type of action: Below grade tank registration Permit of a pit or proposed alternative method
Closure of a pit, below-grade tank, or proposed alternative method Modification to an existing permit/or registration Closure plan only submitted for an existing permitted or non-permitted pit, below-grade tank,
or proposed alternative method
Instructions: Please submit one application (Form C-144) per individual pit, below-grade tank or alternative request
lease be advised that approval of this request does not relieve the operator of liability should operations result in pollution of surface water, ground water or the nvironment. Nor does approval relieve the operator of its responsibility to comply with any other applicable governmental authority's rules, regulations or ordinances.
Operator: WPX Energy Production, LLC OGRID #: 120782

WPX Energy Production Co., LLC San Juan Basin: New Mexico Assets

Below-Grade Tank Removal Closure Report Rosa Unit #116 (API #30-039-23484) Unit Letter A, Section 24, T31N, R06W Rio Arriba County, NM

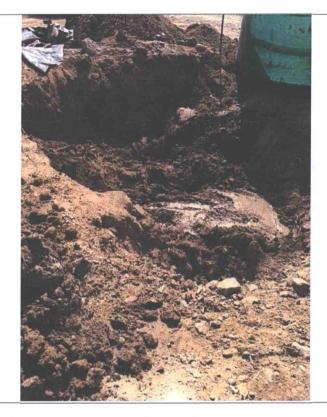
A five-point composite sample (SC-1) was collected from beneath the BGT following BGT removal on August 7, 2017. No obvious stained soils were observed beneath the BGT.

Description: Soil beneath liner following BGT removal.

Sampling results indicate no release occurred from the BGT. See attached Form C-141.

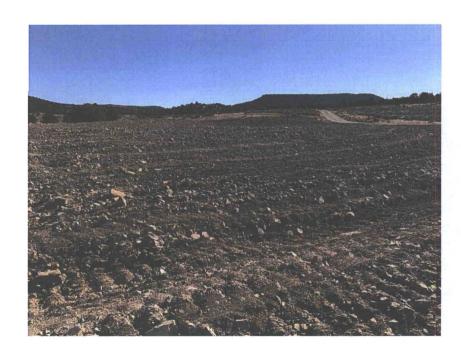
Description: Facing E, looking at former well pad location following recontouring and reseeding.

The BGT location was backfilled with clean soil and compacted during reclamation activities. The BGT location was included in P&A reclamation activities which were conducted to meet requirements and guidelines of the BLM-FFO Bare Soil Reclamation Procedures (BLM 2013a) and Onshore Oil and Gas Order No. 1. Seeding was completed on September 16, 2017.

Disturbed areas of the location were re-contoured to blend with surrounding landscape, emphasizing restoration of the existing drainage patterns and landform to pre-construction conditions, to the extent practicable. Stockpiled topsoil was evenly redistributed across the reclaimed area prior to the final seedbed preparation. Seedbed preparation within the compacted areas included ripping to a minimum depth of 18 inches and spacing furrows feet apart. Final seedbed preparation consisted of raking or harrowing the spread topsoil prior to seeding. A pinyon-juniper community plus fourwing saltbush and sagebrush seed mix was chosen for the area.

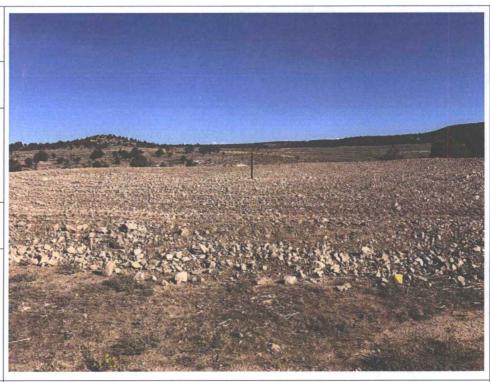
Description: Facing N, looking at former well pad location following recontouring and reseeding.

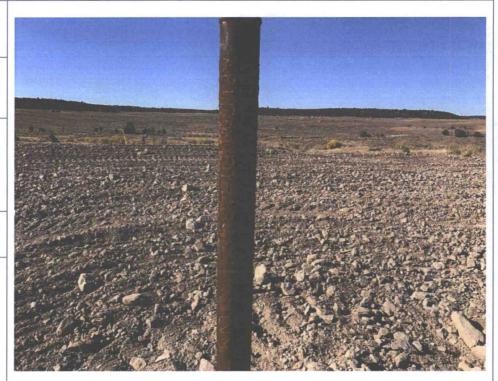
Description: Facing NNW, looking at former well pad location following recontouring and reseeding.
