Pit, Below-Grade Tank, or
Proposed Alternative Method Permit or Closure Plan Application

1.
Operator: Hilcorp Energy Company OGRID #: 372171
Address: PO BOX 4700, Farmington, NM 87499
Facility or well name: Scott 9
API Number: 30-045-21818 OCD Permit Number: _____
U/L or Qtr/Qtr C Section 17 Township 31N Range 10W County: San Juan
Center of Proposed Design: Latitude 36.90335°N Longitude -107.90961°W NAD: 1927 1983
Surface Owner: Federal State Private Tribal Trust or Indian Allotment

\\SVRMAIN2\Shared\Animas 2000\Dropbox (Animas Environmental)\0000 AES Server Client Projects
Dropbox\2017 Client Projects\ConocoPhillips\Scott 9 (Hudson 5M)\Scott 9 BGT Release Assessment and
Excavation Report 072517.docx

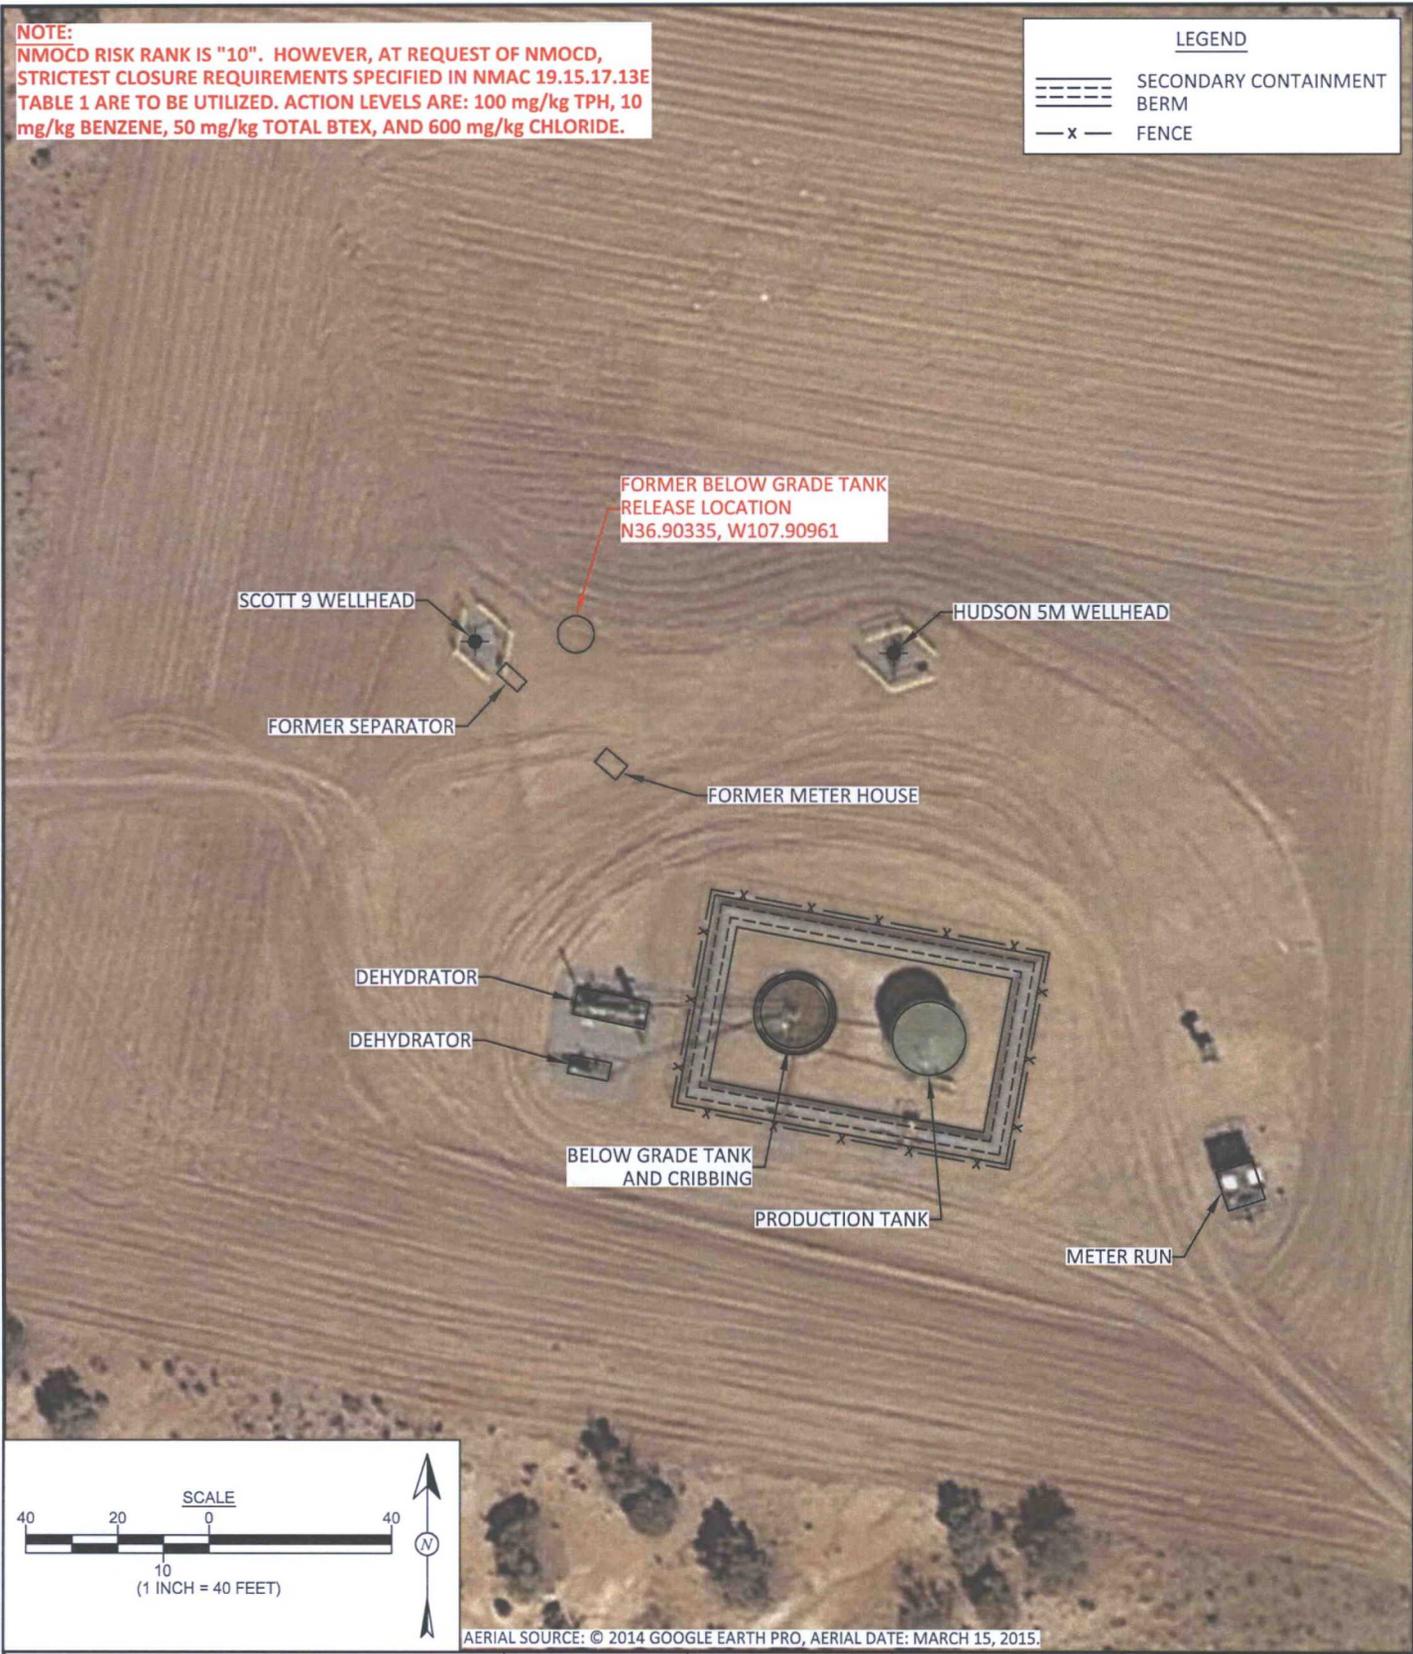
On December 13, 2016, AES personnel returned to the location to complete the release assessment field work. The assessment included collection and field sampling of 14 soil samples from 11 soil borings (SB-1 through SB-11). Based on field sampling results, AES recommended excavation of the release area. Sample locations are shown on Figure 3.

reported in SB-4, with a concentration of 47,800 mg/kg TPH. Excavation of the release area was recommended.

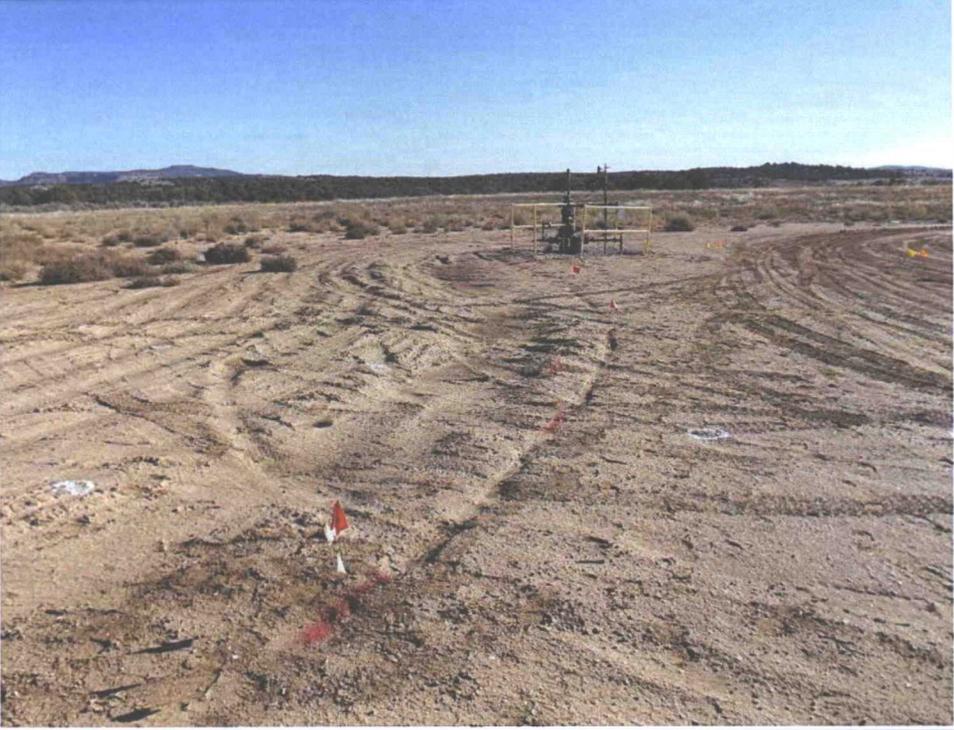
Photo #1

Client: ConocoPhillips		
Project Name: Scott 9 San Juan County, NM		
Date Photo Taken: November 10, 2016		
BGT GPS and Location: 36.90335, -107.90961 NE¼ NW¼, Section 17, T31N, R10W		
Taken by: Corwin Lameman, AES		Subject: BGT Sampling, November 2016
		Description: Facing E, BGT S-1 sample location.

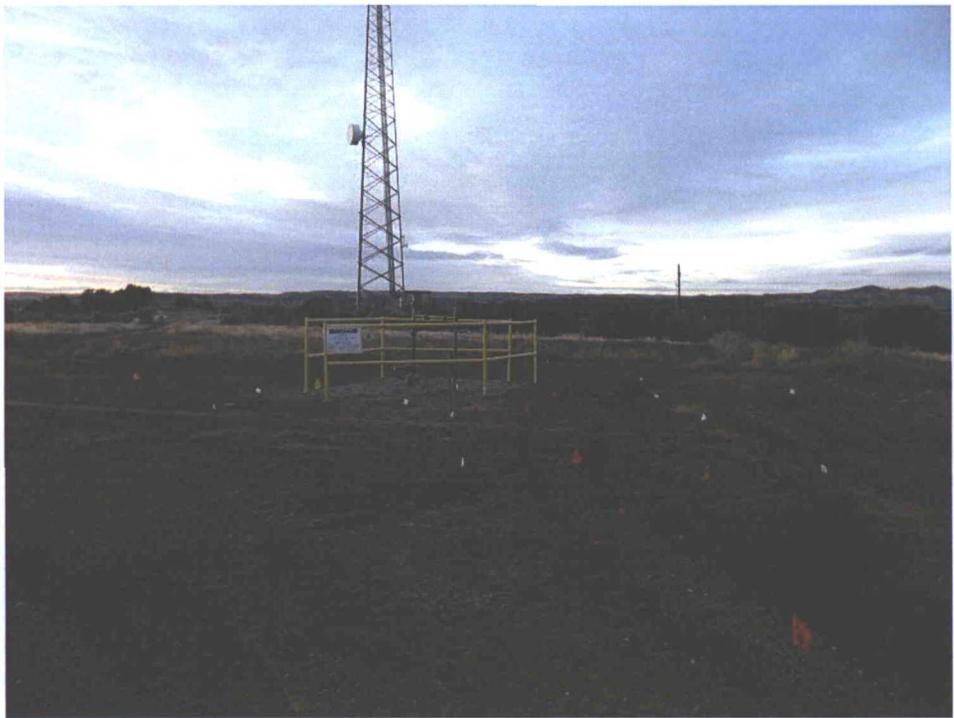
Photo #2

Client: ConocoPhillips		
Project Name: Scott 9 San Juan County, NM		
Date Photo Taken: December 13, 2016		
BGT GPS and Location: 36.90335, -107.90961 NE¼ NW¼, Section 17, T31N, R10W		
Taken by: Corwin Lameman, AES		Subject: Release Assessment, December 2016
		Description: Facing W, SB-1 through SB-11 sample locations.

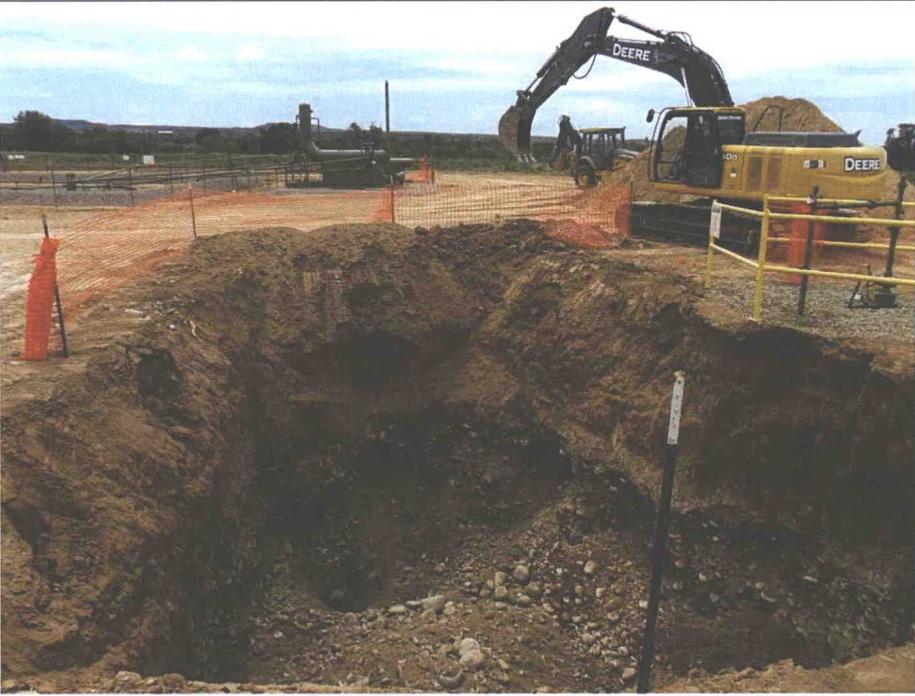
Photo #3

Client: ConocoPhillips	
Project Name: Scott 9 San Juan County, NM	
Date Photo Taken: April 26, 2017	
BGT GPS and Location: 36.90335, -107.90961 NE¼ NW¼, Section 17, T31N, R10W	
Taken by: Corwin Lameman, AES

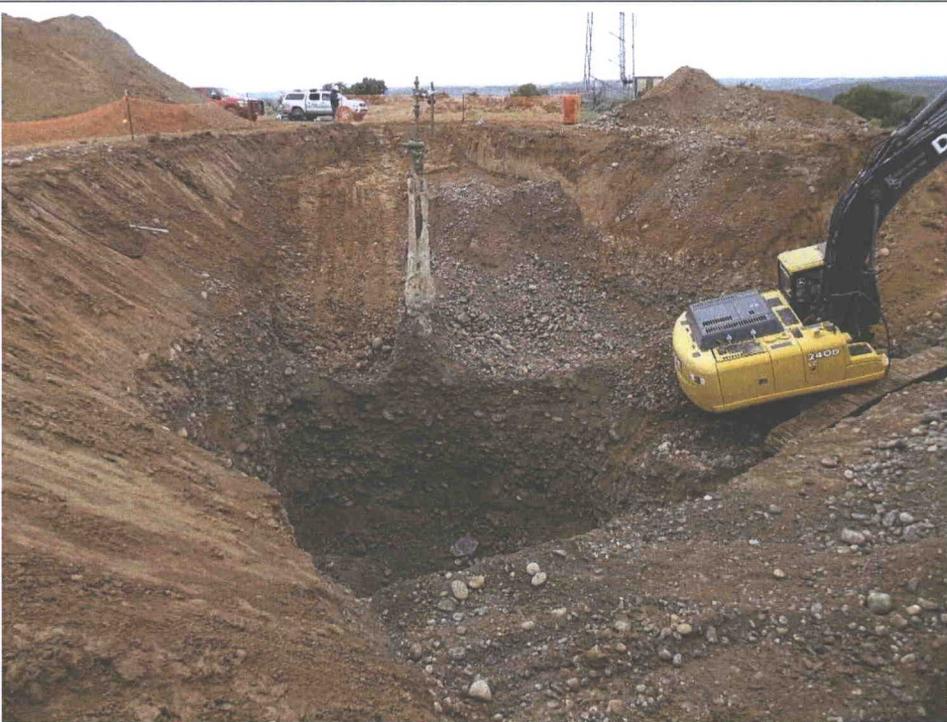
Photo #4

Client: ConocoPhillips	
Project Name: Scott 9 San Juan County, NM	
Date Photo Taken: May 10, 2017	
BGT GPS and Location: 36.90335, -107.90961 NE¼ NW¼, Section 17, T31N, R10W	
Taken by: Corwin Lameman, AES

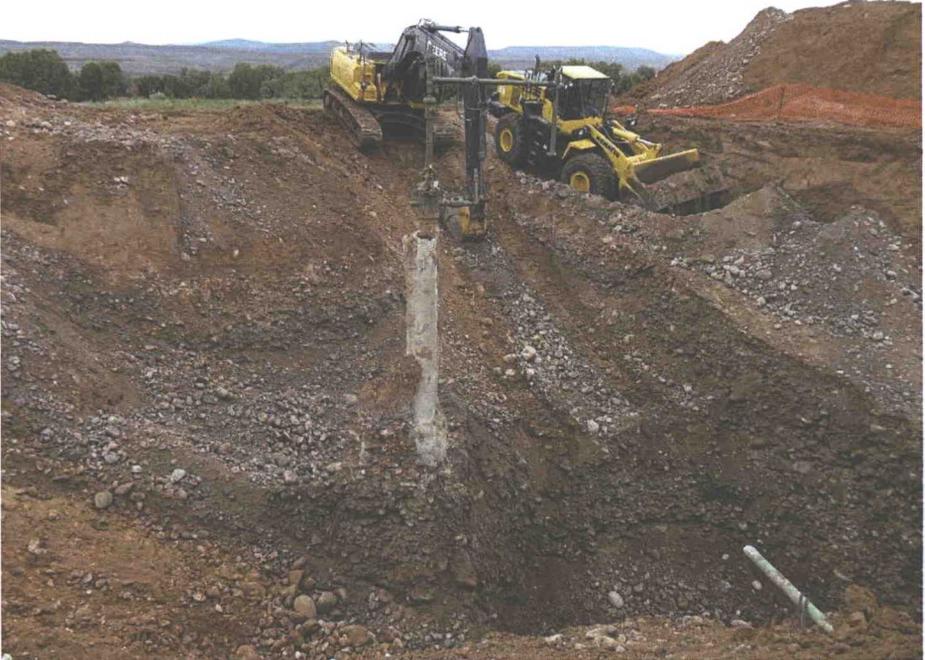
Photo #5

Client: ConocoPhillips	
Project Name: Scott 9 San Juan County, NM	
Date Photo Taken: May 10, 2017	
BGT GPS and Location: 36.90335, -107.90961 NE¼ NW¼, Section 17, T31N, R10W	
Taken by: Corwin Lameman, AES	
	Excavation Dimensions: In Progress
	Description: Facing NE, wellhead and construction of ramp access.

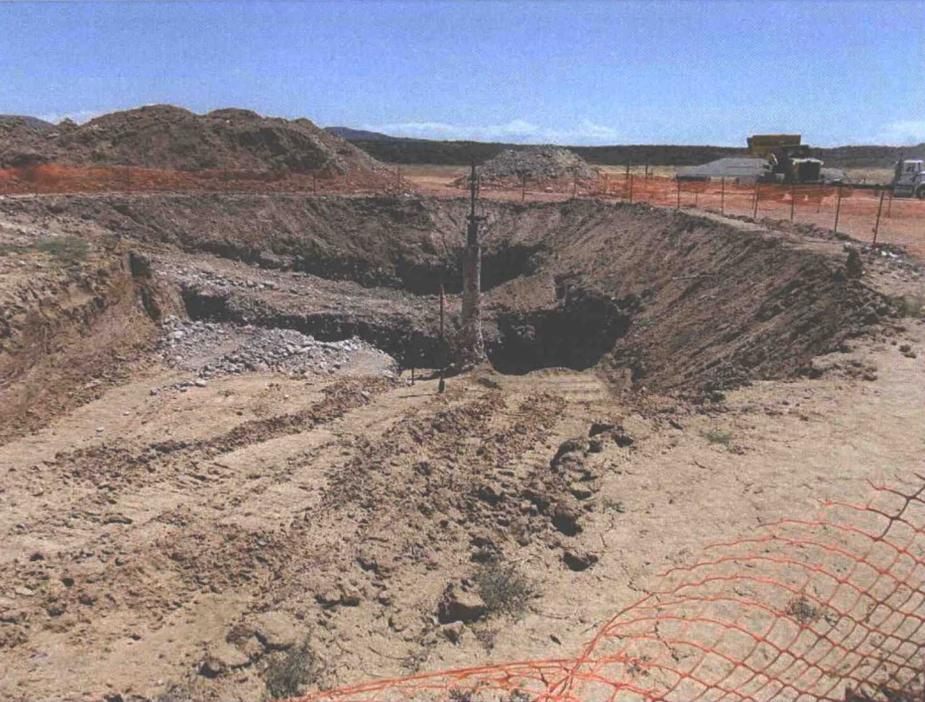
Photo #6

Client: ConocoPhillips	
Project Name: Scott 9 San Juan County, NM	
Date Photo Taken: July 17, 2017	
BGT GPS and Location: 36.90335, -107.90961 NE¼ NW¼, Section 17, T31N, R10W	
Taken by: Corwin Lameman, AES	
	Excavation Dimensions: 32 ft x 40 ft x 38 ft deep
	Description: Facing SE, final excavation extents.

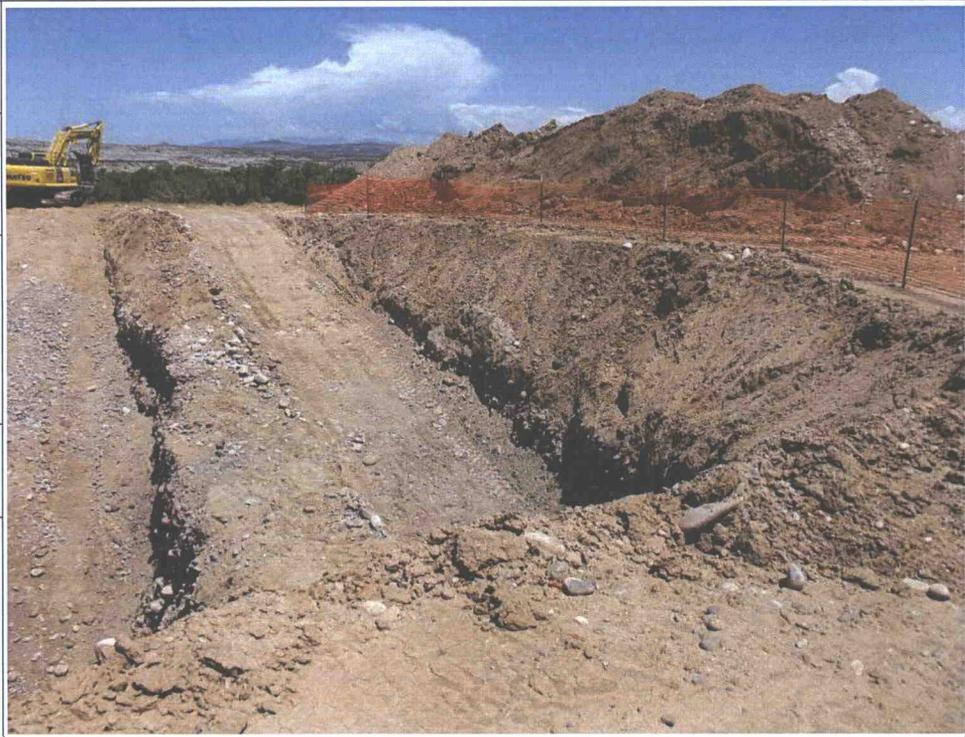
Photo #7

Client: ConocoPhillips	
Project Name: Scott 9 San Juan County, NM	
Date Photo Taken: July 17, 2017	
BGT GPS and Location: 36.90335, -107.90961 NE¼ NW¼, Section 17, T31N, R10W	
Taken by: Corwin Lameman, AES	
Subject: Completed Excavation, July 2017	
Excavation Dimensions: 32 ft x 40 ft x 38 ft deep	
Description: Facing N, ramp access to completed excavation.
