Below Grade Tank (BGT) Closure Plan DJR Operating, LLC Ginny Corbett 1 API: 30-045-26791

RE: Below Grade Tank Closure, Release and Final Excavation Report

Ginny Corbett #1 API #3004527125

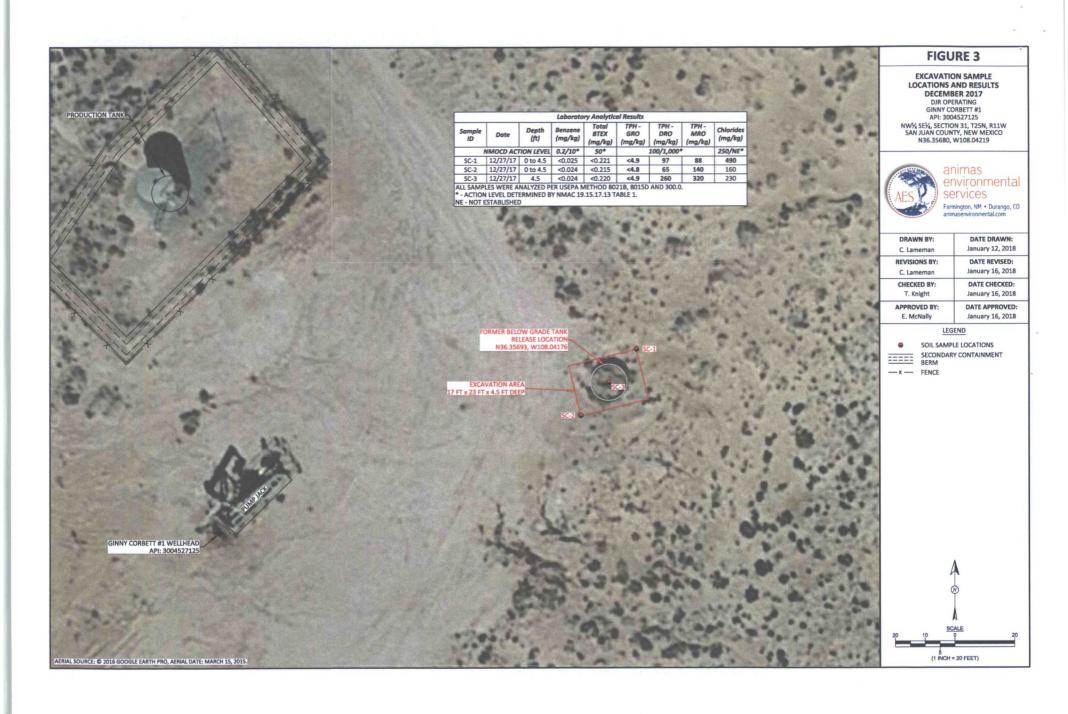
AES was initially contacted by Amy Archuleta of DJR on December 27, 2017, and on the same day, Corwin Lameman of AES completed the excavation field work. The field sampling activities included collection of three confirmation soil samples from the walls (SC-1 and SC-2) and base (SC-3) of the excavation, which included the BGT footprint. The area of the final excavation measured approximately 17 feet by 23 feet by 4.5 feet in depth. Sample locations and final excavation extents are presented on Figure 3.

Laboratory analytical results are summarized in Table 1 and on Figure 3. The laboratory analytical report is attached.
