16388
Pit, Below-Grade Tank, or
Proposed Alternative Method Permit or Closure Plan Application

BELOW-GRADE TANK CLOSURE REPORT

Hallador Petroleum LLP

Horton #3B

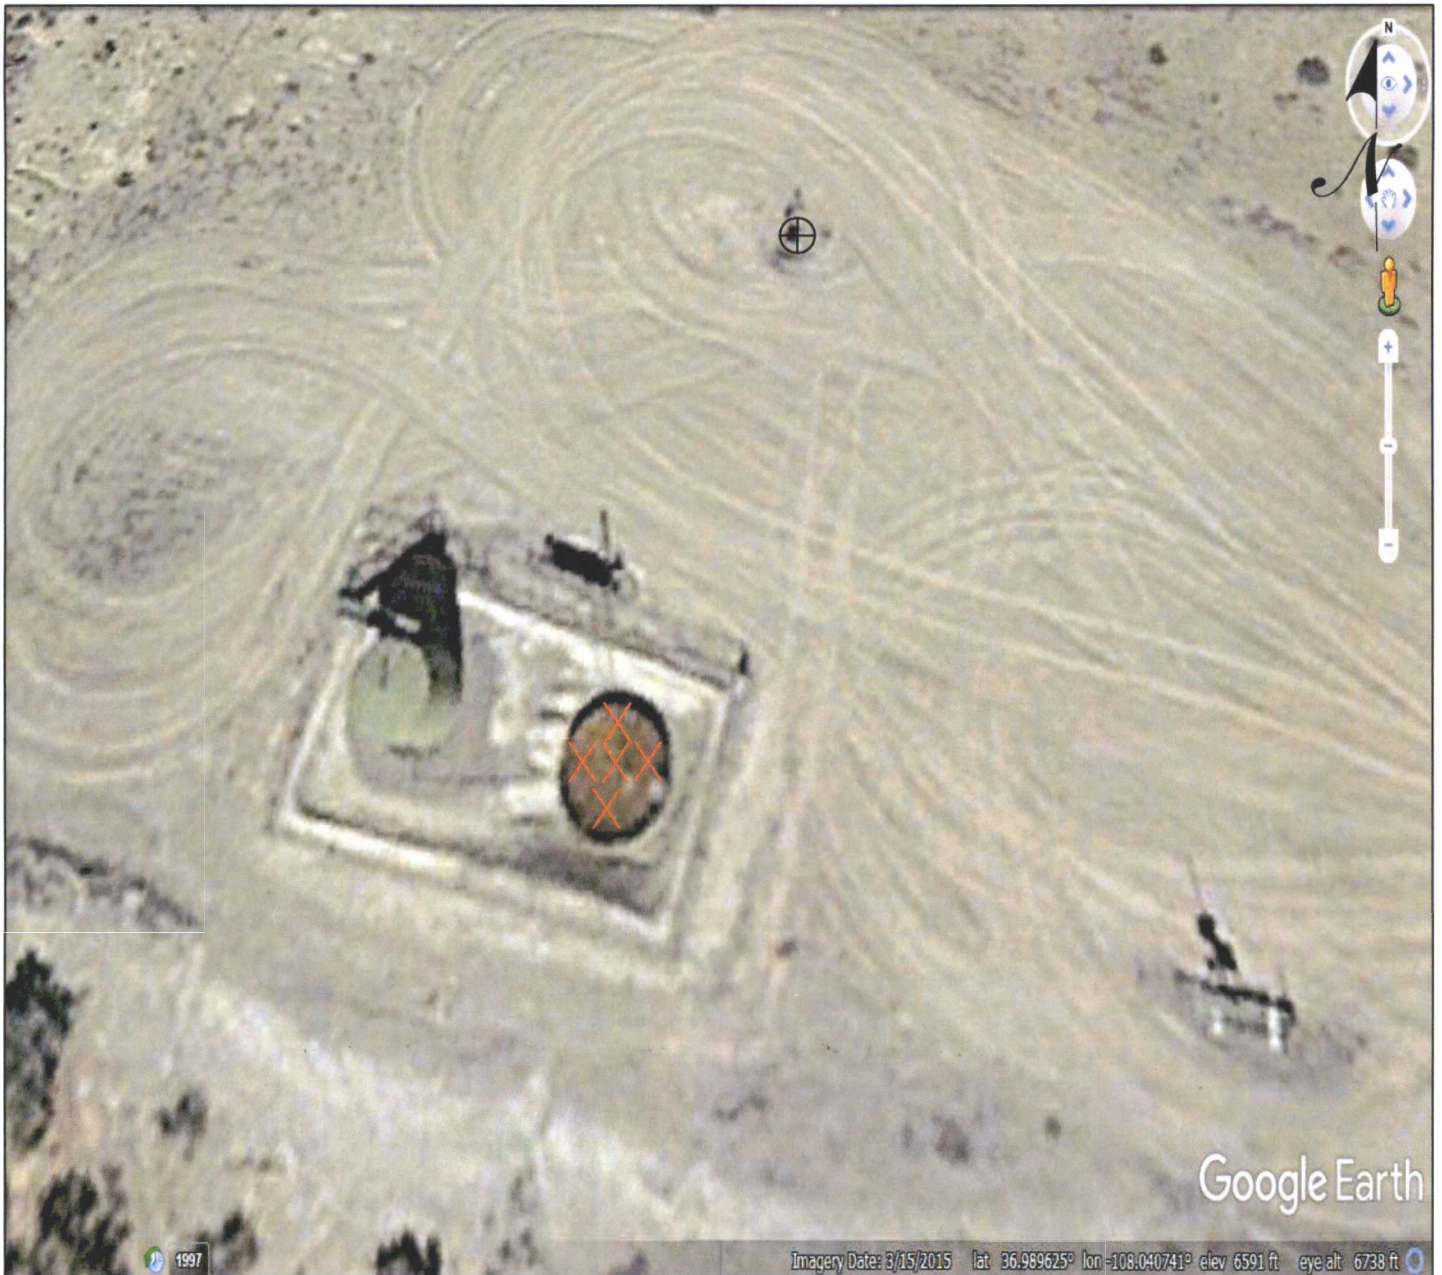
X BGT Sample
Location

SAMPLE ID	RESULTS (mg/kg)
<u>BGT Comp</u>	<u>0.0</u>

SITE PERIMETER
