BP AMERICA PRODUCTION COMPANY SAN JUAN BASIN, NORTHWEST NEW MEXICO

BELOW-GRADE TANK CLOSURE PLAN

GCU 390

API No. 3004528309

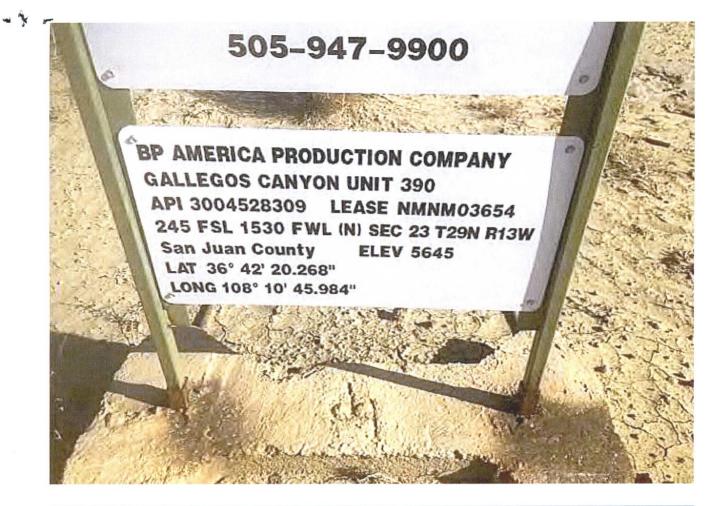
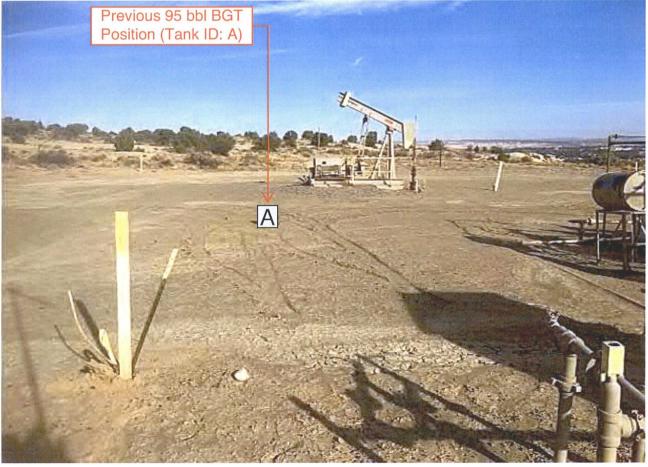
The area has been backfilled and BGT location's surface condition is clear. The location will be reclaimed when the well is plugged and abandoned.

Closure report on C-144 form is included including photos of reclamation completion.
