Pit, Below-Grade Tank, or
Proposed Alternative Method Permit or Closure Plan Application

1.
Operator: BP America Production Company OGRID #: 778
Address: 380 North Airport Road, Durango, CO 81303
Facility or well name: FLORANCE GC J # 16A
API Number: 3004521790 OCD Permit Number: _____
U/L or Qtr/Qtr P Section 06 Township 30N Range 09W County: San Juan
Center of Proposed Design: Latitude 36.834225 Longitude -107.816653 NAD83
Surface Owner: Federal State Private Tribal Trust or Indian Allotment

3.
 Below-grade tank: Subsection I of 19.15.17.11 NMAC **TANK D**
Volume: 95 bbl Type of fluid: Remedial Seep Collection
Tank Construction material: Steel
 Secondary containment with leak detection Visible sidewalls, liner, 6-inch lift and automatic overflow shut-off
 Visible sidewalls and liner Visible sidewalls only Other Double wall/ Double bottom; sidewalls not visible
Liner type: Thickness _____ mil HDPE PVC Other _____

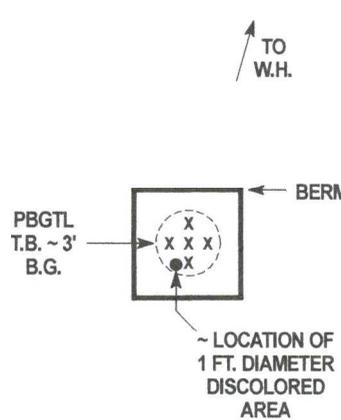
| MOISTURE: <input checked="" type="checkbox"/> DRY / <input checked="" type="checkbox"/> SLIGHTLY MOIST / <input type="checkbox"/> MOIST / <input type="checkbox"/> WET / <input type="checkbox"/> SATURATED / <input type="checkbox"/> SUPER SATURATED | ISOLATED PATCH AT SOUTHERN QUADRANT OF BGT (AREA - 1 FT. DIAMETER). |
| DISCOLORATION/STAINING OBSERVED: <input checked="" type="checkbox"/> YES / <input type="checkbox"/> NO EXPLANATION - BLACK ISOLATED PATCH AT SOUTHERN QUADRANT OF BGT. | |

| APPARENT EVIDENCE OF A RELEASE OBSERVED AND/OR OCCURRED: <input checked="" type="checkbox"/> YES / <input type="checkbox"/> NO EXPLANATION: DISCOLORED ISOLATED PATCH AT SOUTHERN QUADRANT OF BGT. | |
| DEPTH TO GROUNDWATER: <100' NEAREST WATER SOURCE: <1,000' NEAREST SURFACE WATER: <1,000' NMOCED TPH CLOSURE STD: 100 ppm | |

| SITE SKETCH BGT Located : off / <input checked="" type="checkbox"/> on site PLOT PLAN circle: attached TO W.H. ↑ N ↑ ~ LOCATION OF 1 FT. DIAMETER DISCOLORED AREA X - S.P.D. | <table border="1" style="width:100%; border-collapse: collapse;"> <tr> <td>OVM CALIB. READ. = 99.8 ppm</td> <td>RF = 1.00</td> </tr> <tr> <td>OVM CALIB. GAS = 100 ppm</td> <td></td> </tr> <tr> <td>TIME: 10:00 am/pm</td> <td>DATE: 07/26/18</td> </tr> </table> MISCELL. NOTES WBS: L1-001CR-E:FLRNCGCJ16A REF #: VID: VHIXONEVRM PJ #: Permit date(s): 09/29/17 OCD Appr. date(s): 10/06/17 <table border="1" style="width:100%; border-collapse: collapse;"> <tr> <td>Tank ID</td> <td>OVM = Organic Vapor Meter ppm = parts per million</td> </tr> <tr> <td>D</td> <td>BGT Sidewalls Visible: Y / (N)</td> </tr> <tr> <td></td> <td>BGT Sidewalls Visible: Y / N</td> </tr> <tr> <td></td> <td>BGT Sidewalls Visible: Y / N</td> </tr> </table> Magnetic declination: 10° E | OVM CALIB. READ. = 99.8 ppm | RF = 1.00 | OVM CALIB. GAS = 100 ppm | | TIME: 10:00 am/pm | DATE: 07/26/18 | Tank ID | OVM = Organic Vapor Meter ppm = parts per million | D | BGT Sidewalls Visible: Y / (N) | | BGT Sidewalls Visible: Y / N | | BGT Sidewalls Visible: Y / N |

BP will return to this location of staining and excavate this small area to ensure full closure. This work will be scheduled for next week. I will notify when the schedule is confirmed.
