Release Notification

Site Name Federal 29 #1	Site Type Gas
Date Release Discovered 11/14/2018	API# (if applicable) 30-045-25052

**Re: Closure Report: nVF1833048464
Federal 29 #1
B-29-T25N-R9W
30-045-25052**

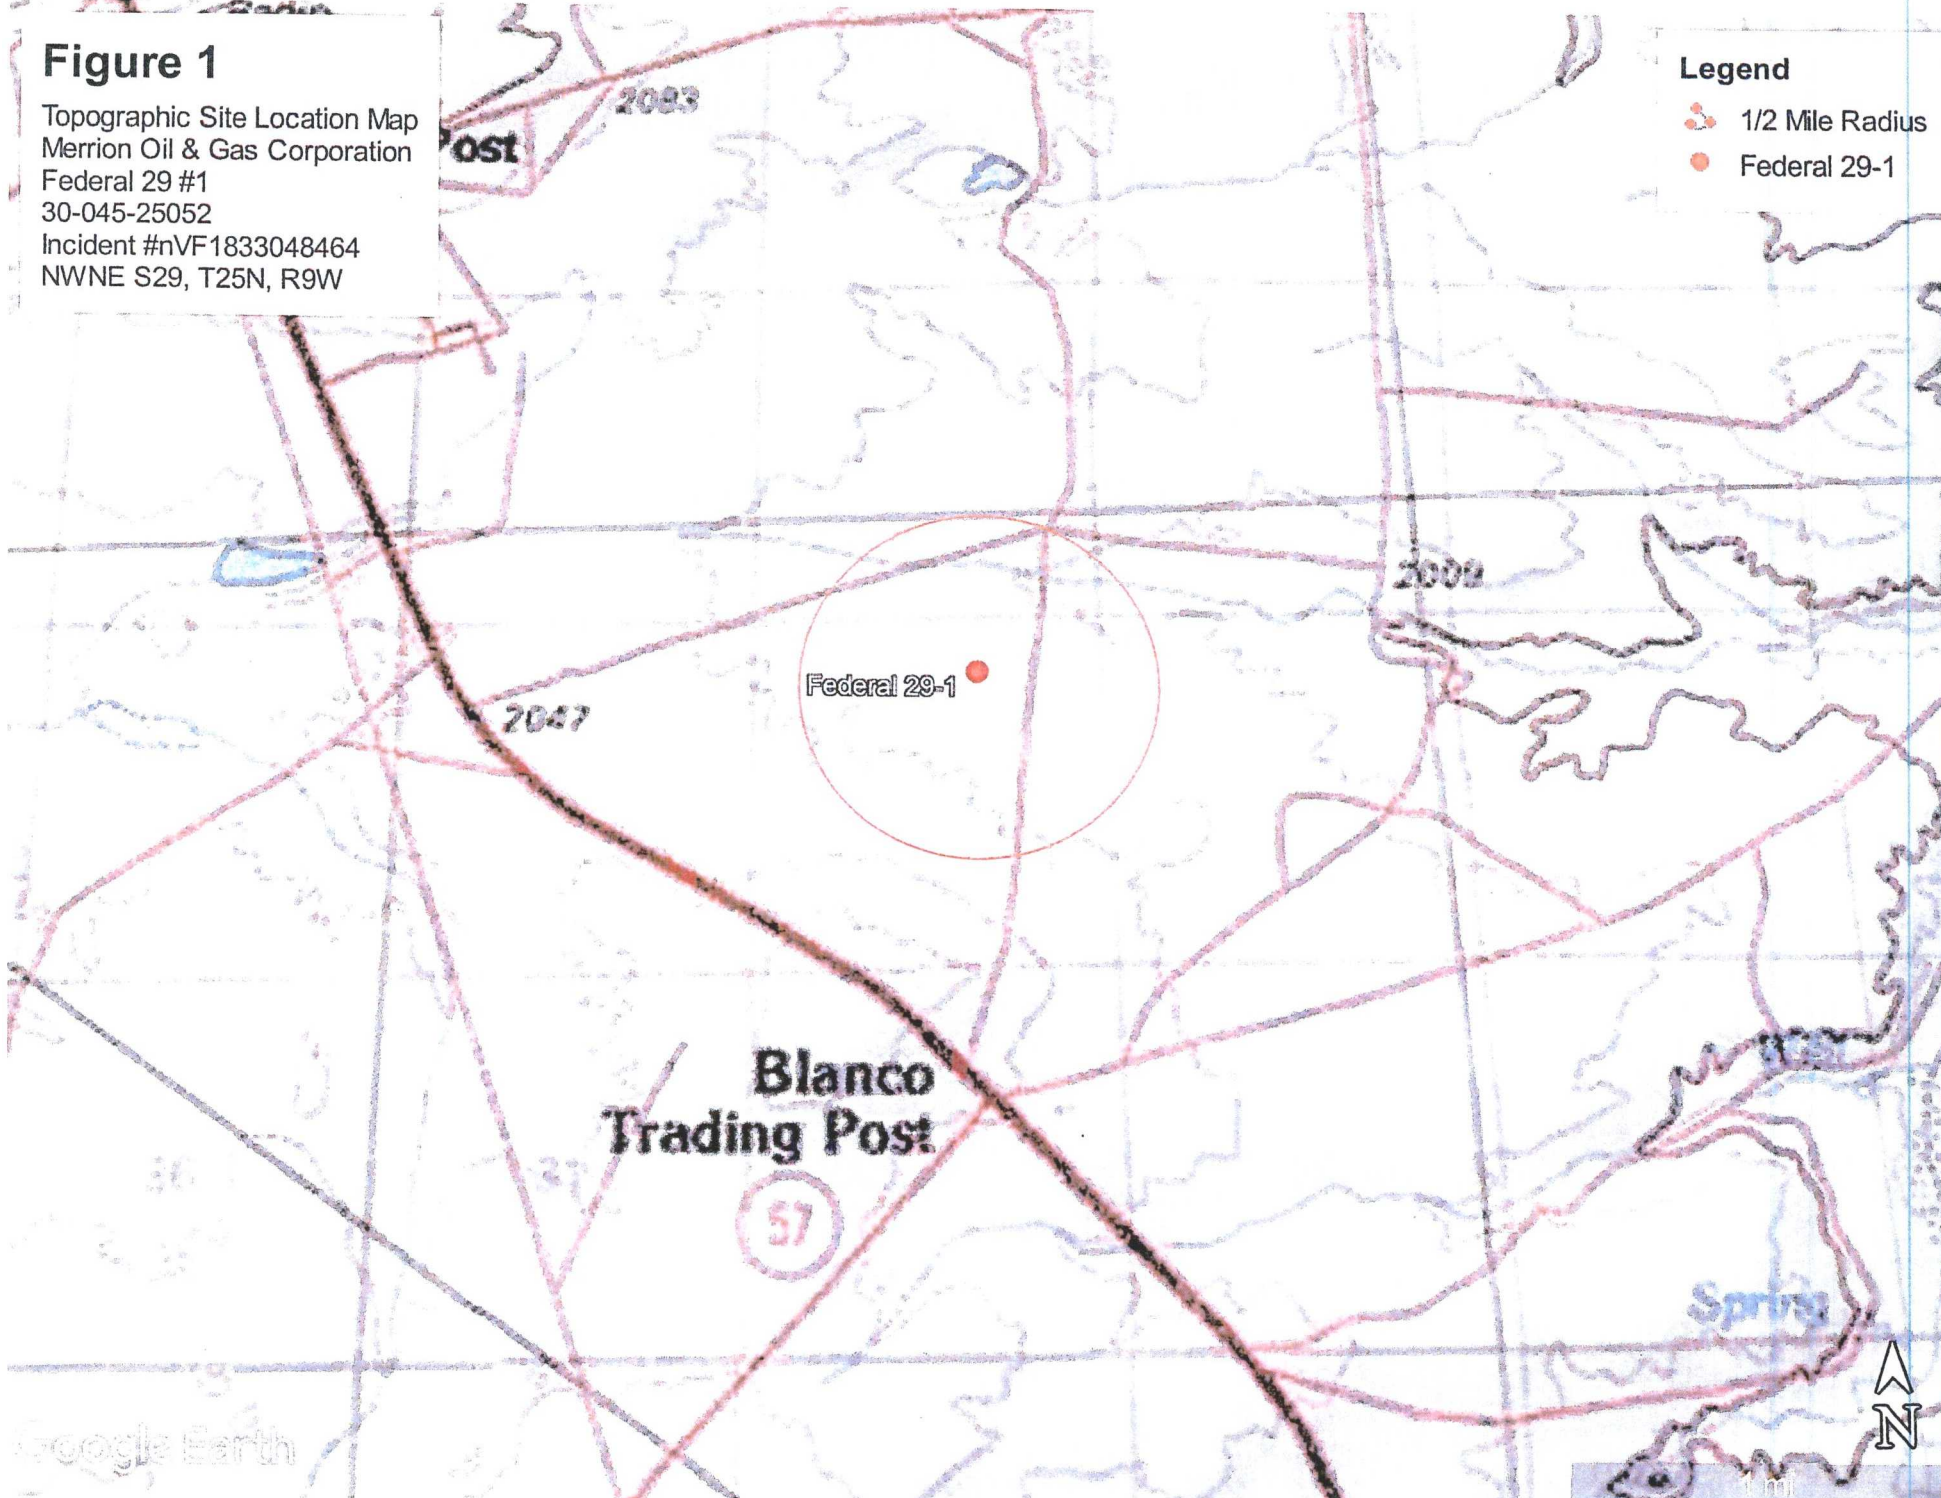
Figure 1

Topographic Site Location Map
Merrion Oil & Gas Corporation
Federal 29 #1
30-045-25052
Incident #nVF1833048464
NWNE S29, T25N, R9W

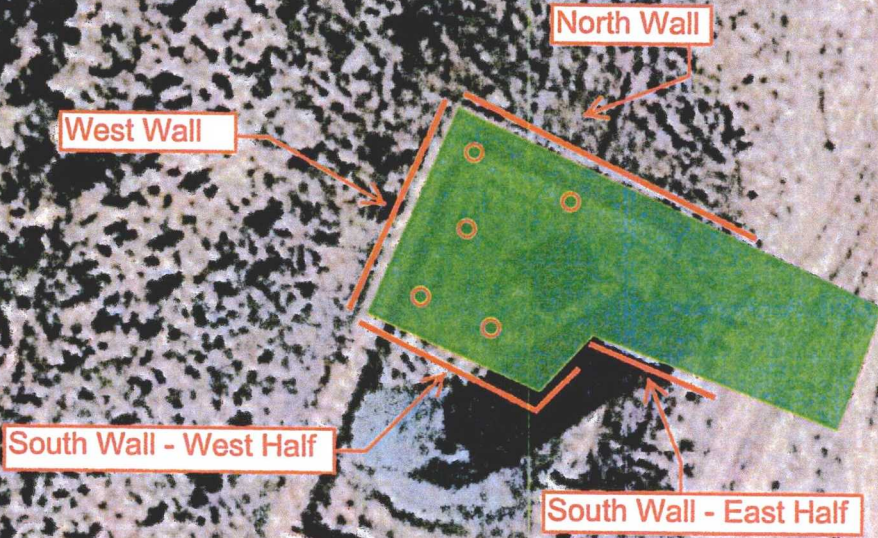
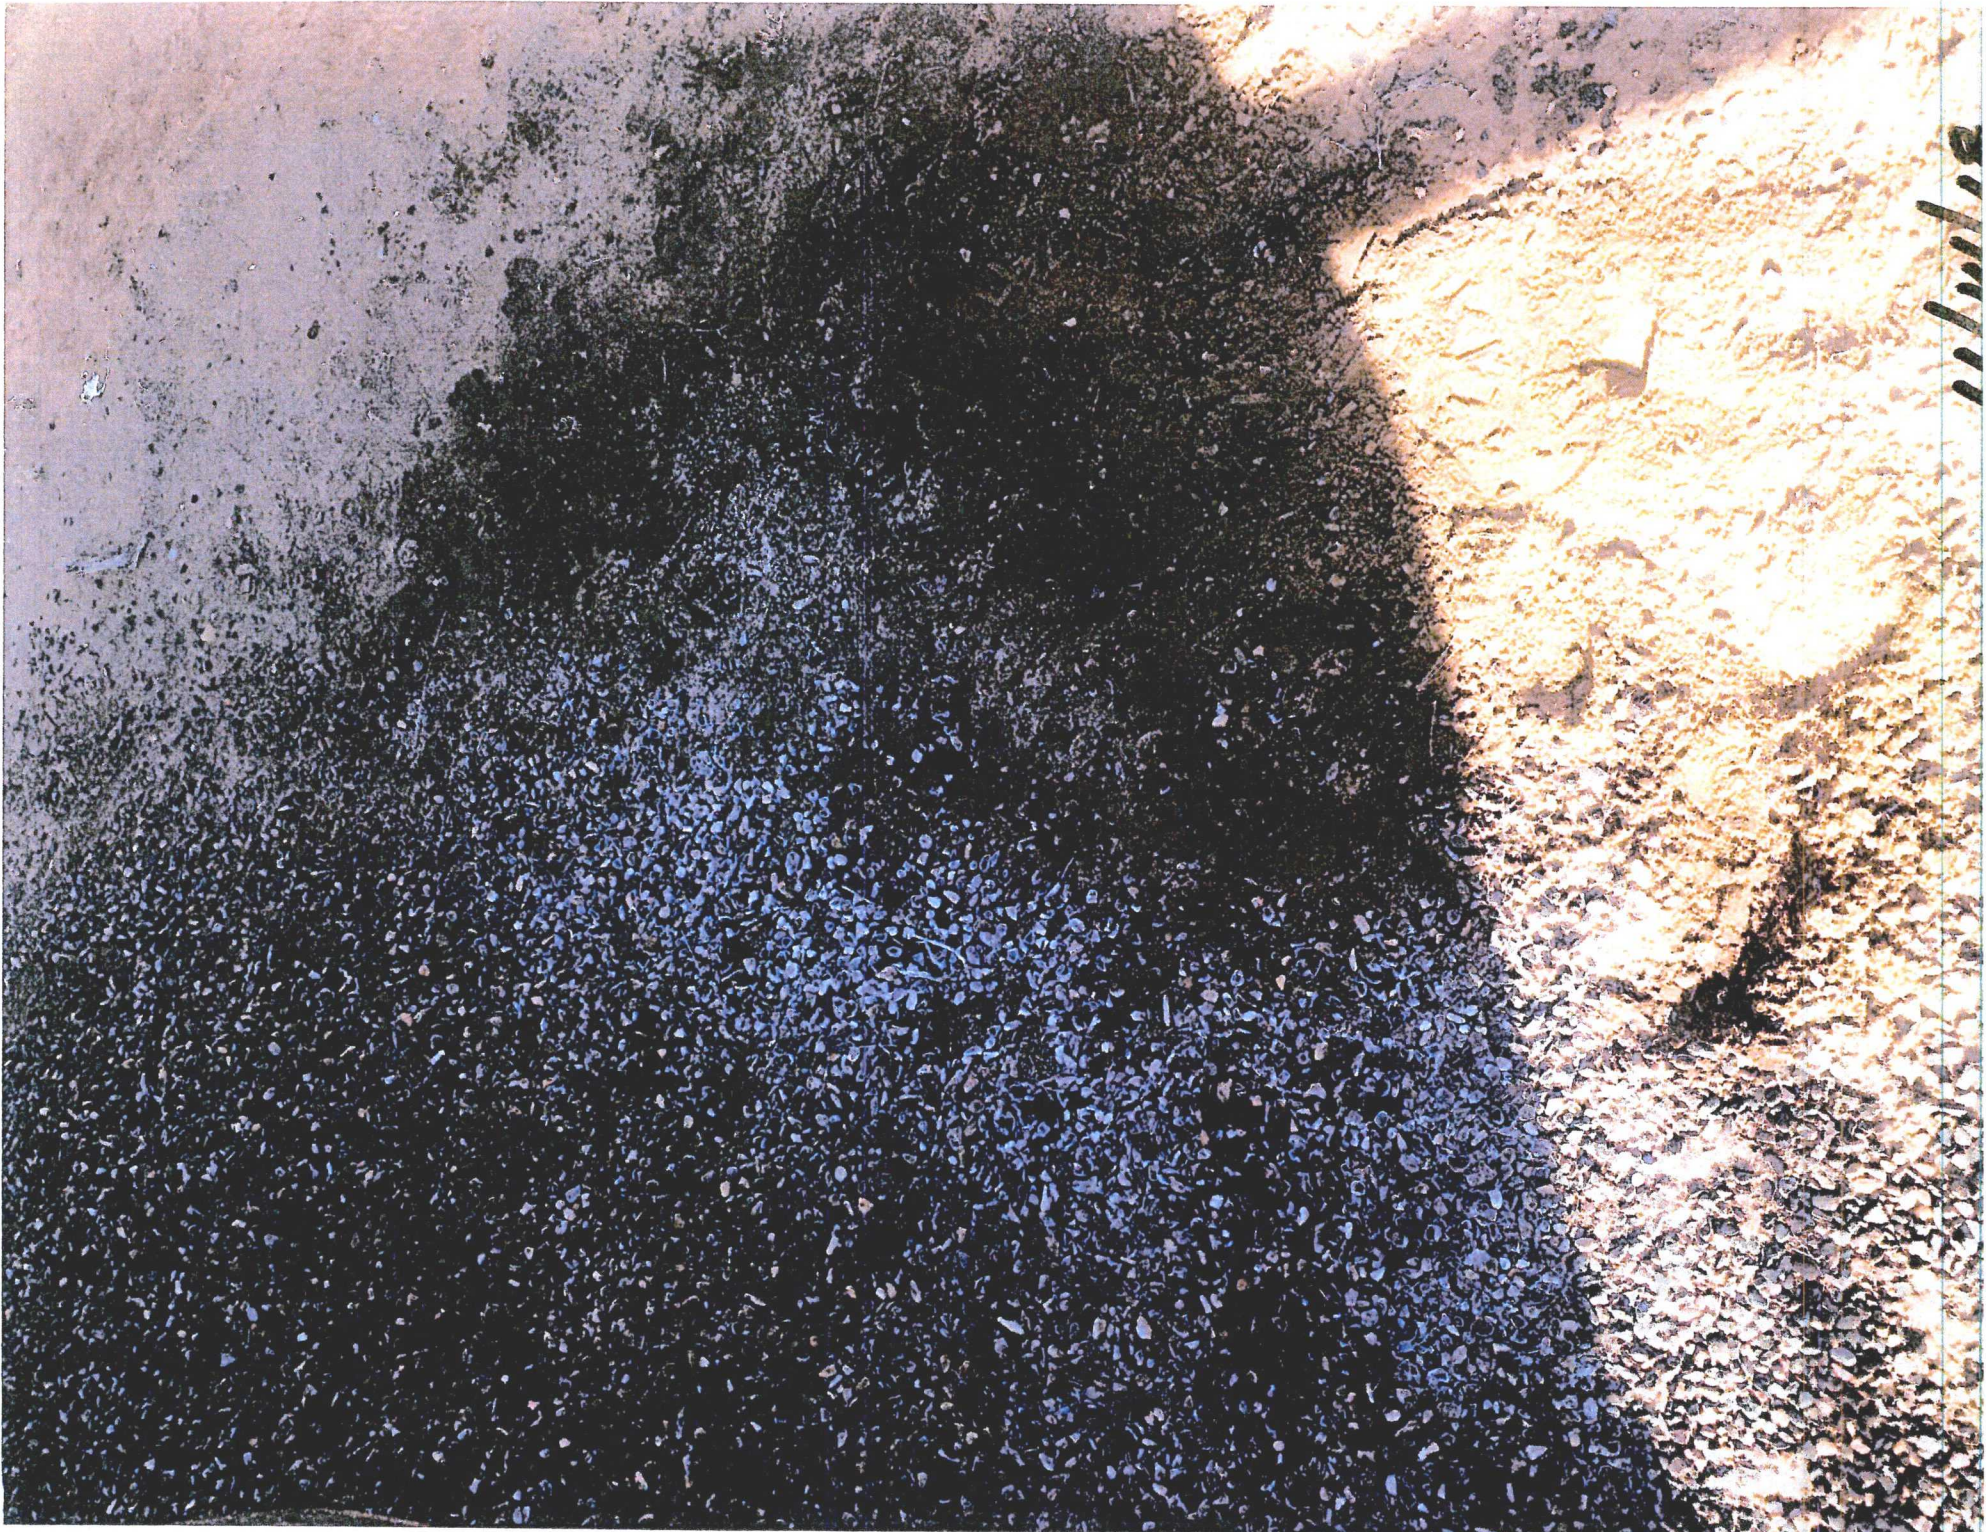
Figure 2

Topographic Site Location Map
Merrion Oil & Gas Corporation
Federal 29 #1
30-045-25052
Incident #nVF1833048464
NWNE S29, T25N, R9W

Legend
Excavation Extent
