South Bisti Federal 29 #1

30-045-26730

BGT Release Closure Report

Closure documents for South Bisti Federal 29 #1

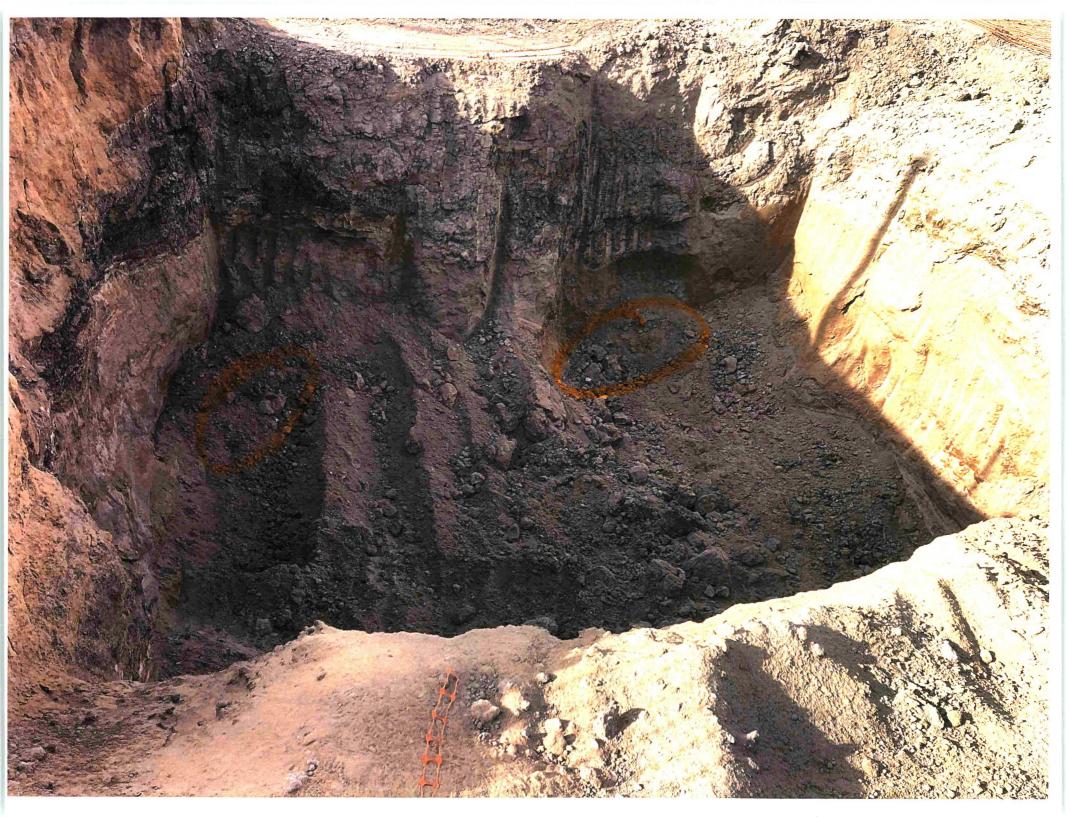
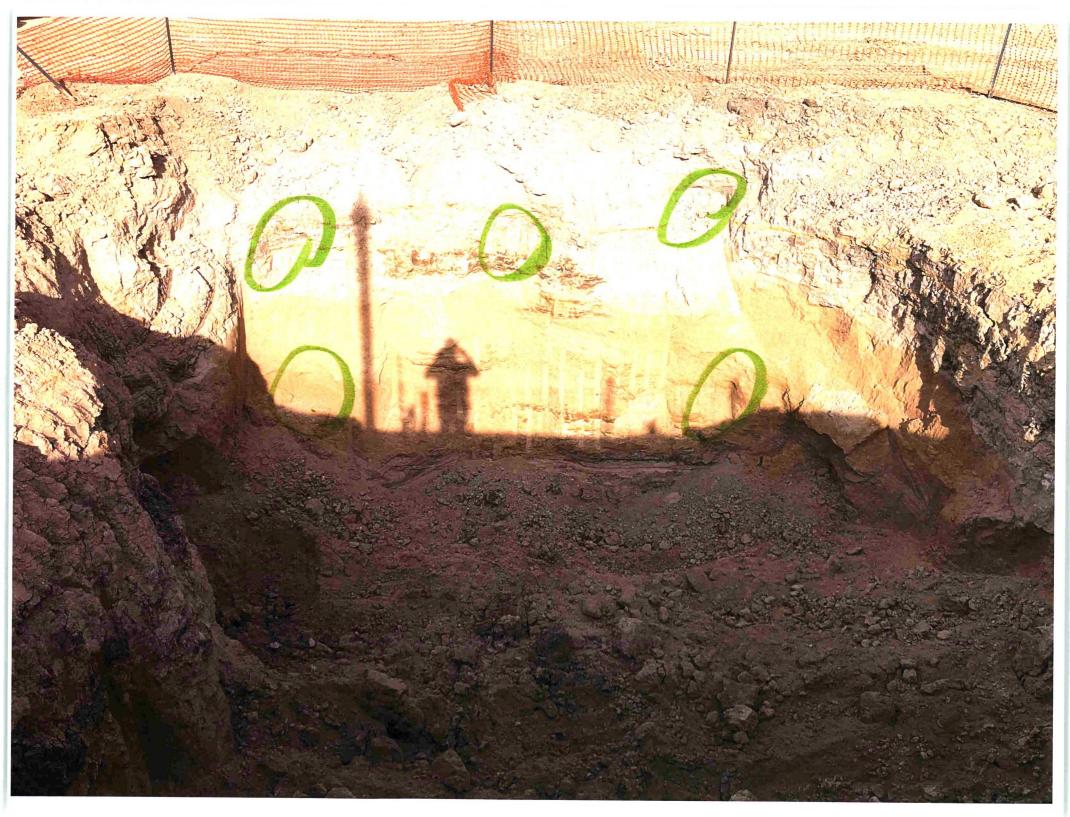
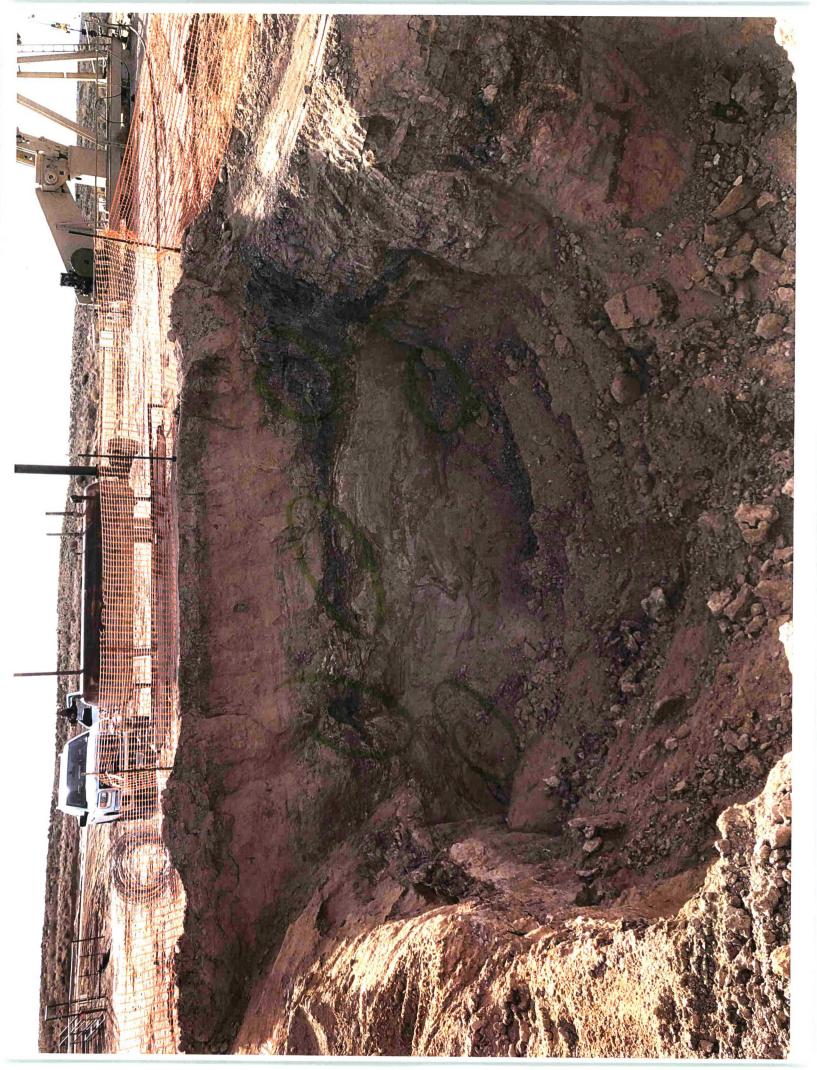
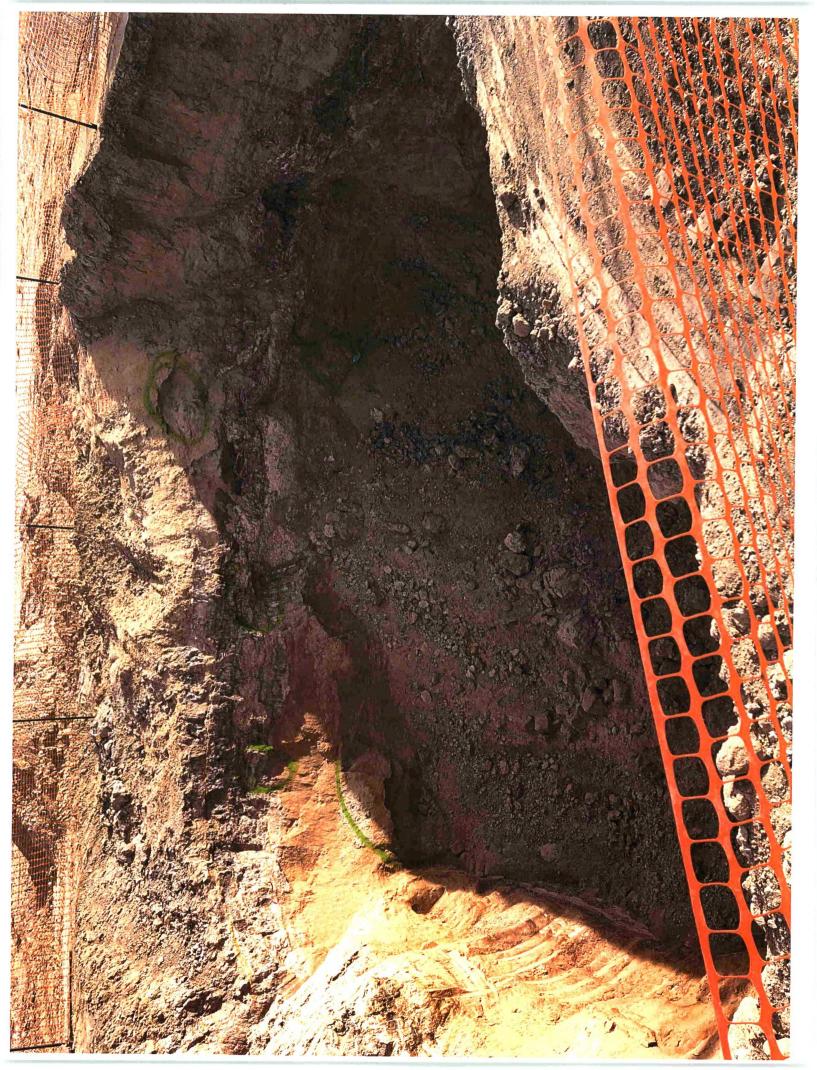
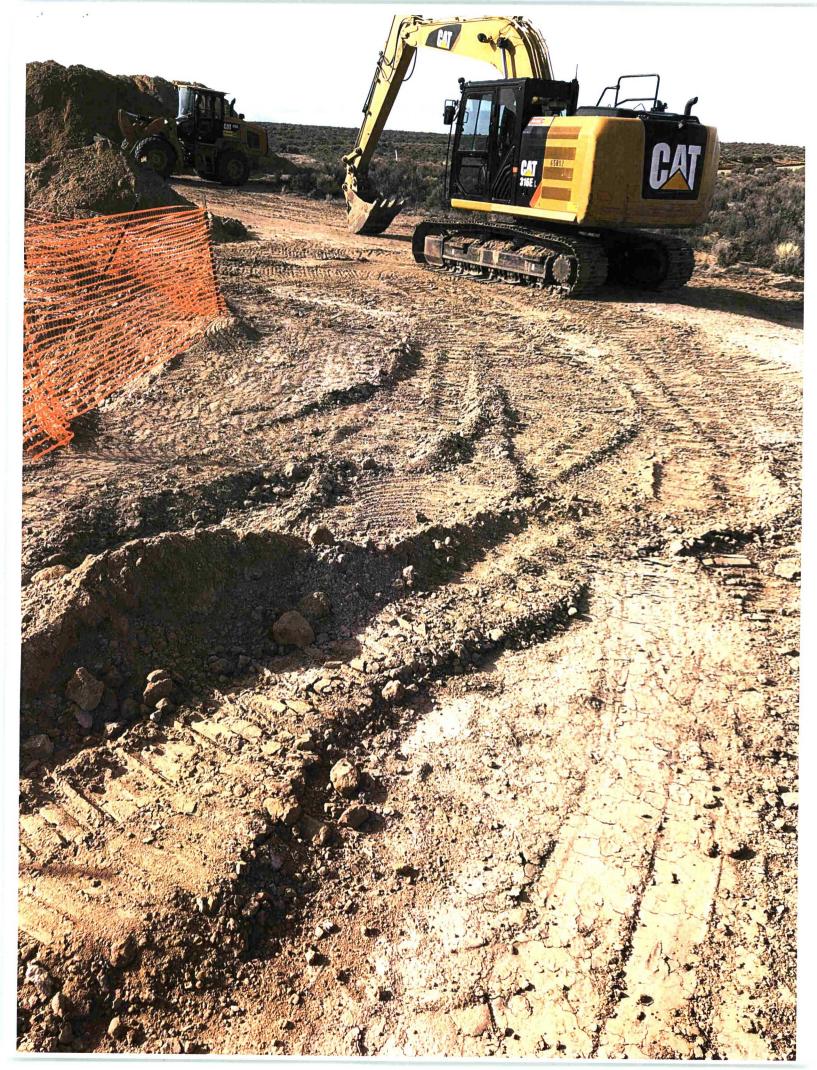
- 1. A scaled site map
- 2. Sampling results
- 3. Sampling Diagram
- 4. Photographs of the BGT pit prior to back filling

The initial hole's size was roughly 20'x20'x10'. After removing all contaminated soils the hole grew to be 26'x31'x20'. Once Dugan was satisfied with the work that had been done the NMOCD and BLM were notified that samples would be taken, on March 28th, in the event the agency would like to witness the sampling. The samples came back within the allowable limits of the "spill rule" and the hole was back filled.
