## Release Notification

| Site Name: Northeast Blanco Unit 102 | Site Type: Natural Gas Production Well Pad |

| <b>FIELD REPORT:</b> (circle one: BGT CONFIRMATION / RELEASE INVESTIGATION / OTHER: | | PAGE #: <u>1</u> of <u>1</u> |

Project Name/Location: NEBU 102

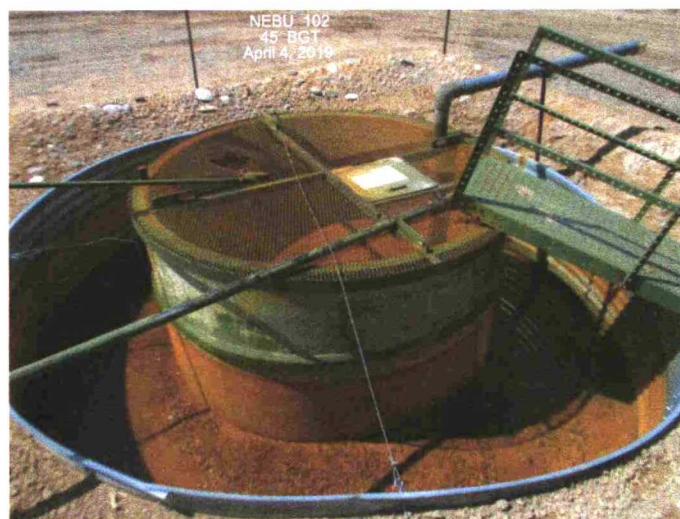
| <b>SITE SKETCH</b> BGT Located: off / on site PLOT PLAN circle: attached<br><div style="text-align: center;"> </div> <p>X = 5-pt Composite Points collected with HAND AUGER</p> <p>* GAS well</p> | | |
