Release Notification

GCU 232 - API: 30-045-11630

(M) Sec 26 – T28N – R12W, San Juan County, New Mexico

Summary Record of Impact Remediation (Steel 95 BGT (SW/DB) – for Separator/Compressor)

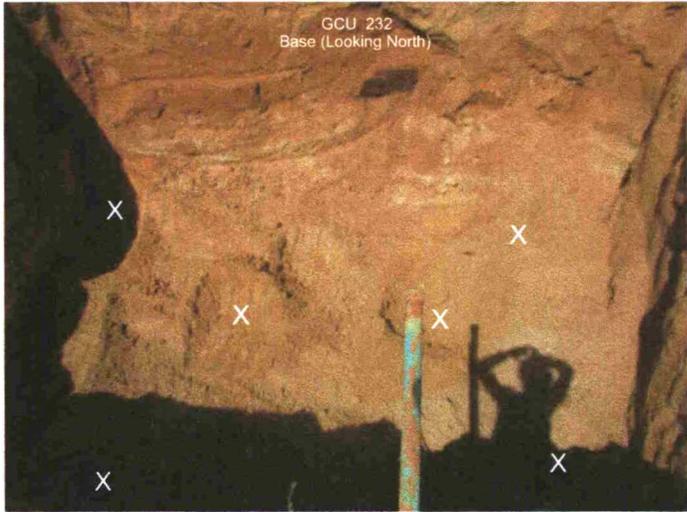
GCU 232
(M) Sec 26 - T28N - R12W
API: 30-045-11630

Prior Steel 95 BGT (SW/DB)
(Separator/Compressor)

Remedial Excavation
14' x 14' x 8' Deep

Separator

Compressor

April 12, 2019 Remedial excavation completed. Final size: 14' x 14' x 8' deep.
Field screening of chlorides conducted while excavating to establish preliminary closure
Excavation sampled for closure of chlorides.

Completed excavation backfilling with clean imported material.
