Pit or Below-Grade Tank Registration or Closure

# JICARILLA 93 #4 EXCAVATION

BELOW GRADE TANK REPLACEMENT  
AT JICARILLA 93 #4 FOR,  
WILLIAMS PRODUCTION  
RIO ARriba COUNTY, NEW MEXICO

**JICARILLA 93 #4 EXCAVATION  
BELOW GRADE TANK REPLACEMENT  
AT JICARILLA 93 #4 FOR,  
WILLIAMS PRODUCTION  
RIO ARriba COUNTY, NEW MEXICO**

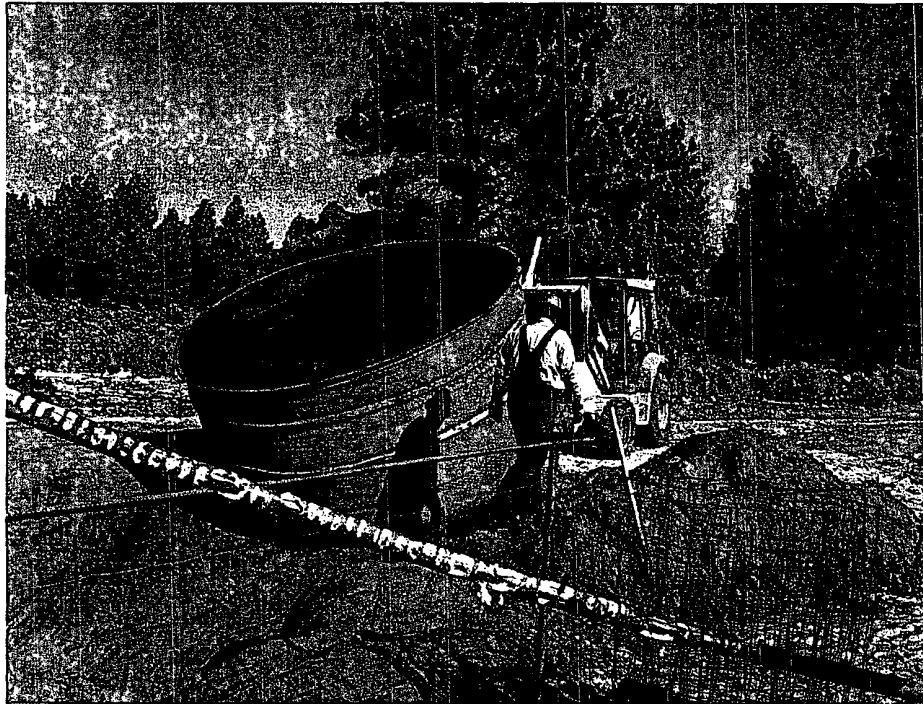
**Photo 7: 7' x 15' 120 bbl BGT**
