Release Notification and Corrective Action

SPILL CLEANUP REPORT

SALAZAR No. 4E

API No. 30-039-23368

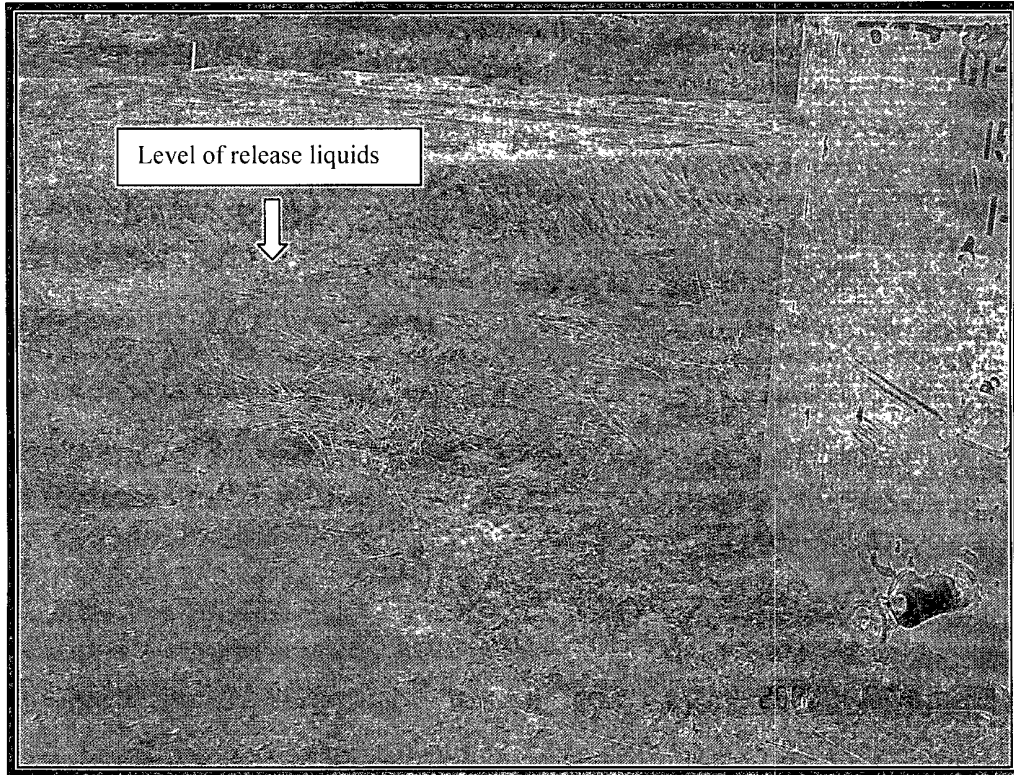
Photo 1: View of the initial release and level visible on inside of berm

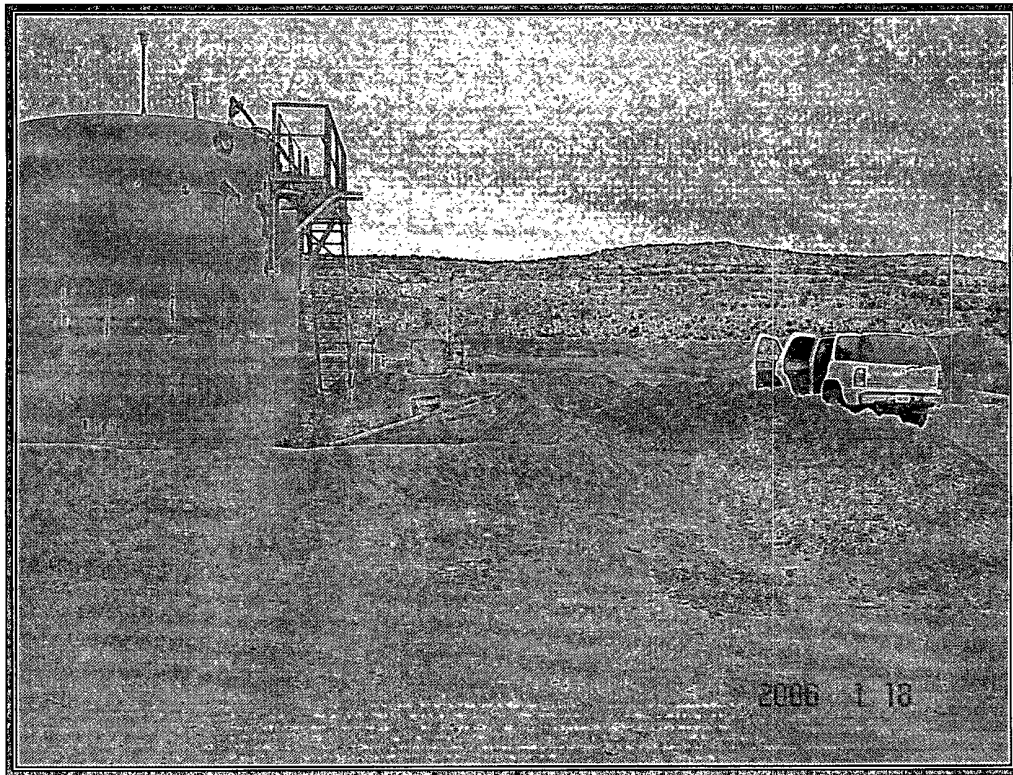
Photo 2: A trench dug at site before Envirotech's arrival

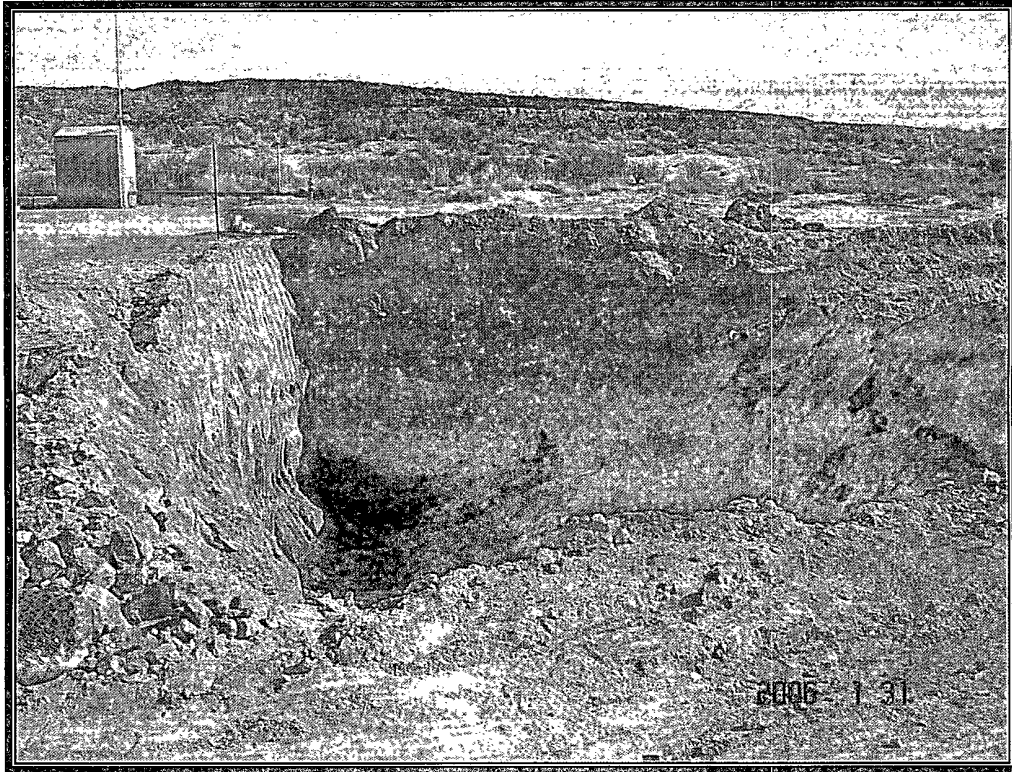
At approximately nine (9) feet below ground surface (BGS), dark grey to black soils were encountered; see ***Section 3, Site Photography.*** Additional excavation visually verified we had encountered substantially more impacted soils than previously anticipated. With this new site information, environmental excavation would follow all contaminants until remaining soils were below NMOCD guidelines.

Photo 3: Initial excavation, visible contamination at 10' BGS

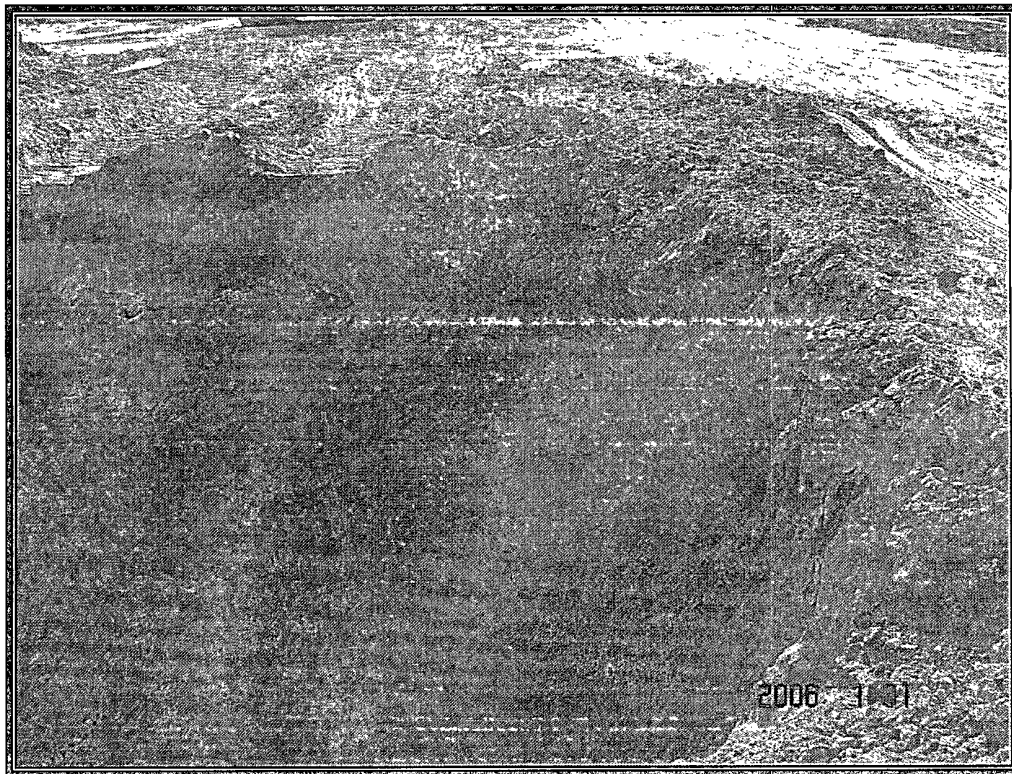
Photo 4: Penetration of condensate release visible

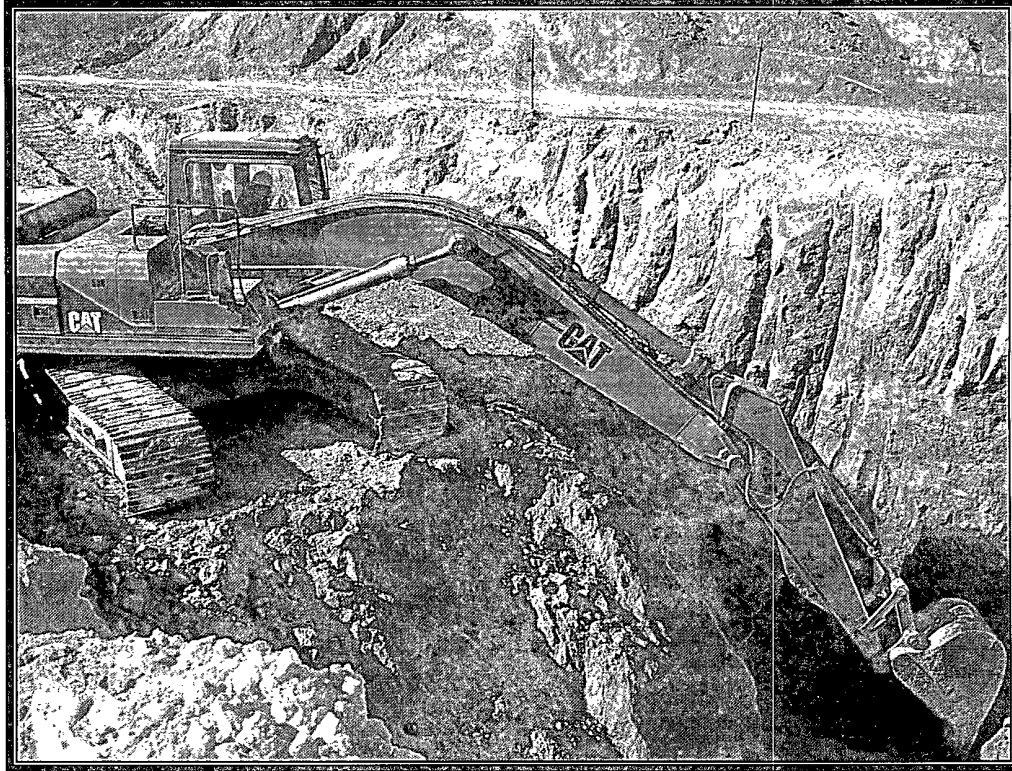
Photo 5: Initial benchdown on southwestern side of excavation

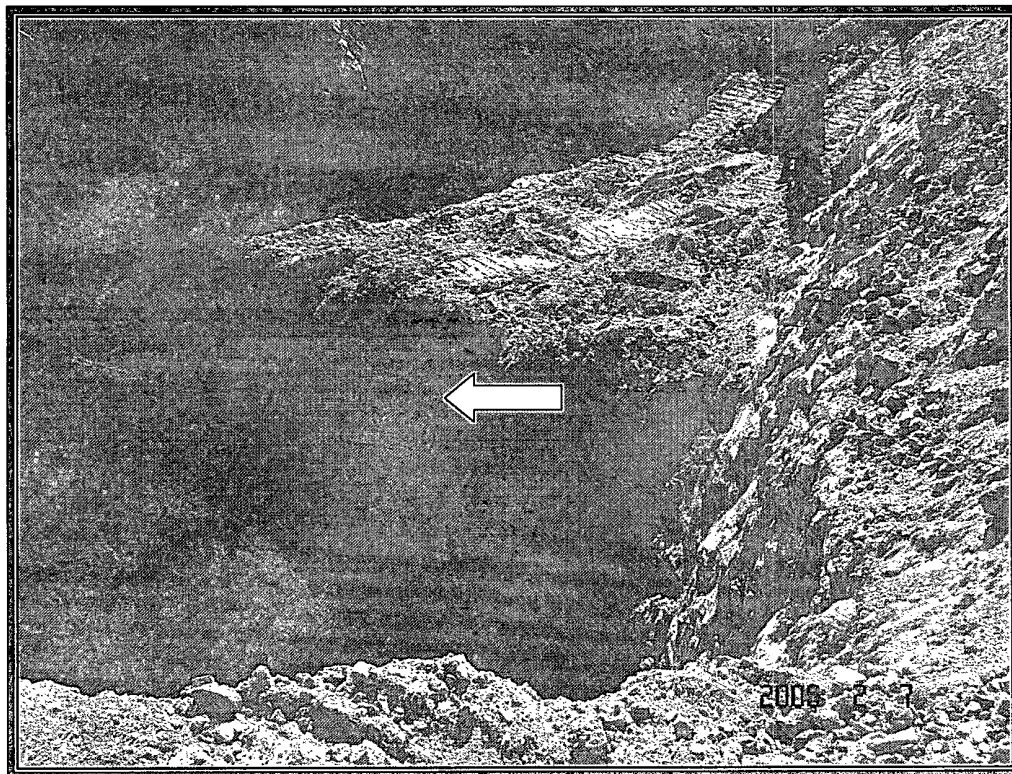
Photo 6: Indentation in middle of picture shows sample location of south wall

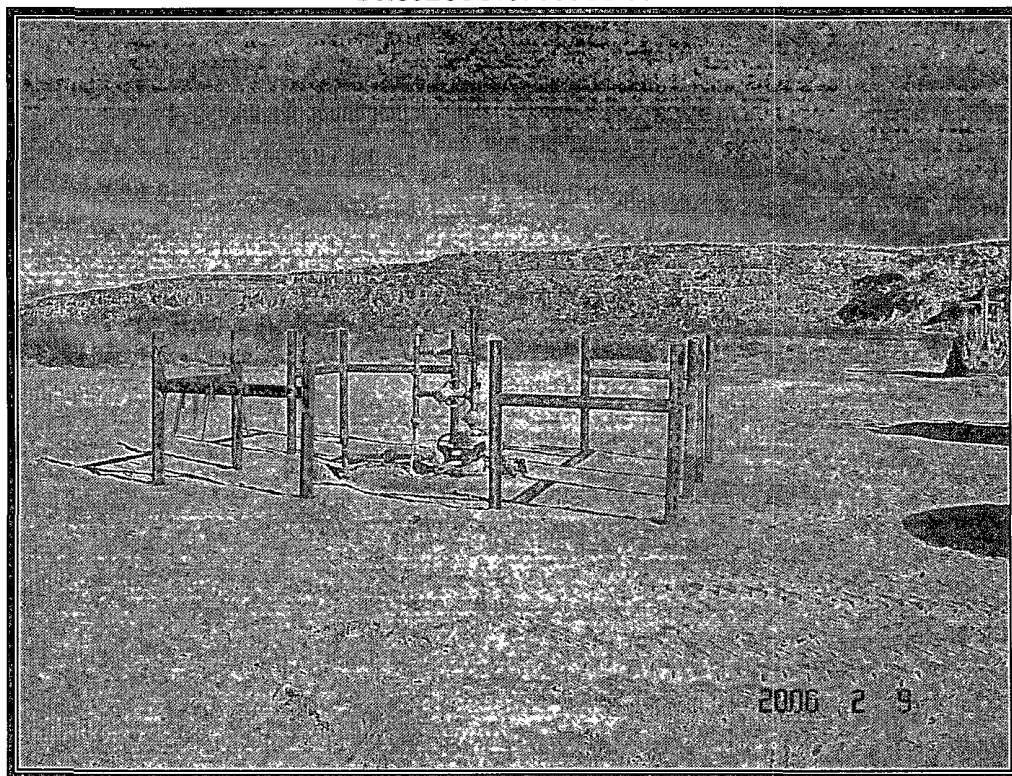
Photo 7: Barrier placed to protect wellhead as requested by Mr. Denny Foust, NMOCD

Mr. Denny Foust of the NMOCD inspected the site on February 7, 2006. Mr. Foust gave instructions for the continued excavation of the site until all impacted soils had been removed to the greatest extent possible. Also completed on this day was the additional closure sampling of the south wall and southern portion of the east wall. A review of laboratory analysis showed both areas were below regulatory guidelines; see **Section 1, Laboratory Analysis**. Both of these wall areas were the furthest up-gradient as determined by surface geology. The surface was relatively planar with a slight slope to the northeast. As an additional safety measure, Mr. Foust requested a four (4) inch piping barricade to be constructed as a barrier and placed around the wellhead; see **Section 3, Site Photography**. This would prevent the accidental contact of any mobile site equipment with the wellhead. Contact with the wellhead would be detrimental to site activities. Mr. Earl North made the appropriate arrangements for construction of the barrier the following day.

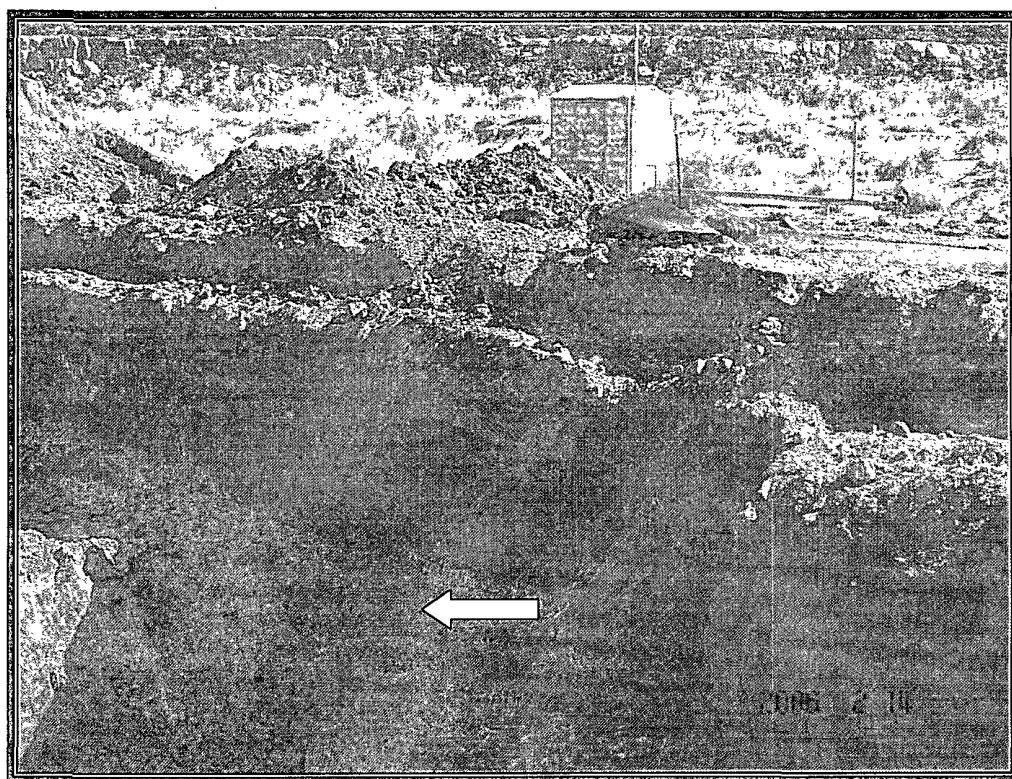
Excavation continued in a northeasterly direction throughout the following days. A sampling event was completed on February 15, 2006. An area of concern was found on the northern area of the east wall, although TPH was at 152 ppm, a Total BTEX analysis showed a measurement of 101,710 ppb; see **Section 1, Laboratory Analysis**. This amount is twice the regulatory level as determined by the NMOCD publication referenced on page one (1) of this report. Field screening was completed throughout this time period to guide the excavation to prevent the unnecessary removal of non-impacted soils.

Photo 8: East wall area, approximate area when BTEX was 101,710 ppb

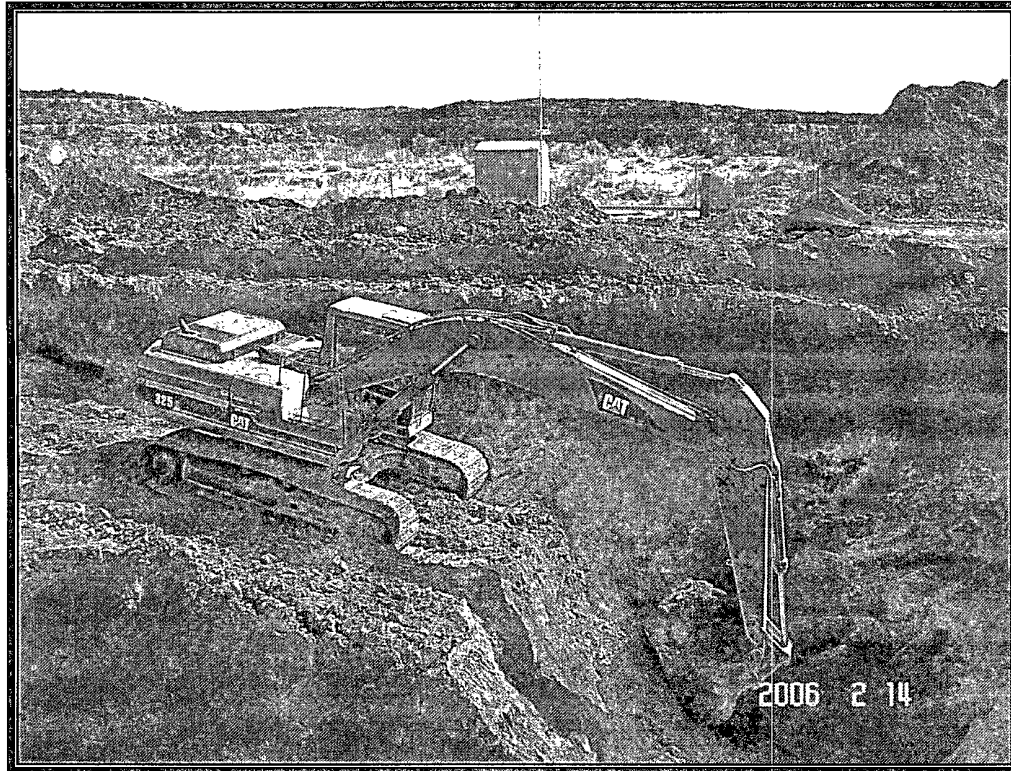
Photo 9: Note, a Cat 325B Excavator benched down to reach depth of contamination

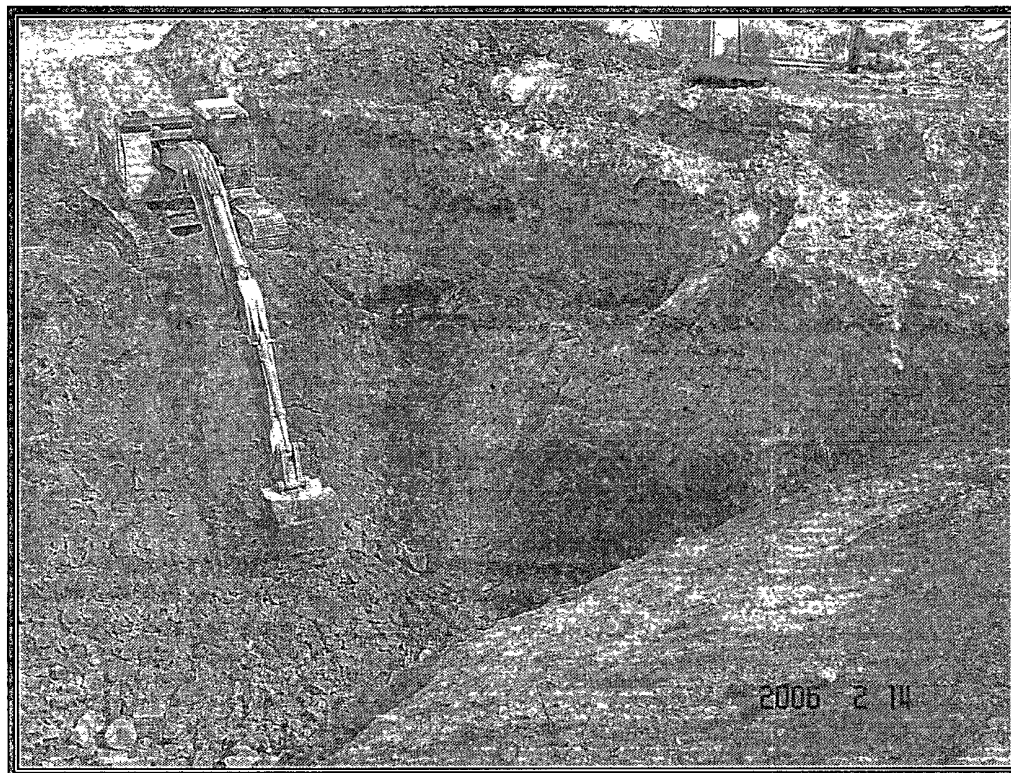
A sample was taken at 28 feet BGS on February 6, 2006. The sample was screened in the field using an OVM following the referenced field method. The sample passed the established 100 ppm screening standard, therefore the soil was transferred into a four (4) ounce glass jar, placed inside an ice chest, and transported under a Chain of Custody document to Envirotech's Laboratory for analysis by USEPA Method 8015 Modified Nonhalogenated Volatile Organics Total Petroleum Hydrocarbons and by USEPA Method 8021 Aromatic Volatile Organics. Upon review of laboratory analysis, the sample showed measurements of 5.1 ppm TPH and Total BTEX of 1,050 parts per billion (ppb), both of which are below NMOCD established guidelines; see **Section 1, Laboratory Analysis**. Based on the laboratory data, it was established that 28 feet BGS would be the vertical extent of contamination.

Photo 10: Cat 325B Excavator with boom near full extension, bottom is 28' BGS

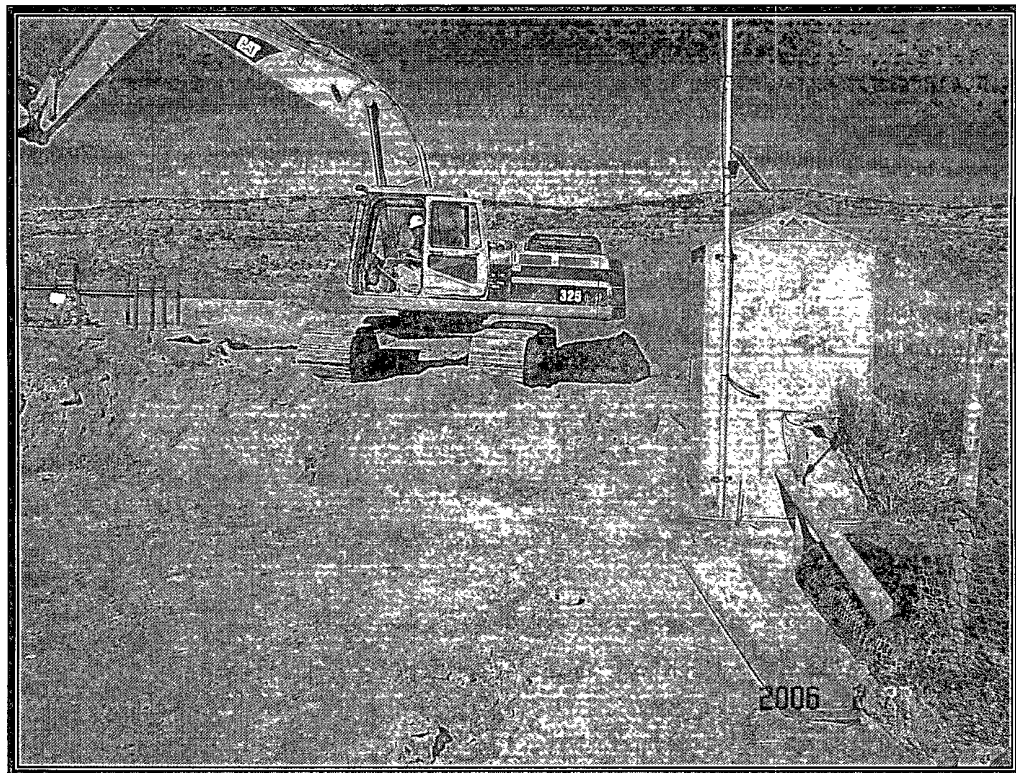
Photo 11: Note proximity of meter house to excavation

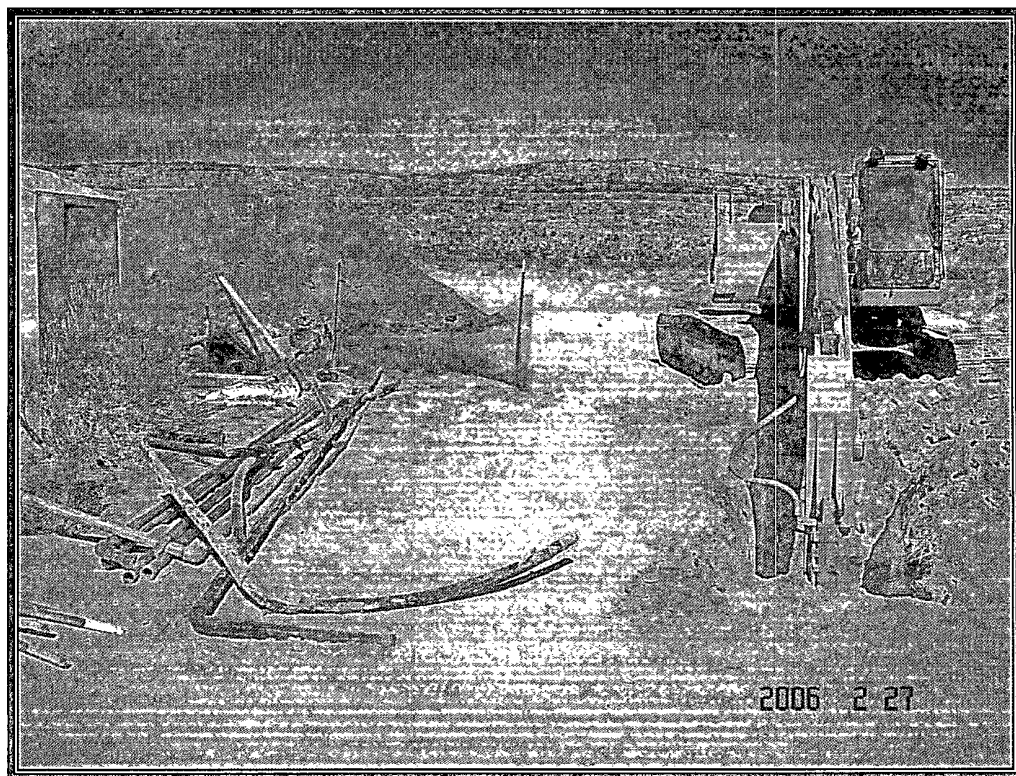
Photo 12: Test Hole (TH-9), approximately 17' east of meter house, at 20' depth; OVM 43 ppm

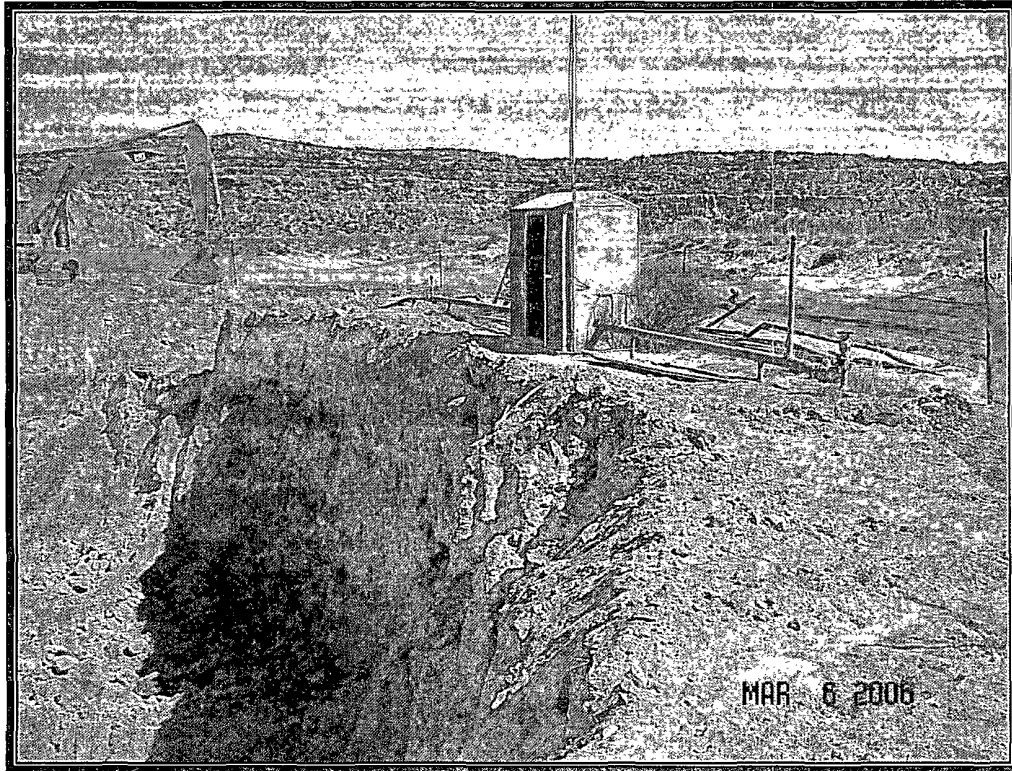
Photo 13: East wall, excavated to below NMOCD guidelines

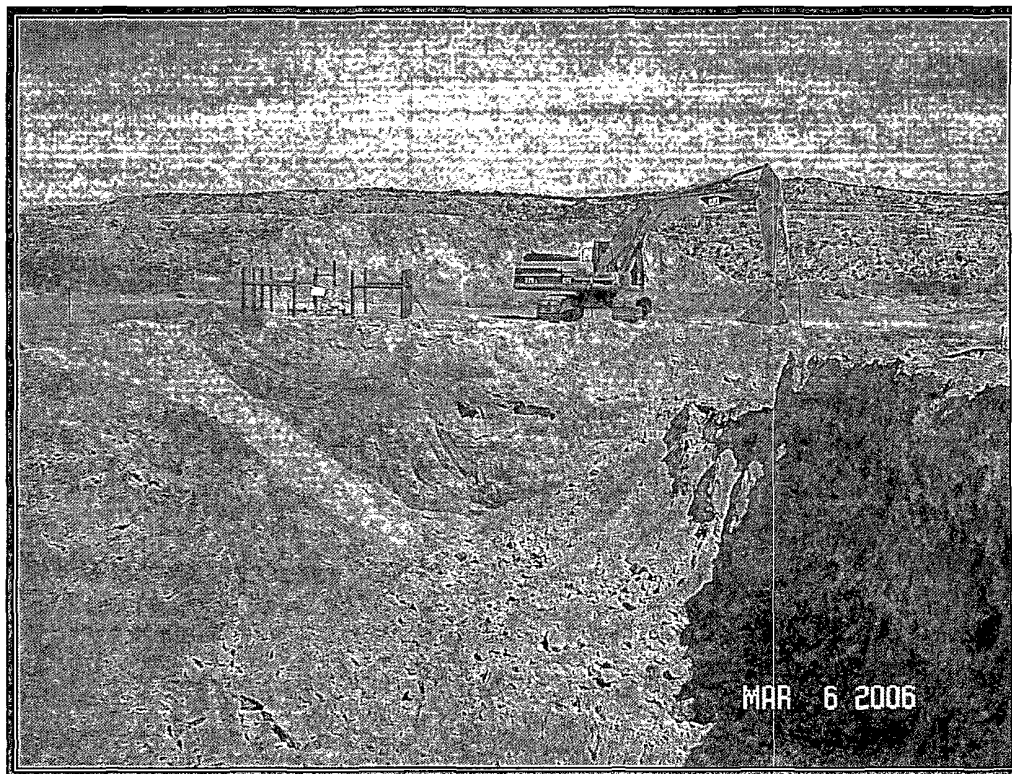
Photo 14: North wall, extent of excavation is below NMOCD guidelines

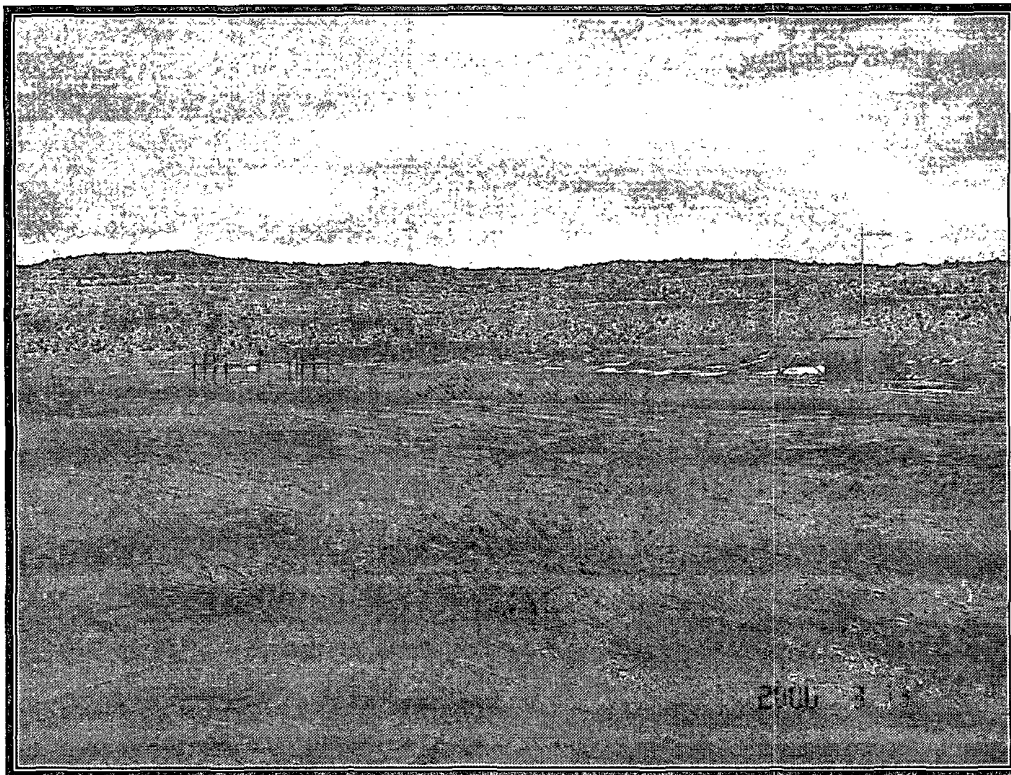
Photo 15: Excavation returned to pre-incident grade and conditions

The site activities were completed on March 13, 2006. The area was returned to original grade and conditions; see **Section 3, Site Photography**.

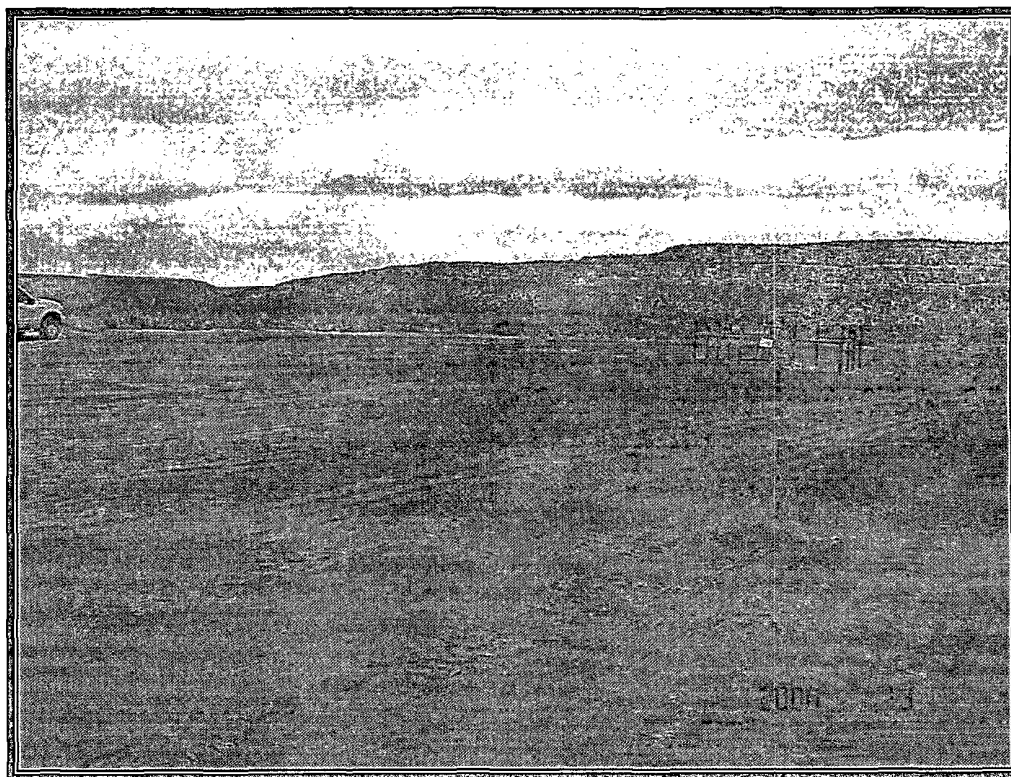
Photo 16: Excavation returned to pre-incident grade and conditions
