PIT REMEDIATION AND CLOSURE REPORT

Operator: PNM Gas Services (Caulkins) **Telephone:** 324-3764

Facility or Well Name: Breech C #216

Location: Unit P Sec 12 T 26 N R 6 W County Rio Arriba

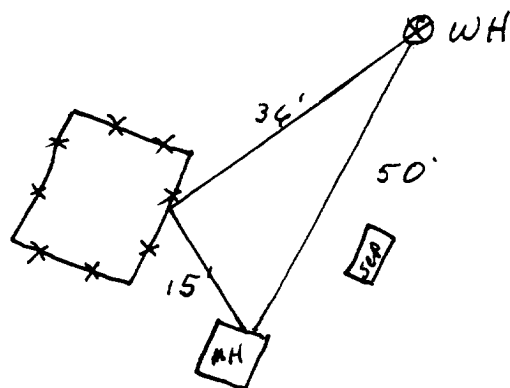
9-3-97 @ 0845

55° E of S

36' from W.H.

Excavated contaminated soil to a pit size of 17' X 15' X 5' and landfarmed soil onsite within a bermed area at a depth of 6" to 12". Soil was aerated by disking/plowing until soil met regulatory levels.

5 pt. composite - 4 side walls and center of pit bottom.

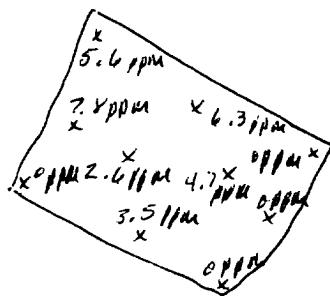
Sample # 9709110930

9-11-97 @ 0930

Land farm field head space. 3.5 ppm

2"-10"
