**PIT REMEDIATION AND CLOSURE REPORT**

**Operator:** PNM Gas Services ( Cross Timbers ) **Telephone:** 324-3764

**Facility or Well Name:** EH Pipken #8

**Location:** Unit N Sec 1 T 27N R 11W County San Juan

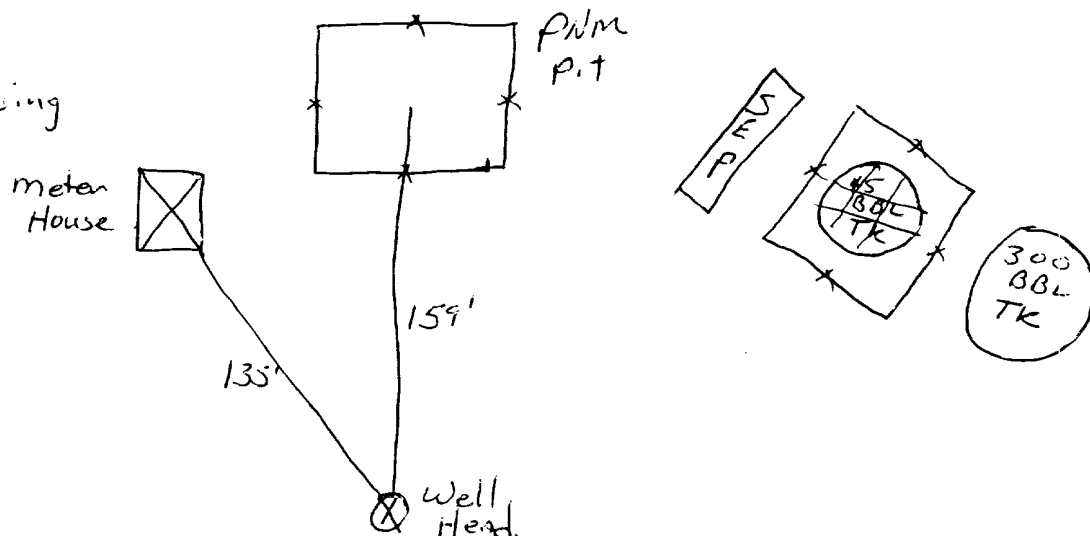
Site Drawing

**Pit Location:** Pit dimensions: length 15 width 15 depth 3

(Attach diagram) **Reference:** wellhead ☒ other ☐

**Footage from reference:** 159'

**Direction from reference:** Due Degrees      East      North ☒  
of  
     West      South ☐

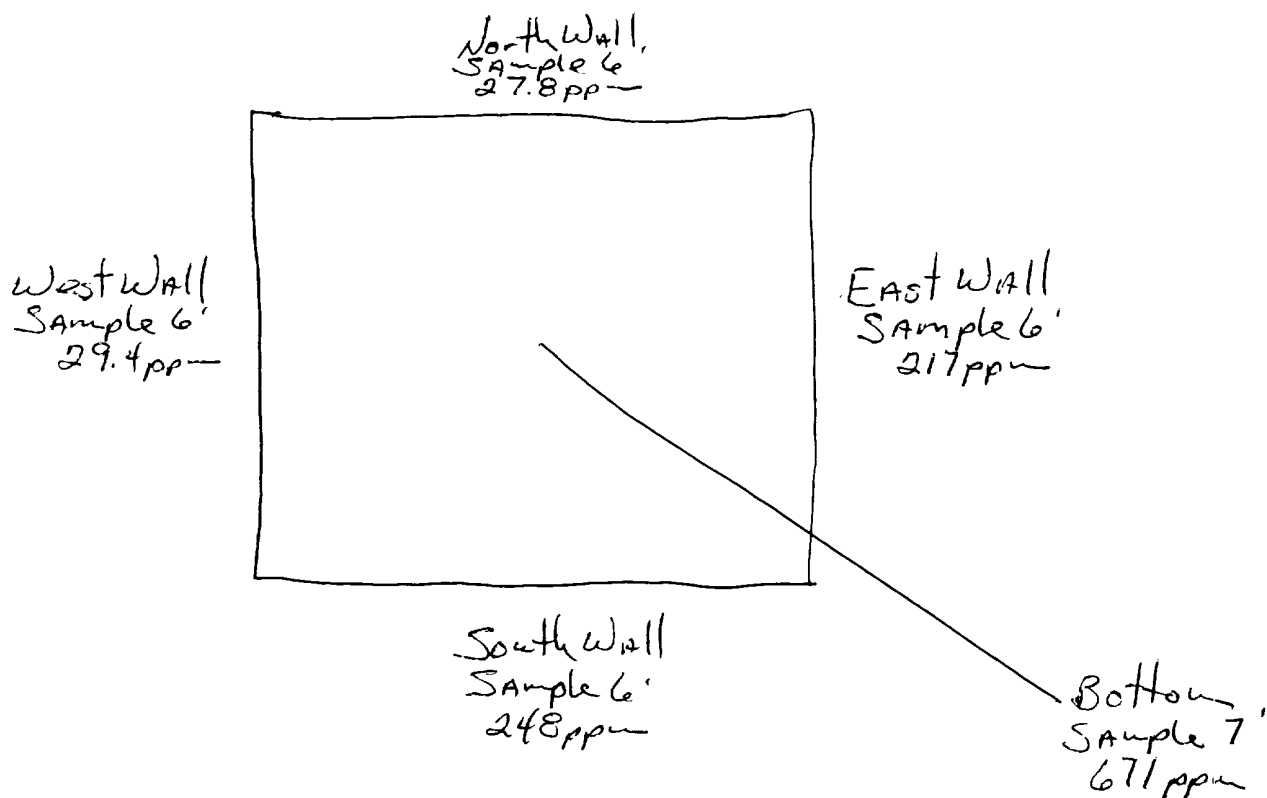
Excavation Drawing

Excavated contaminated soil to pit size of 25' X 25' X 7' and landfarmed soil onsite within a bermed area at a depth of 6" to 12". Soil was aerated by disking/plowing until soil met regulatory levels.

\*\*\* Bedrock encountered at 7'. See attached risk analysis and lab analysis form.

Bottom of excavation (3 pt.).

7'

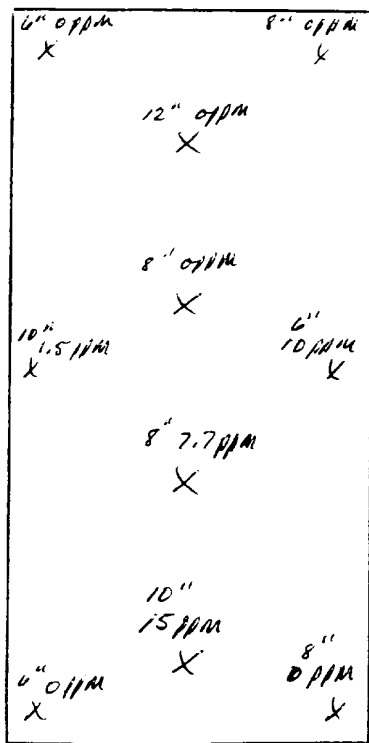
Pipken  
~~Apr 10~~ 8

Lab Sample # 9805210730

Field head space 11.0 ppm

6" - 12"
