### FIELD PIT SITE ASSESSMENT FORM

# FIELD PIT REMEDIATION/CLOSURE FORM

FIELD SERVICES LABORATORY  
ANALYTICAL REPORT  
PIT CLOSURE PROJECT - Soil

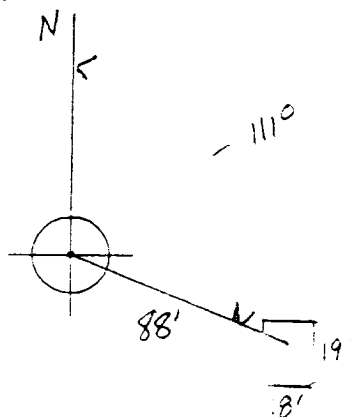
## ORIGINAL PIT LOCATION

Original Pit : a) Degrees from North 111° Footage from Wellhead 88'  
b) Length : 19' Width : 18' Depth : 2'
