## PIT REMEDIATION AND CLOSURE REPORT

Operator: Conoco Inc.

Facility Or: Maxey #1

Location: Unit or Qtr/Qtr Sec B Sec 24 T 29N R 12W County San Juan

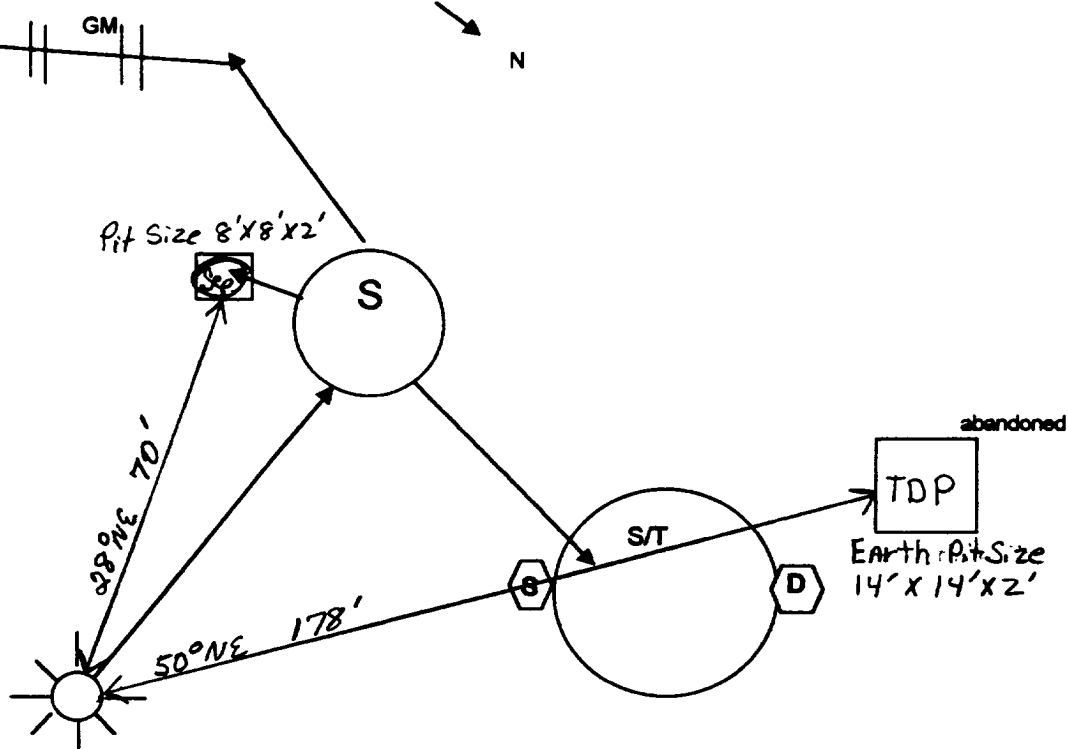
Lease Name: Maxey 1 Operator: S H Miller Date: 9/2/98

Site Security

to P-3 gathering system

Load line valves :  
Sealed during Production

Drain line valves :  
Sealed during Production

Production Line valve:  
Sealed during sales

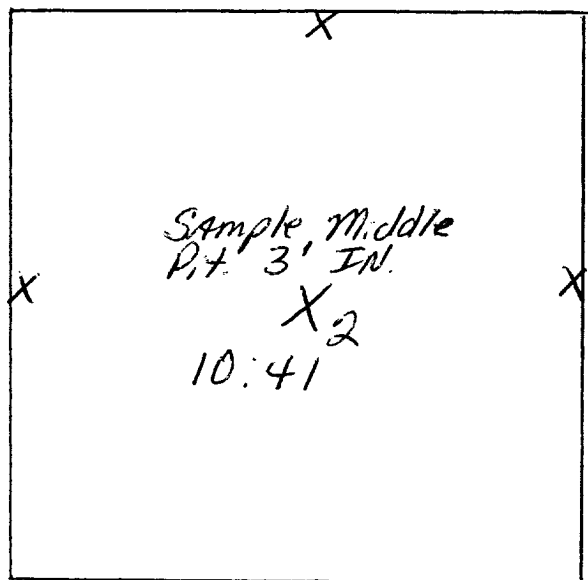
# MAXEY 1

TANK Drip TANK

Rocky AND Sandy Soil - Lots of Rock.

North Sample  
Time: 10:48 1 PPM

West Sample  
Time: 10:56  
1 PPM

EAST Sample  
Time: 10:51  
2

South Sample  
Time: 11:03  
1 PPM
