PIT REMEDIATION AND CLOSURE REPORT

Facility or Well Name: Florance #44

Groundwater Site Summary Report

Florance 44 (continued)

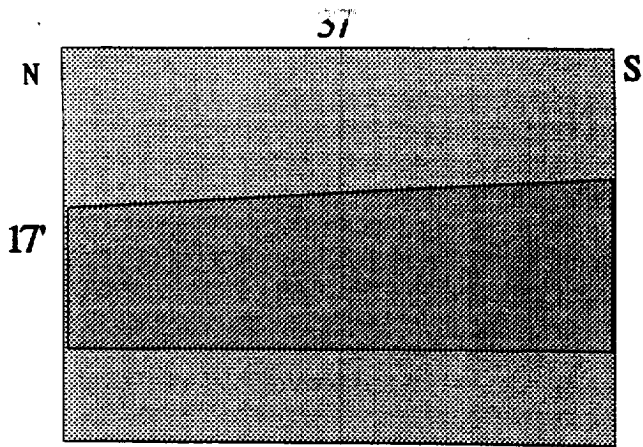
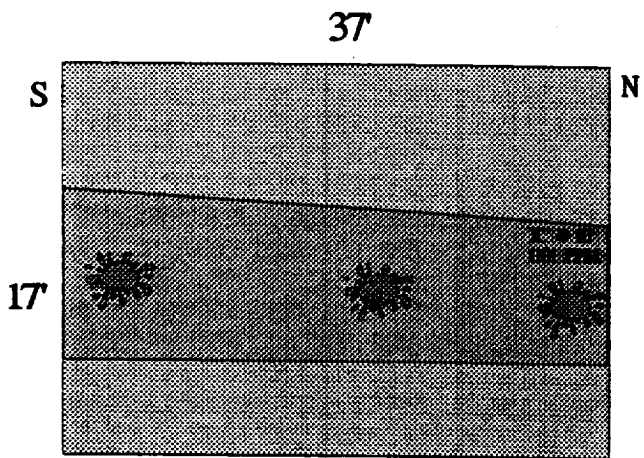
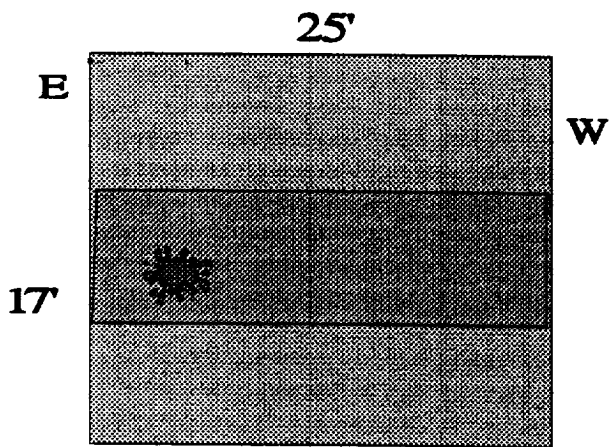
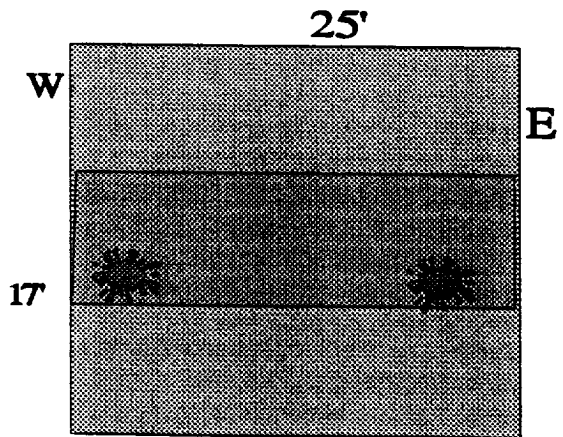
EAST WALL

EXCAVATION AT END
 PIT WATER SAMPLE 9605151010
 WELL H2O SAMPLE 9605151005
 WEST WALL SAMPLE 9605151630

WEST WALL

= WATER SEEPS

= CONTAMINATION

SOUTH WALL

NORTH WALL

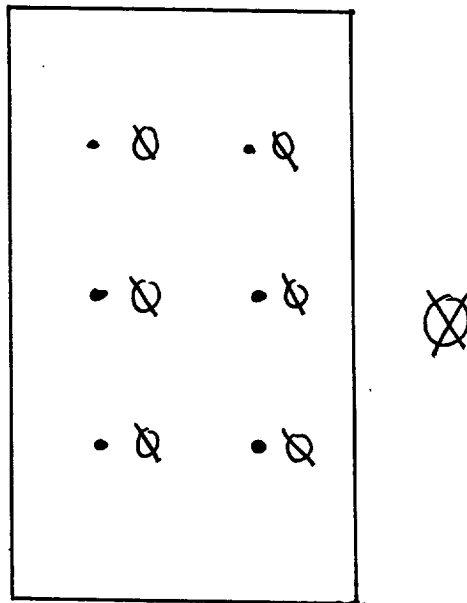
FLORANCE #44
Amoco
Sec. 31-30N-09W

Land Farm: On Location
120 Yards

Composite Sample #: 9607231500

Soil Vapor Head-Space Reading = 3.8 ppm (PID)

Sample depths between 2" and 12"

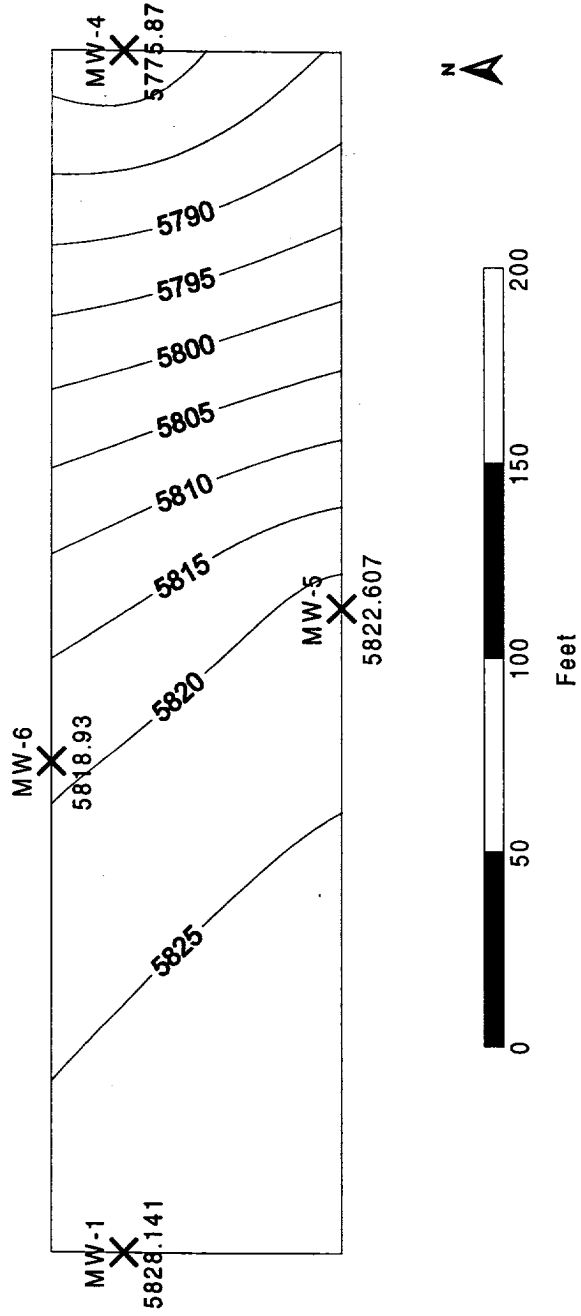
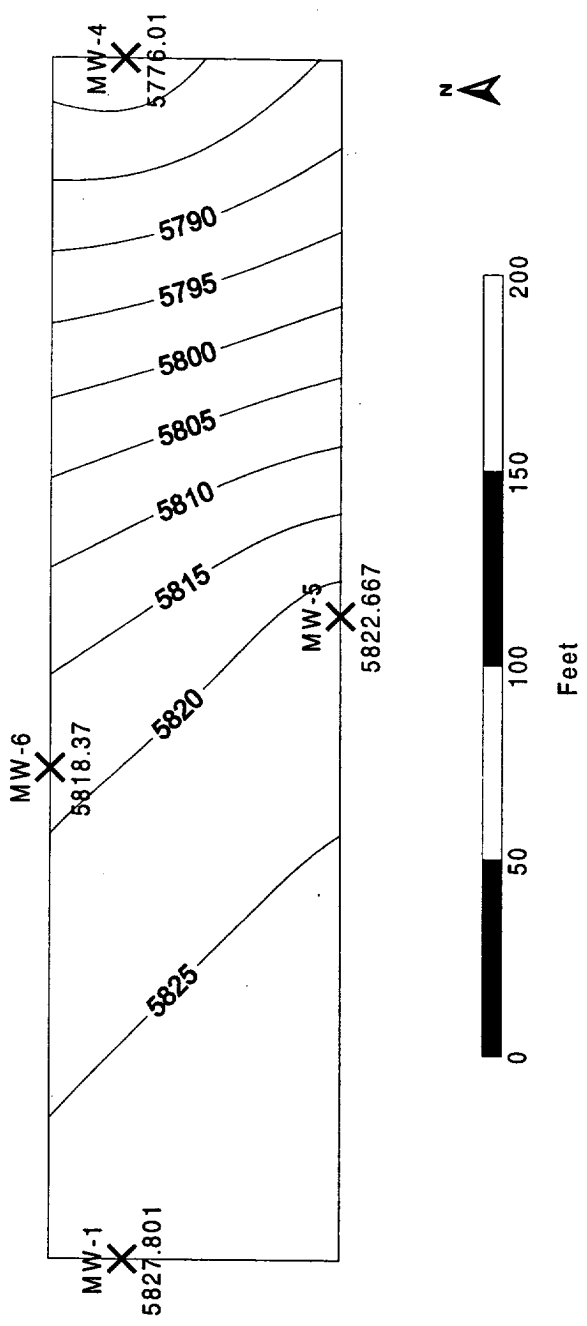
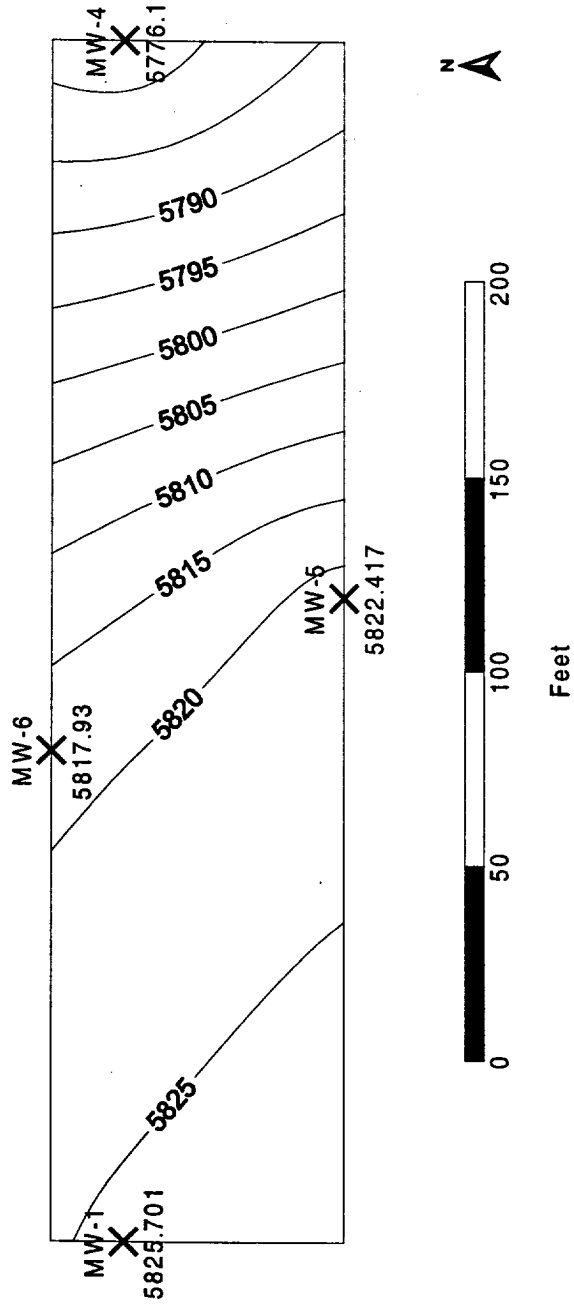
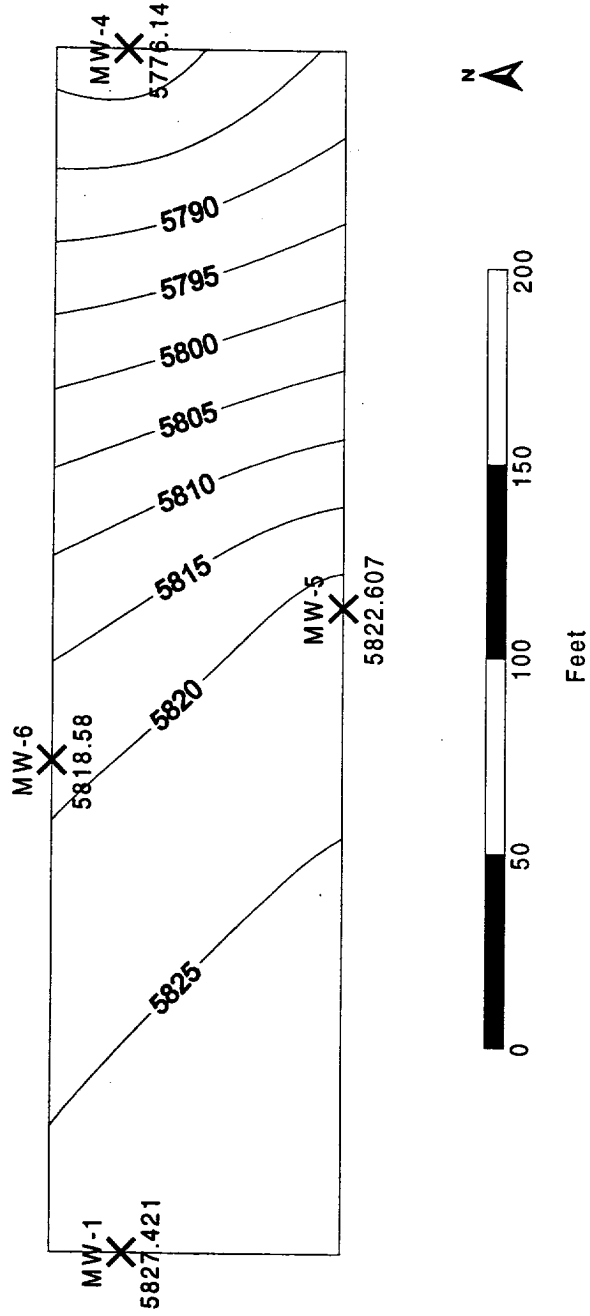
Figure 3.
Florance 44 Groundwater Contour Map (January 12, 1999)

Groundwater beneath the site is as shallow as 7 feet (in upgradient well MW-1) to as deep as 43 feet (in downgradient well MW-4). Groundwater flows east-northeast beneath the site (Figures: 3-6), parallel with surface topography and in the same direction as the assumed bedrock-alluvium contact. The water levels are found within alluvium, which is saturated in the area of study.

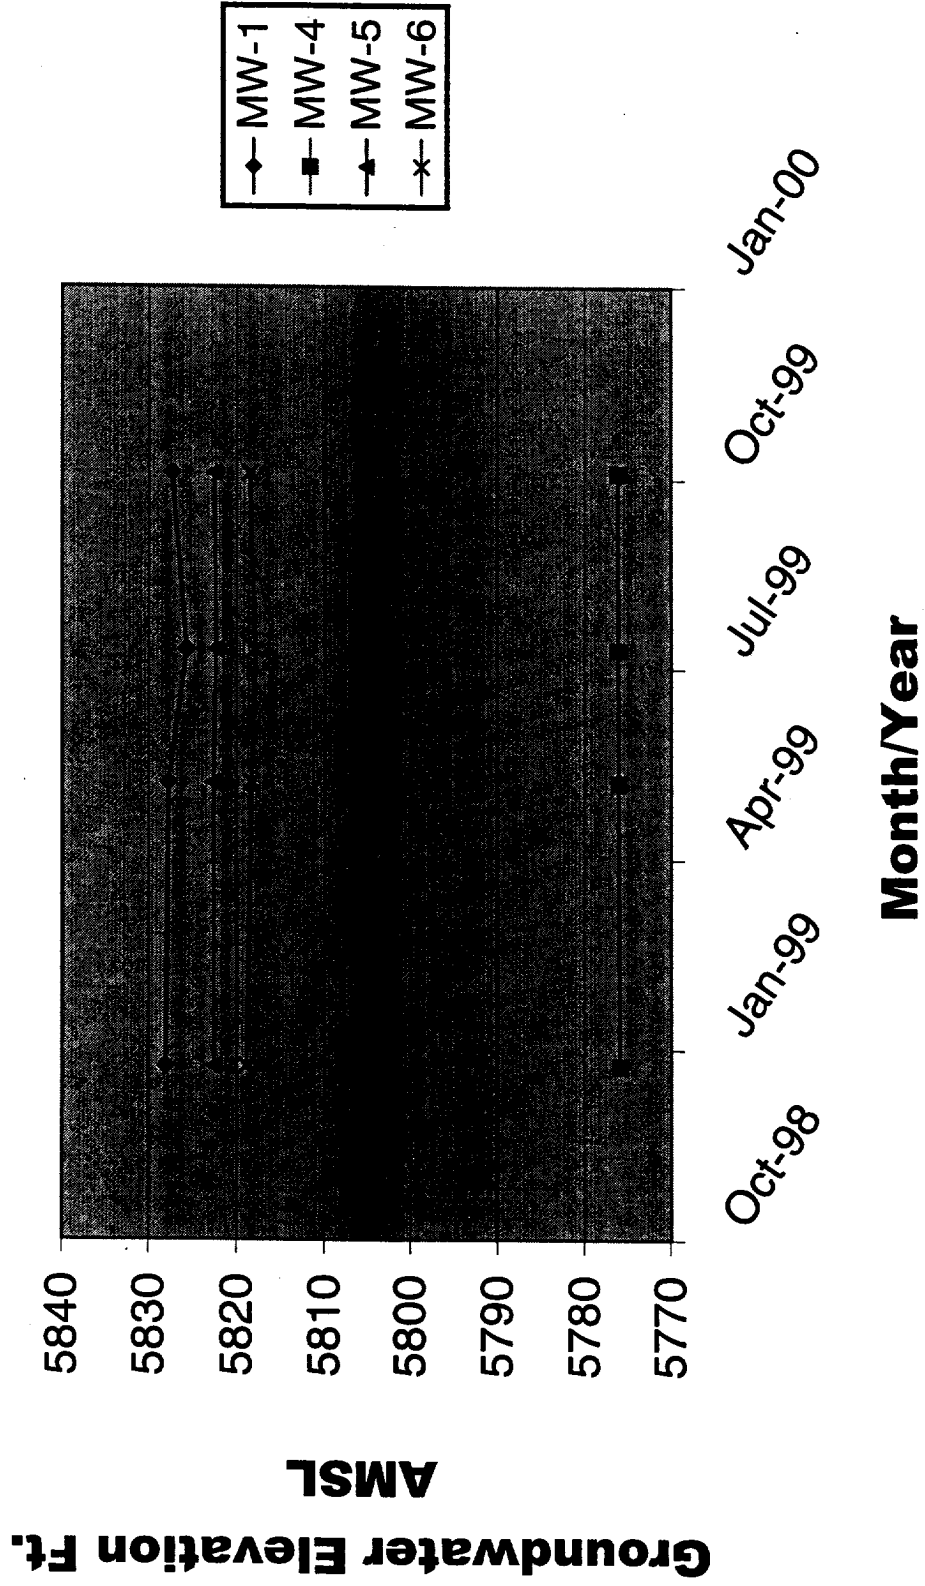
Figure 7.
Florance 44 Hydrograph

The hydrograph of the site (Figure 7) shows fairly steady to slightly falling water levels over time. Owing to the removal and reinstallation of wells, it is not possible to construct a comprehensive hydrograph in the central part of the well pad. However, bore holes SB-1 through SB-3 (see Figure 2) showed dry conditions to the bedrock surface, and wells MW-5 and MW-6 contain only a few feet or less of saturated alluvium. It is believed that the diversion of the spring on the south side of the study area has caused the gradual dewatering of the local alluvium. The site was recently resurveyed using a slightly different datum, thus the inconsistency of past hydrographs to current. However, the groundwater elevations recorded at each of the monitoring wells track nicely with the greatest changes occurring in wells MW-1 and MW-6, closest to the wash on the northern edge of the site.
