PIT REMEDIATION AND CLOSURE REPORT

Operator:	PNM Gas Services (Floyd Oil	Company) Telephone:	324-3764	
Address:	603 W. Elm Street Farmington, NM	87401		
Facility or W	ell Name: New Mexico Federal N #1	E		
Location:	Unit P Sec		R 12 W County	San Juan
Pit Type:	Separator Dehy	drator Othe	er	
Land Type:	BLM State	Fee Othe	er	
Pit Location:	Pit dimensions: length	18 ' width	18 ' depth	3 '
(Attach diagram	m) Reference: wellhead	✓ other		
	Footage from reference:	94'		
	Direction from reference:	Degrees	East North	
			of West South	<u> </u>
Depth to Grou	und Water:	Less than 50 feet 50 feet to 99 feet		(20 points) (10 points)
(Vertical distance from c seasonal high water elevi water		Greater than 100 feet		(0 points) 0
Wellhead Pro		1 2000 Yes		(20)
(Less than 200 feet from domestic water source, o feet from all other water	or, less than 1,000	No 3		(20 points) (0 points) 0
Distance to Su	urface Water:	Less than 200 feet		(20 points)
(Horizontal distance to ponds, rivers, streams, cr	perennial lakes,	200 feet to 1,000 feet Greater than 1,000 feet		(10 points) (0 points) 0

New Mexico Federal N #1E Date Remediation Started:	06/10/1999	Date Completed: 06/10/1999
Remediation Method:	Excava

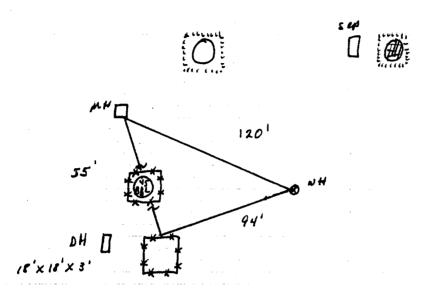
excavation sampling

17'(N+5)x 20'(E+W) X 6'(0)

MD Readings 4-1774 ppm 6-1444 ppm

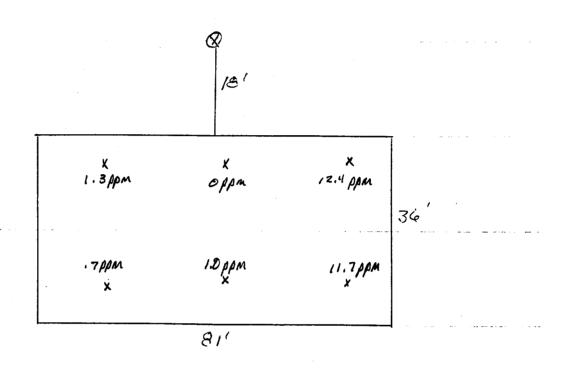
LANd farm Drawing

Sec. 17 T301 Claw Unit P Floyd Dil Company

Not to Scale

2" to 12"

Head Space - 10.1 ppm Sample # - 9908101325
