PIT REMEDIATION AND CLOSURE REPORT

Operator: PNM Gas Services (Meridian/SRC)		Telephone: 324-3764	
Address: 603 W. Elm Street Farmington, NM 87401			
Facility or Well Name: Nye #17			
Location:	Unit: L	Sec: 1	T. 30 N R. 11 W County: San Juan
Pit Type:	Separator	Dehydrator <input checked="" type="checkbox"/>	Other
Land Type:	BLM <input checked="" type="checkbox"/>	State	Fee Other
Pit Location:	Pit dimensions:	length 18	width 18 depth 4
(Attach diagram)	Reference:	wellhead <input checked="" type="checkbox"/>	other
	Footage from reference:	88'	
	Direction from reference:	42 Degrees	East North <input checked="" type="checkbox"/>
		<input checked="" type="checkbox"/> West	South
Depth to Ground Water:		Less than 50 feet	(20 points)
		50 feet to 99 feet	(10 points)
		Greater than 100 feet	(0 points)
(Vertical distance from contaminants to sea level; high water elevation of ground water)			0
Wellhead Protection Area:		Yes	(20 points)
		No	(0 points)

NYE #17 EXCAVATION
06/03/96

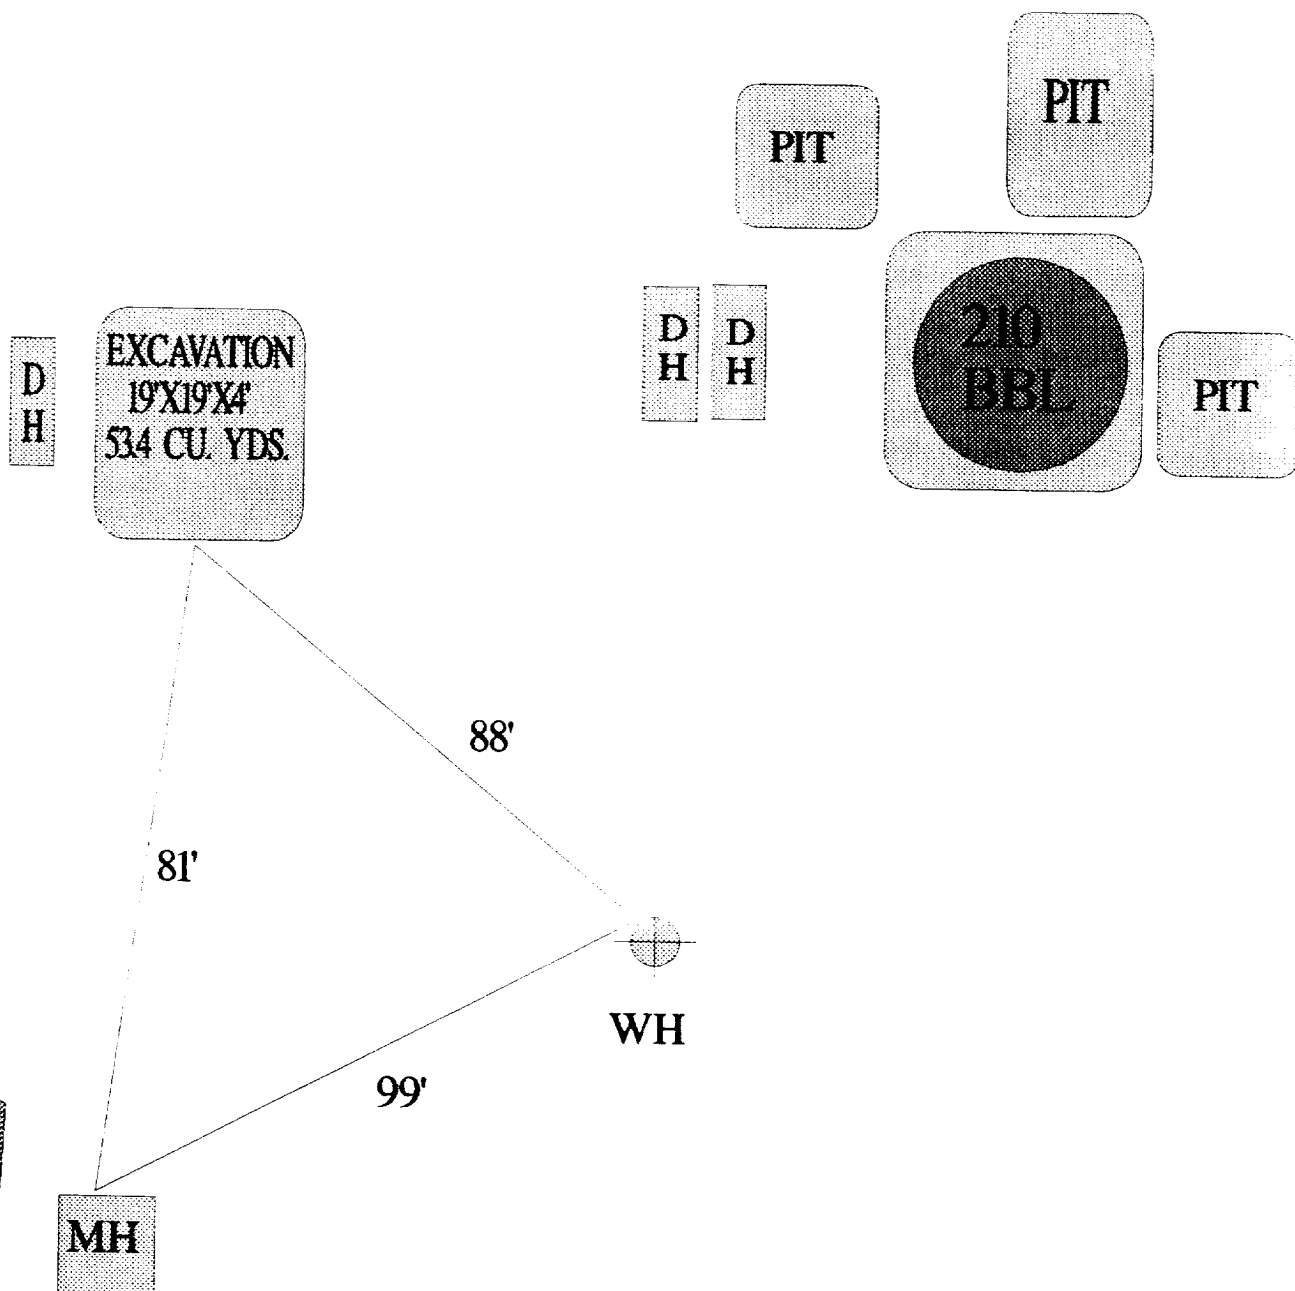
Excavated contaminated soil to pit size of 19'x19'x4' and landfarmed soil onsite within a bermed area at a depth of 6" to 12". Soil was aerated by plowing/disking until soil met regulatory levels.

5 pt composite-4 side walls and center of pit bottom

4'
