PIT REMEDIATION AND CLOSURE REPORT

Operator: PNM Gas Services (Burlington)		Telephone: 324-3764	
Address: 603 W. Elm Street Farmington, NM 87401			
Facility or Well Name: Sanchez #3E			
Location:	Unit J	Sec 34	T 30N R 10W County San Juan
Pit Type:	Separator <input checked="" type="checkbox"/>	Dehydrator <input type="checkbox"/>	Other Drip
Land Type:	BLM <input checked="" type="checkbox"/>	State <input type="checkbox"/>	Fee <input type="checkbox"/> Other
Pit Location:	Pit dimensions: length 20 ' width 20 ' depth 3 '		
(Attach diagram)	Reference: wellhead <input checked="" type="checkbox"/> other		
	Footage from reference: 125'		
	Direction from reference: 85 Degrees <input type="checkbox"/> East North <input checked="" type="checkbox"/> <input checked="" type="checkbox"/> West of South <input type="checkbox"/>		
Depth to Ground Water:	Less than 50 feet (20 points) 50 feet to 99 feet (10 points) Greater than 100 feet (0 points) 0		
Wellhead Protection Area:	Yes (20 points) No (0 points) 0

Sanchez #3E

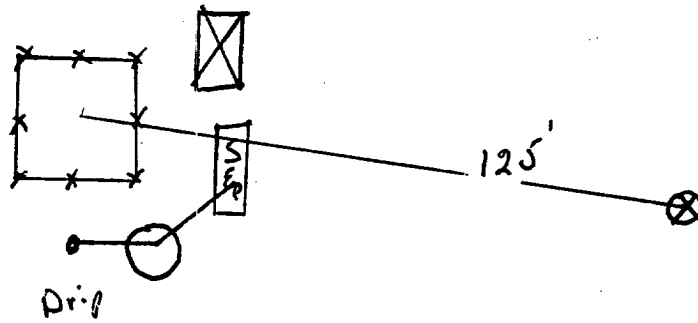
Site diagram:

Sanchez #3E
Burlington
Sec. 34, 30N, 10W, T

6/14/99

Excavated contaminated soil to a pit size of 16' X 16' X 8 and landfarmed soil onsite within a bermed area at a depth of 6" to 12". Soil was aerated by disking/plowing until soil met regulatory levels.

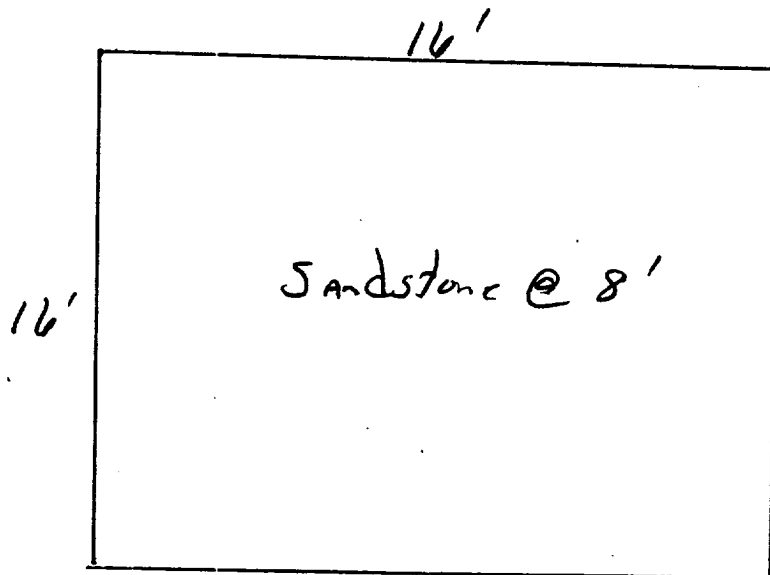
End of excavation:

5 pt. composite - bottom.

8'

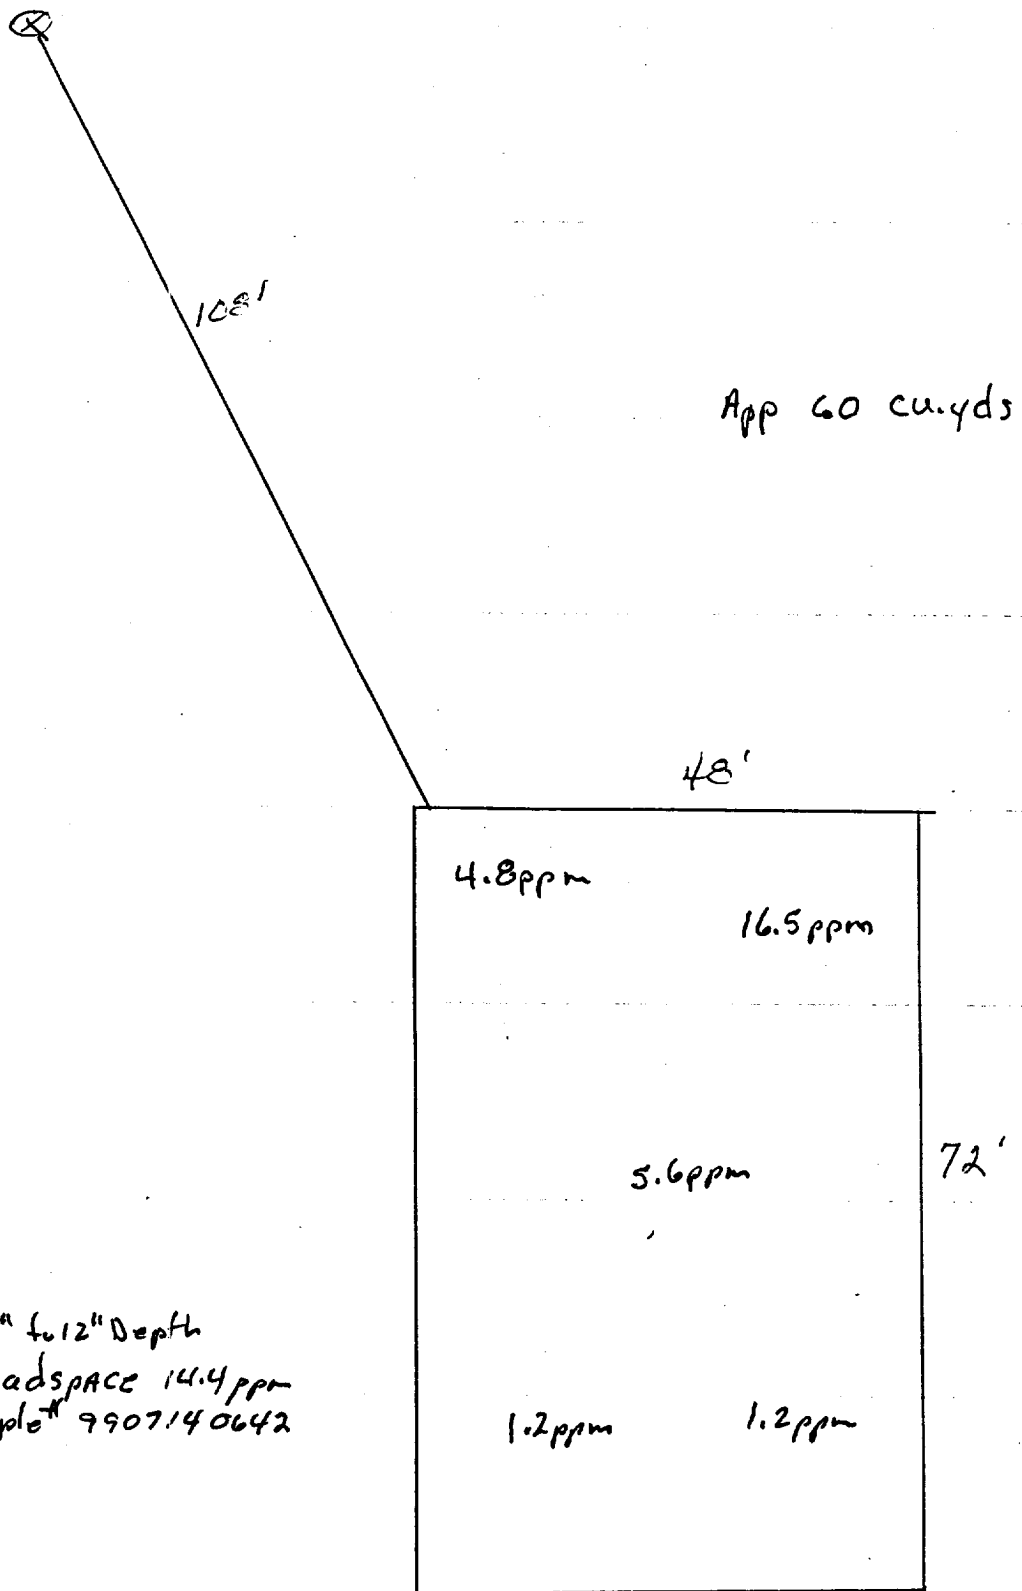
Landfarm Drawing

Sec. 34 T30N R10W Unit 111
Burlington

Not to scale

2" to 12" Depth
Headspace 14.4 ppm
Sample # 9907140642
