PIT REMEDIATION AND CLOSURE REPORT

Operator: PNM Gas Services (Burlington) **Telephone:** 324-3764

Facility or Well Name: Decker #4

Location: Unit M Sec 10 T 32 N R 12 W County San Juan

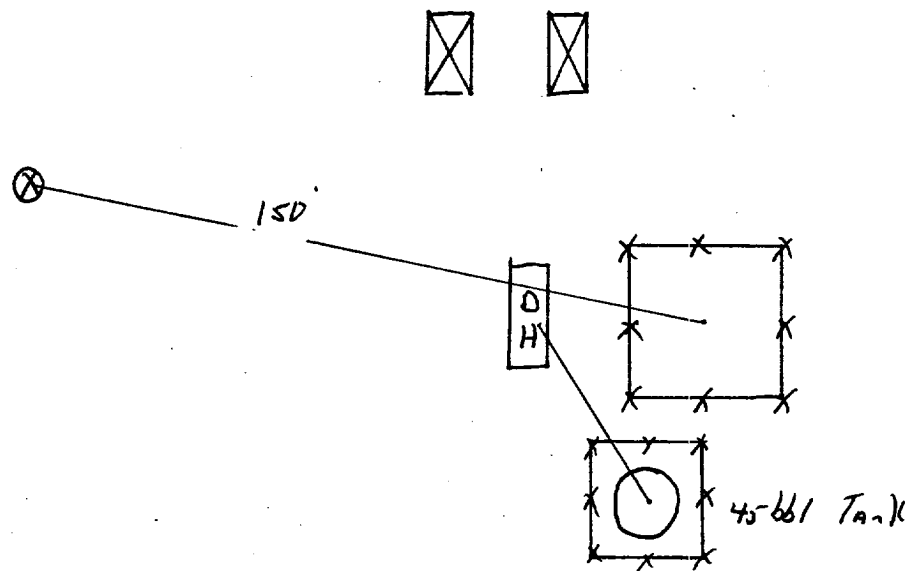
Site diagram:

Decker # 4
Burlington
Sec. 10, 32N, 12W, m

4/29/99

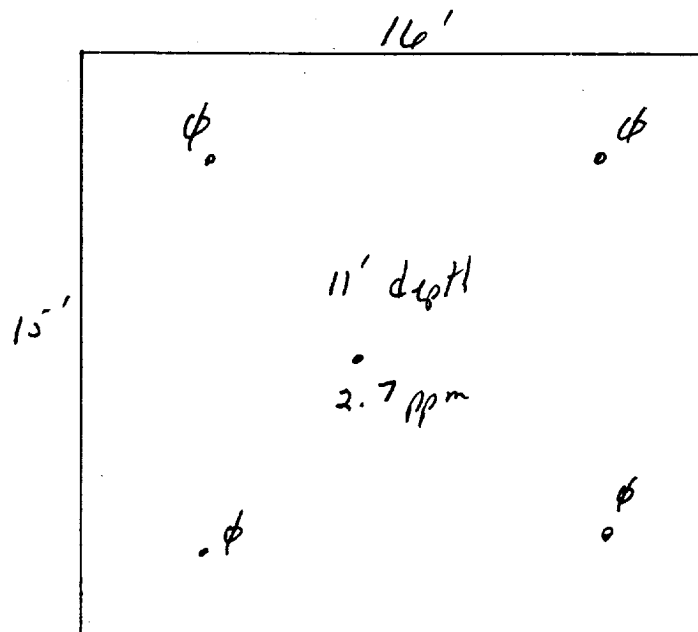
End of excavation:

Excavated contaminated soil to a pit size of 16' X 15' X 11' and landfarmed soil onsite within a bermed area at a depth of 6" to 12". Soil was aerated by disking/plowing until soil met regulatory levels.

5 pt. composite - bottom.

11'

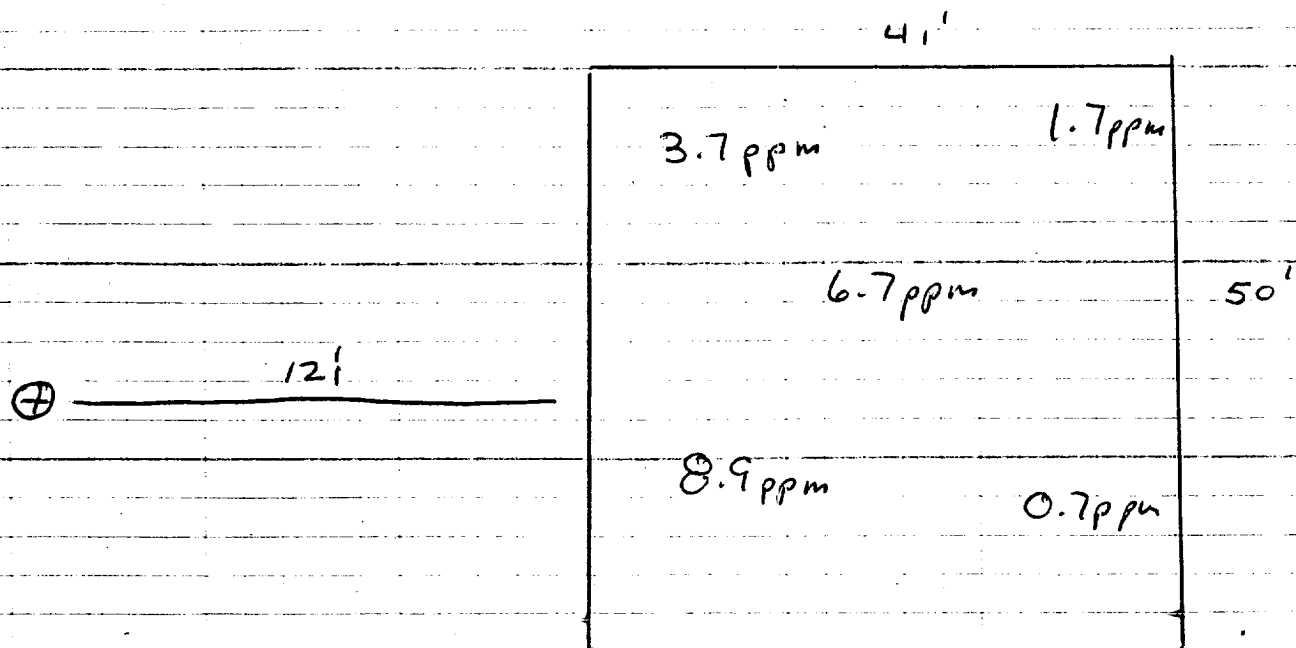
LANDFARM DRAWING

App 97 cu yds

2" to 12" Depth

Headspace Reading 14.0
Sample # 9906091215
