ENVIRONMENTAL PLUS, INC. *Micro-Blaze Micro-Blaze Out*

16 September 2005

RE: **Closure Proposal for Duke Energy Field Services G-28-24 Release Site (Ref. #130015)**
UL-A (NE¼ of the NE¼ of Section 2, Township 23 South, Range 36 East
Latitude N 32° 20' 25.042" and Longitude W 103° 13' 40.062"

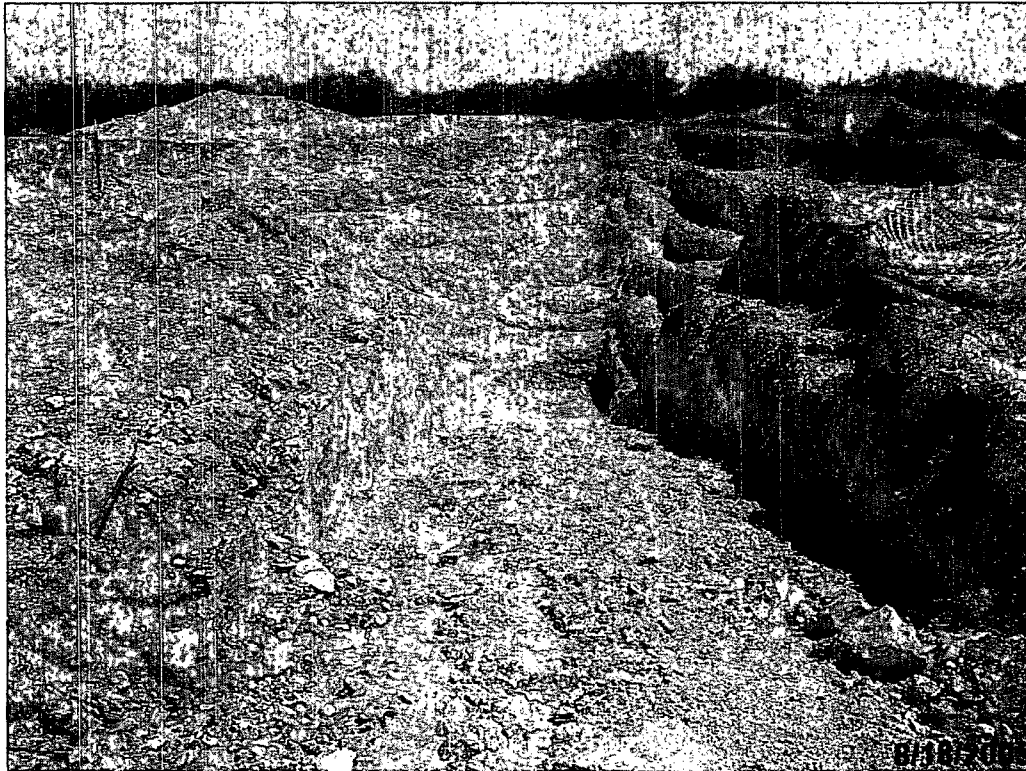
Photograph #1- Western excavation current status, looking easterly down access ramp.

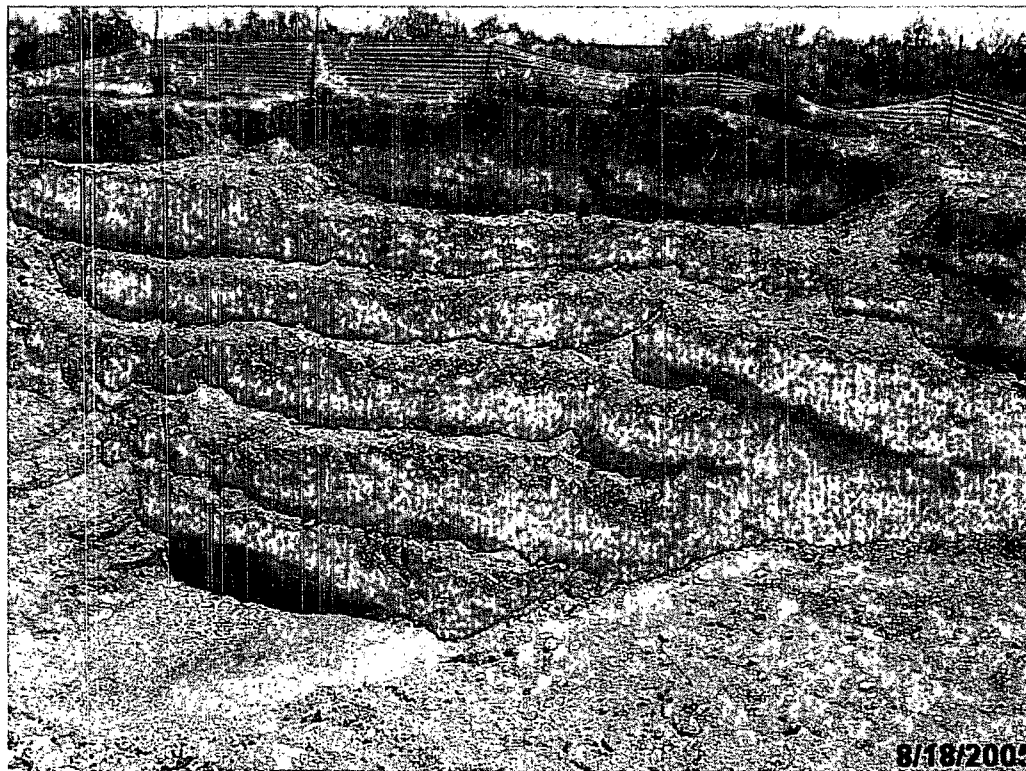
Photograph #2- Western excavation current status, looking southeasterly at south wall.
