J-4-2 Low Pressure Gathering Line Closure Report
Duke Energy Field Services
Lea County, New Mexico

J-4-2 LOW PRESSURE GATHERING LINE

T19S, R35 E, SECTION 28, UNIT D

Re: Removal of Hydrocarbon-Impacted Soils from the J-4-2 Low-Pressure Gathering Line Site
Township 19 South, Range 35 East, Section 28, Unit D

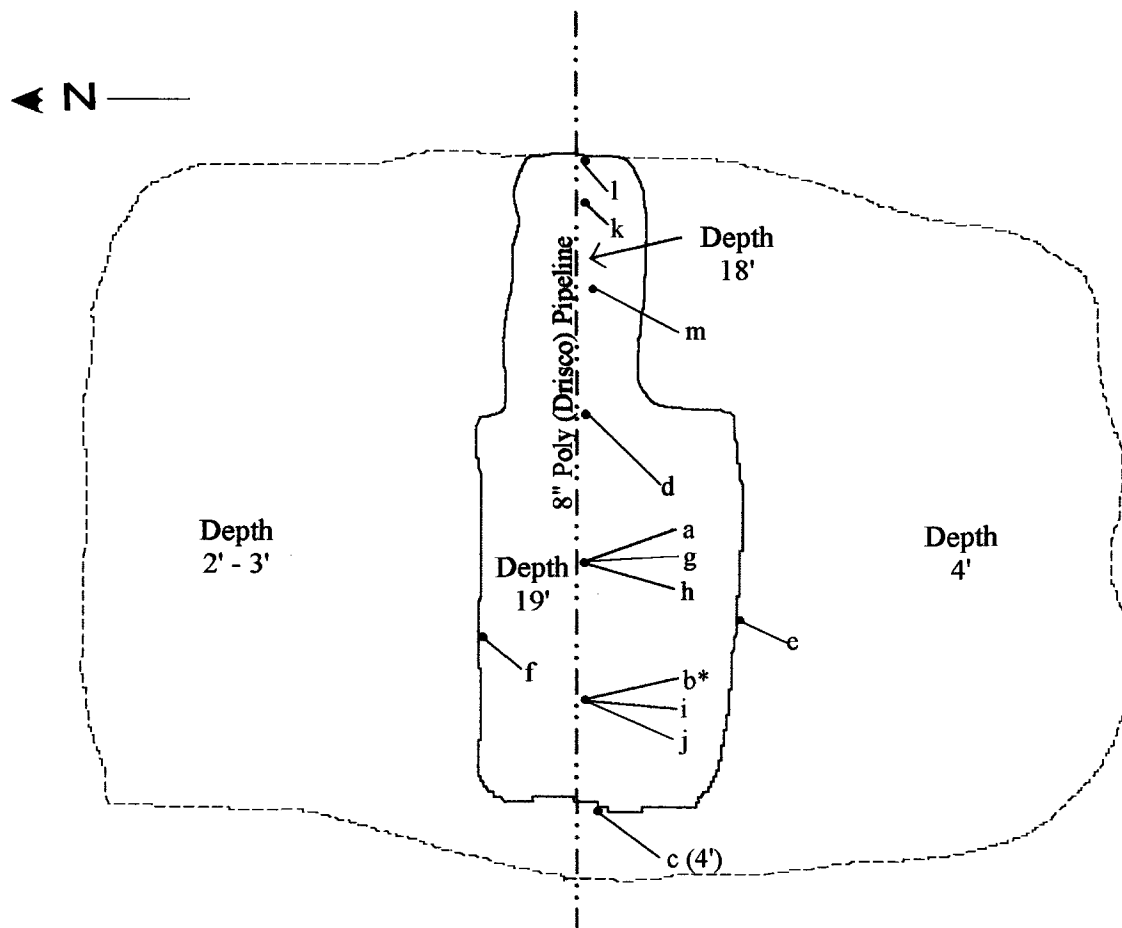
**J-4-2
SITE MAP**

At the completion of excavation activities all areas had petroleum hydrocarbon concentrations below the OCD guidelines listed above. Soil sample locations and site features are depicted on the site map in Attachment A. A Site Data Form that includes a summary of the analytical results and photo documentation are also provided in Attachment A. Laboratory analytical reports, and chain-of-custody documentation for the samples collected are provided in Attachment B. Copies of the field logbook are in Attachment C.

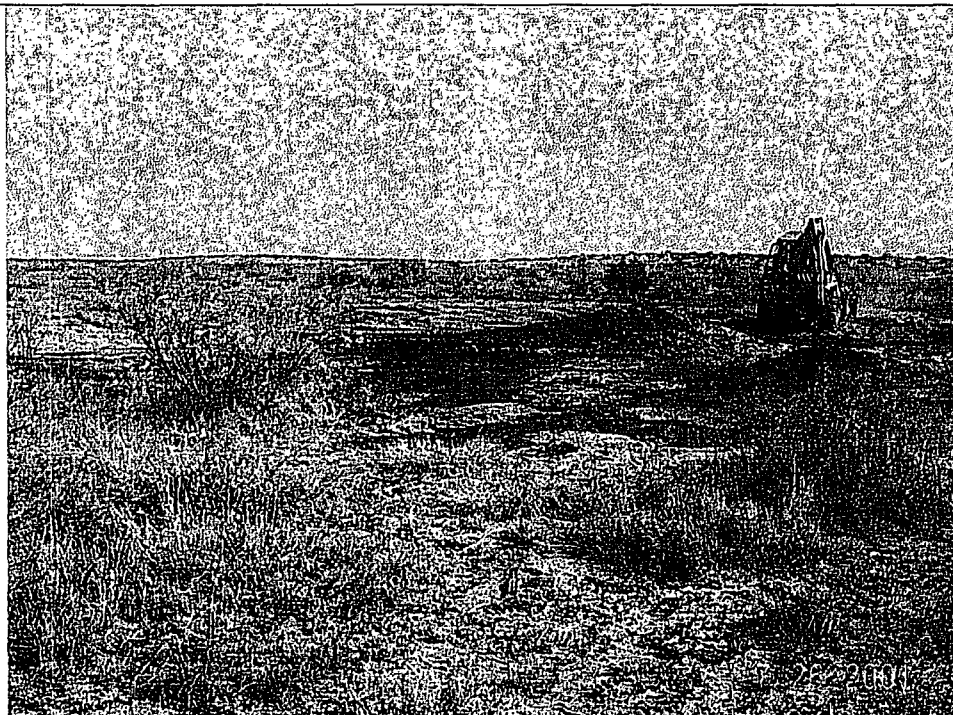
J42_1142
7/26/01

View facing north showing surface impact on first day of excavation activities.

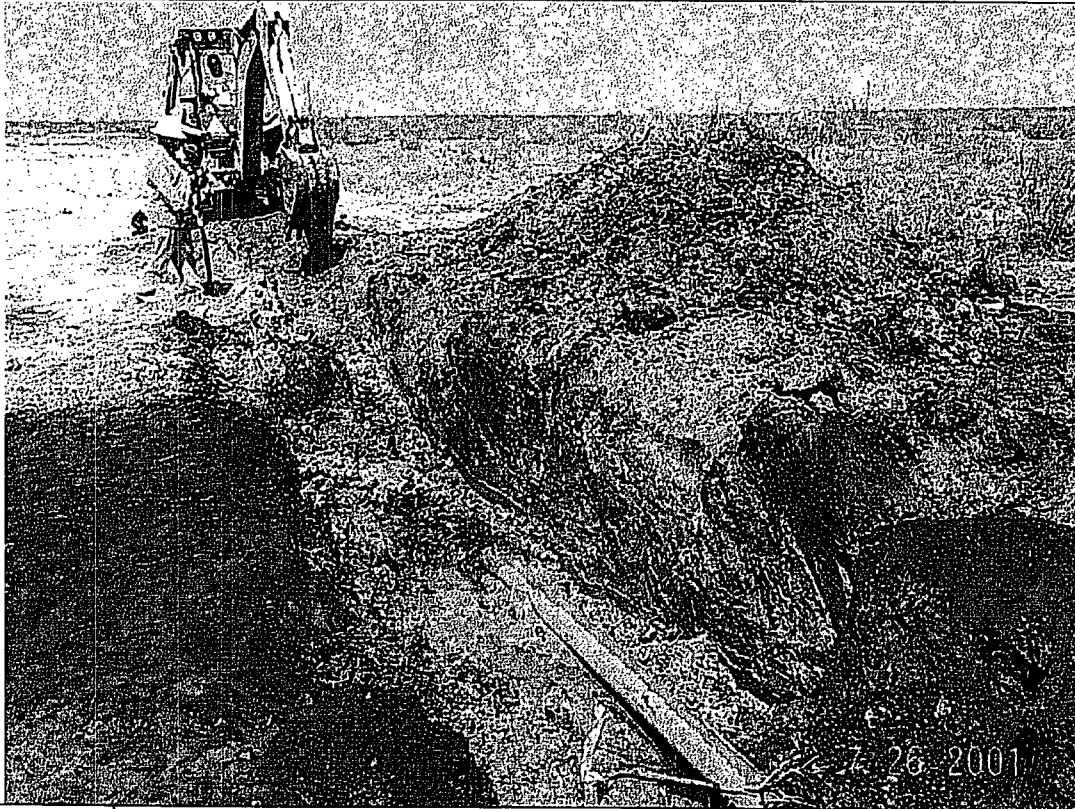
J42_1147.jpg
7/26/01

View facing NW showing north wall at beginning of excavation activities.
Rainwater visible at bottom of excavation.

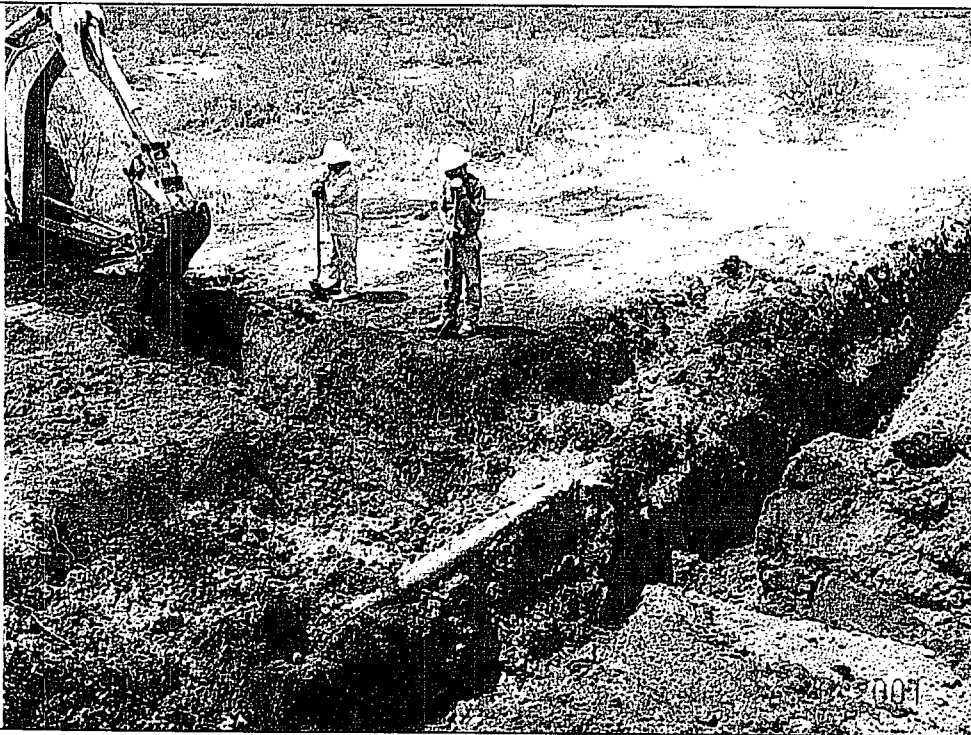
J42_1149
7/26/01

View facing SW showing south wall on the first day of excavation activities.

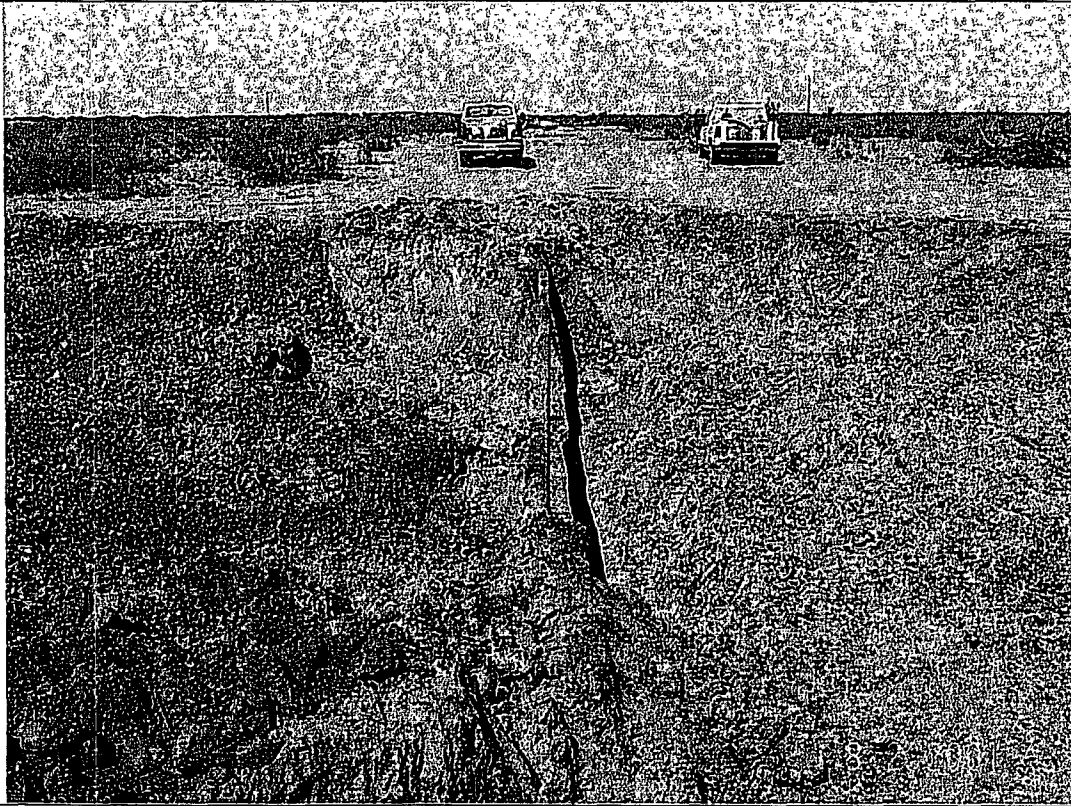
J42_1178.jpg
8/02/01

View facing west showing main excavation.

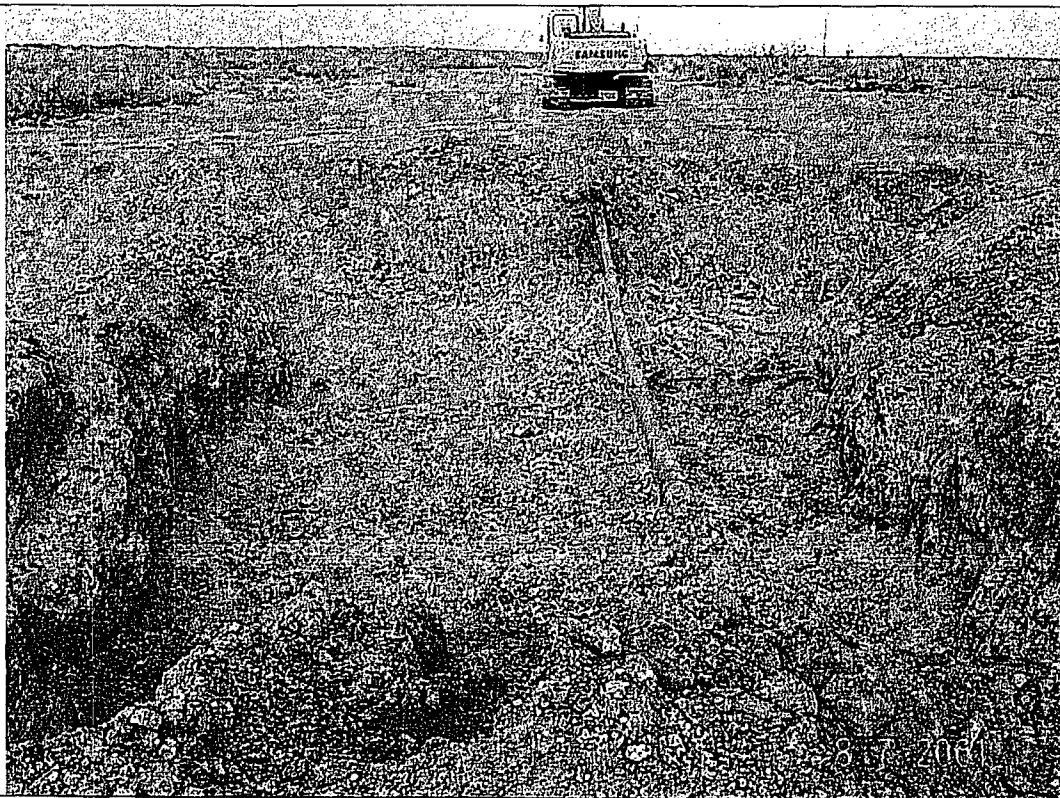
J42_1188
8/07/01

View facing west showing south (left center), west (middle background), and north (right center) walls, and floor (foreground) of excavation.

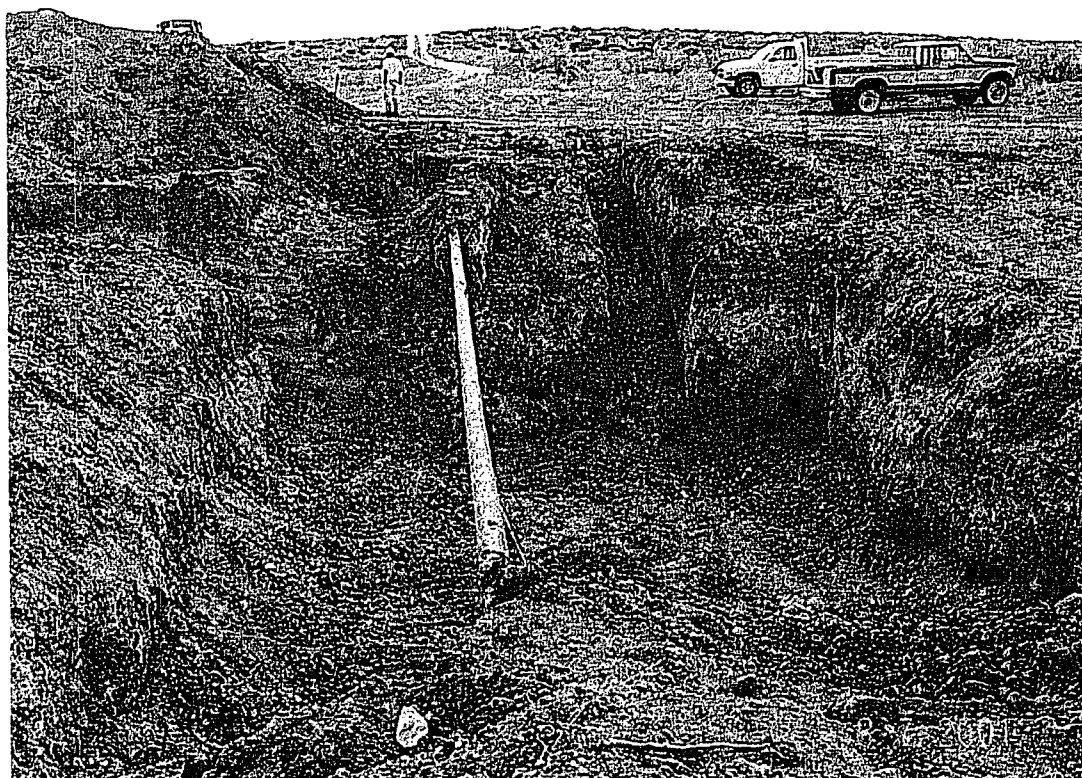
J42_1189.jpg
8/7/01

View facing east showing north (left center), east (middle background), and south (right center) walls, and floor (foreground) of excavation.

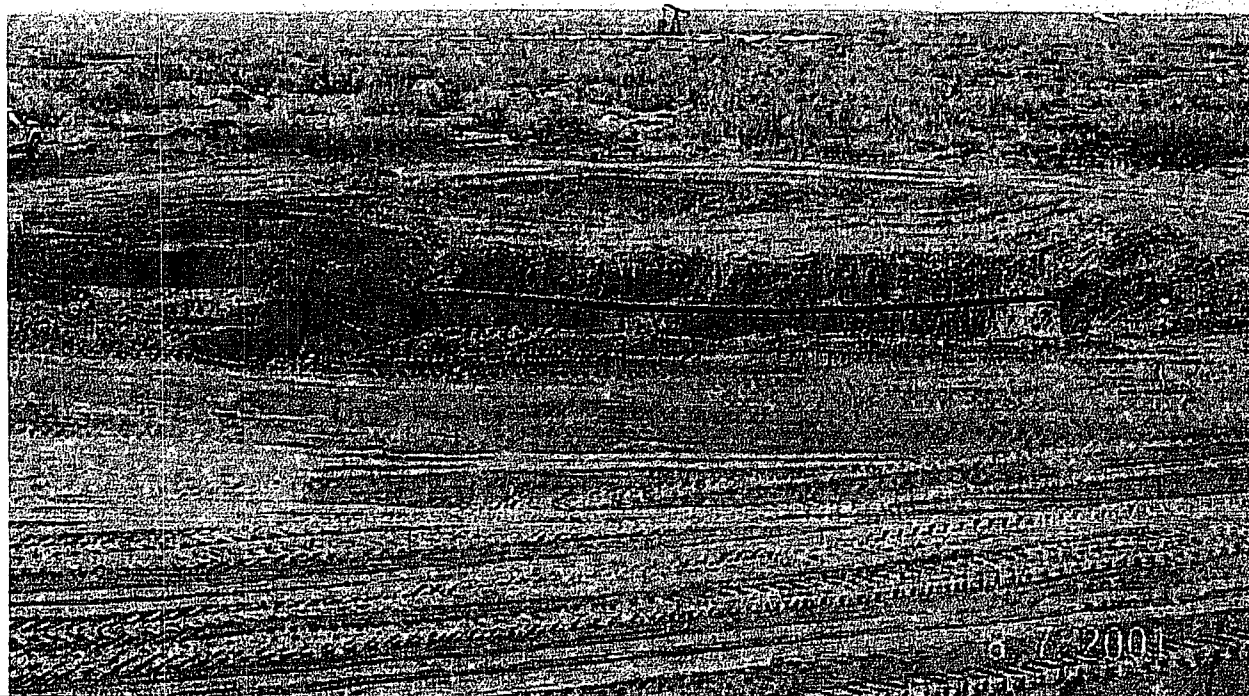
J42_1190
8/7/01

View facing north showing overall area where excavation has taken place to date.

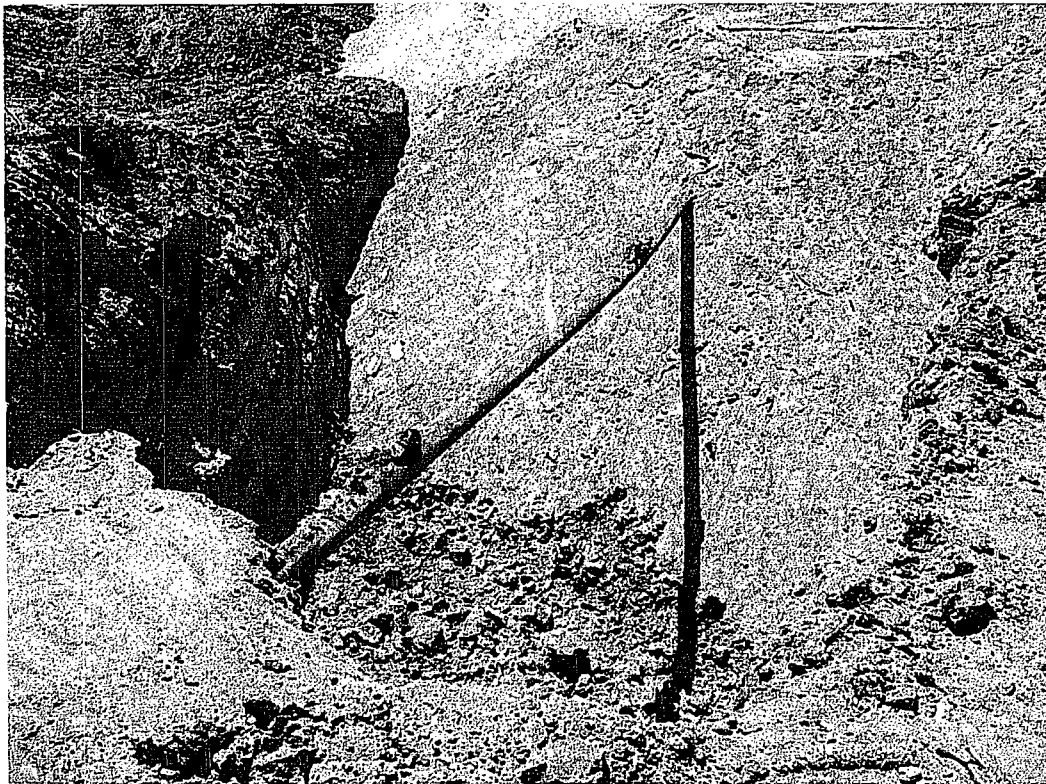
J42_0006.jpg
8/14/01

View facing west showing west end of excavation after partial backfilling for pipeline support to allow further excavation on east end.

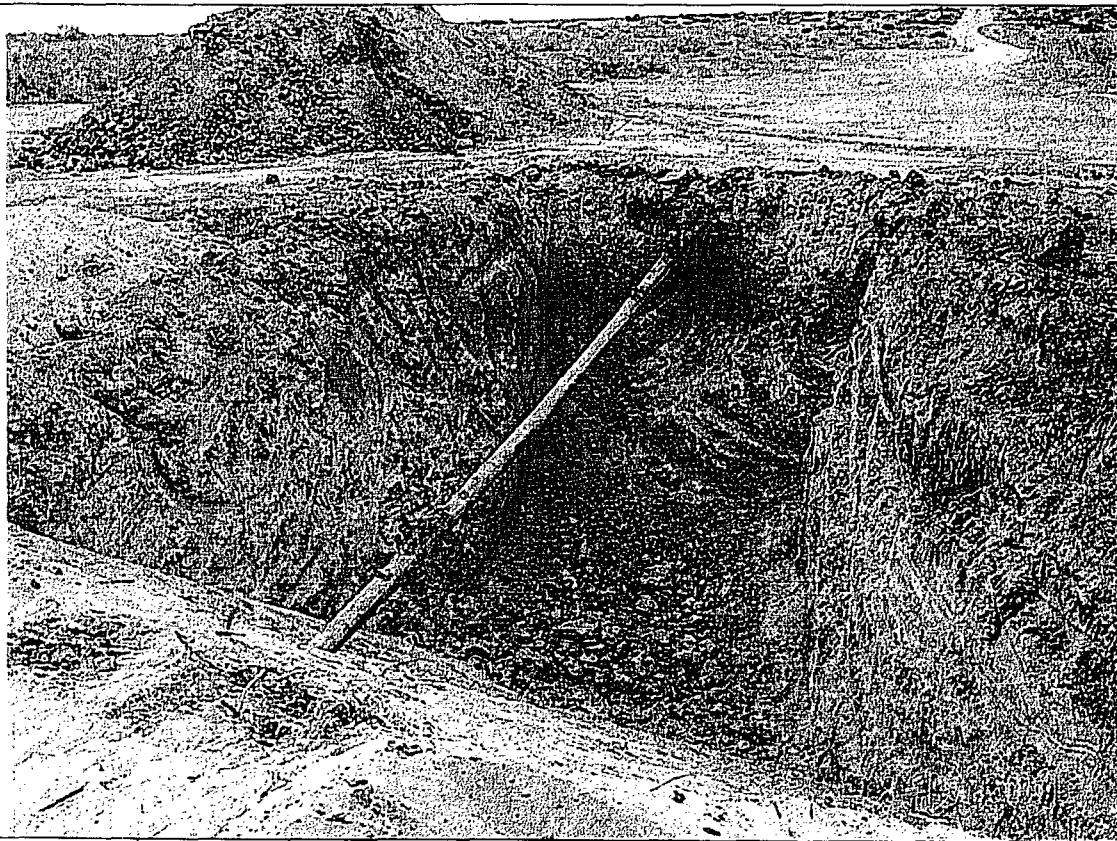
J42_1195.jpg
8/15/01

View facing NE showing north (left center), east (middle background), and south (right center) walls, and floor (foreground) at completion of excavation.

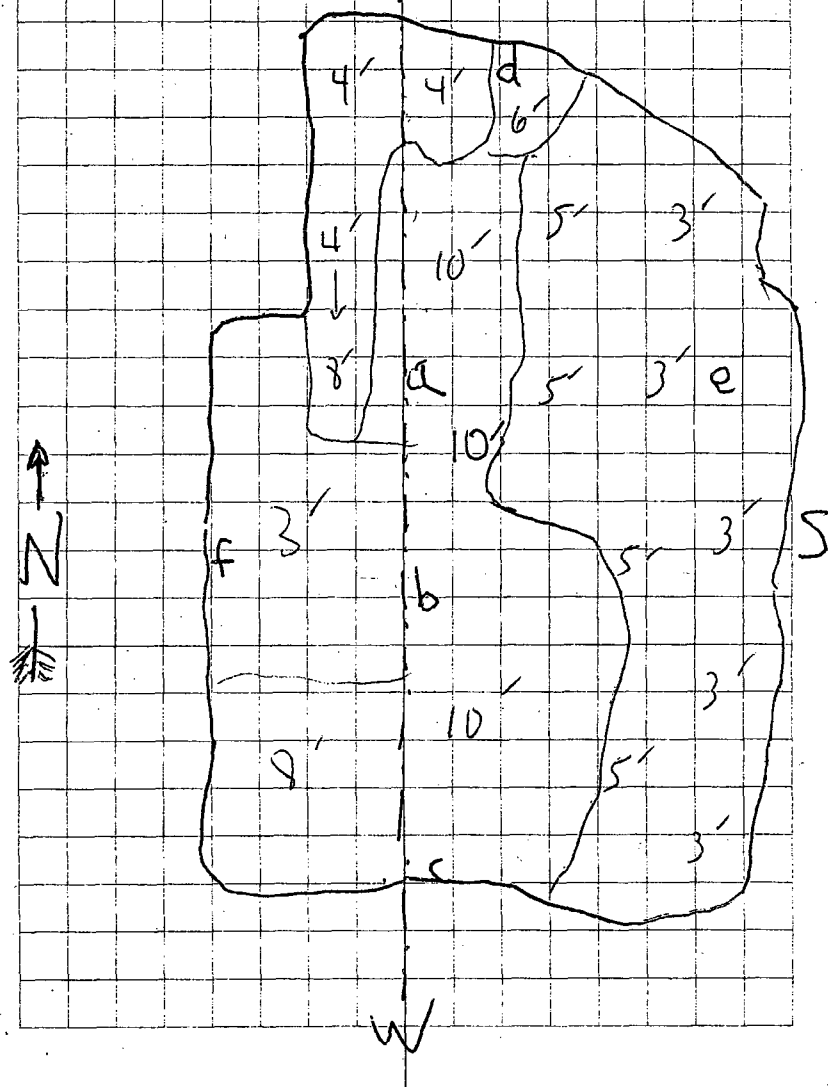
J-4-2 8-2-01

Letter	Location (depth)	DVM	Time
a)	E. Floor -1 (11')	297	1045
b)	W. Floor -1 (12')	587	1055
c)	W. Wall -1 (4')	2	1100
d)	E. Wall -1 (4')	0	1105
e)	S. Wall -1 (2')	2	1125
f)	N. Wall -1 (2')	0	1130

Based on DVM ^{high} readings from floor at low spots excavation needs to go deeper at least 5 ft (or more if odor still moderately strong). Since the excavation is already at about 10' below the pipeline it will be necessary to bring a trackhoe (to replace backhoe). Roy arranging to get trackhoe from CCHG site which will be suspended for a day or so.

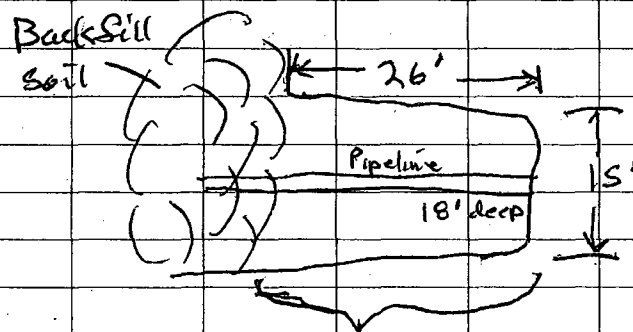
Eastern excavation
 made since yesterday
 (8/13/01)
