Devon Energy Production Co LP

Checkers 24 Federal #005

Delineation Report and Work Plan

Unit Letter M, Section 24, T22S, R32E
Lea County, New Mexico

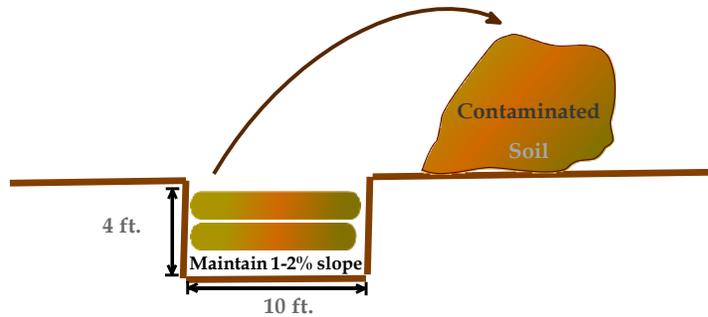
Figure One

1. *Excavation* - RXSoil will direct and supervise the excavation of the entire Effected Area (EA). The poly liner will ensure that no collateral contamination happens during the process. The slope of the excavation area will be 1%-2% grade throughout the project to maximize the removal of contaminant, as illustrated in Figure One:

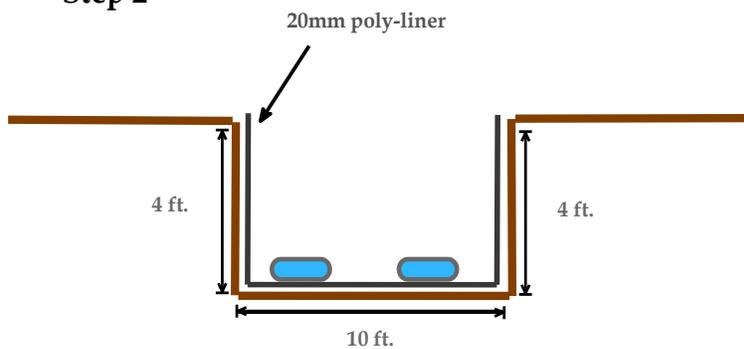
Figure Two

2. *Poly-Liner* - Once the poly liner is firmly in place, the drain infrastructure will be placed on top of the liner and run down-slope to a manifold. The drains will be covered with a sock to avoid silting in and the blockage of drainage. All drains and manifolds are engineered with dual linings to ensure structural support as well as maximum flow.

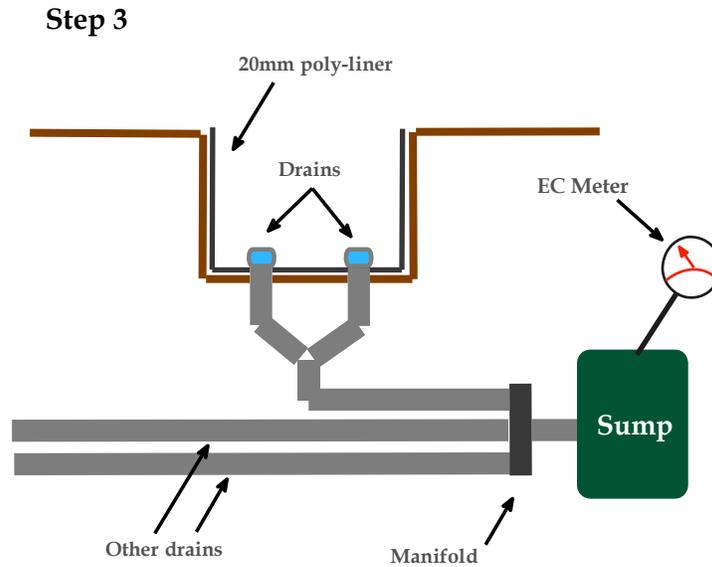
Figure Three

3. *Drainage* - The drainage infrastructure will be attached to a sump area, which includes a submersible pump that activates upon a mercury switch and a redundant backup float system. The sump discharges directly into a series of frac tanks. The discharged leachate will be transferred to third party companies. This will ensure that the used water will be recycled to a secondary industrial purpose.

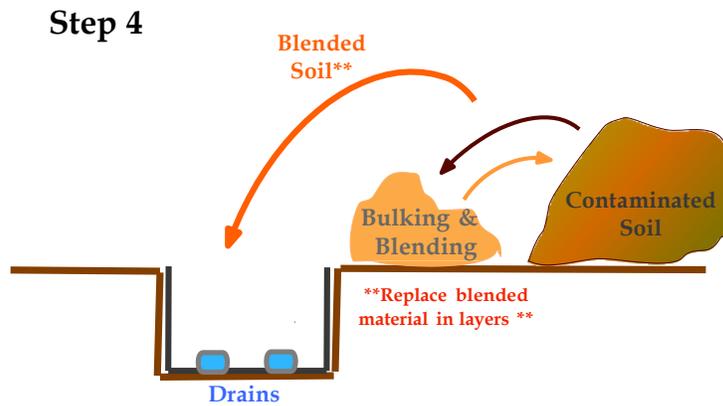
Figure Four

4. *Blending and Bulking* – Blending and bulking is a critical stage in the restoration of the soil to its pre-vegetative state. Canadian sphagnum peat moss or a local organic matter will be used to create a healthy profile and generate a prolific microbial environment. The amount of organic matter used is directly related to the Electrical Conductivity (EC) level. For this example, we will use 5 tons per acre. Adding organic matter (e.g.; peat moss) facilitates percolation and adds a proppant to the soil, substantially increasing the rate at which the soil is remediated

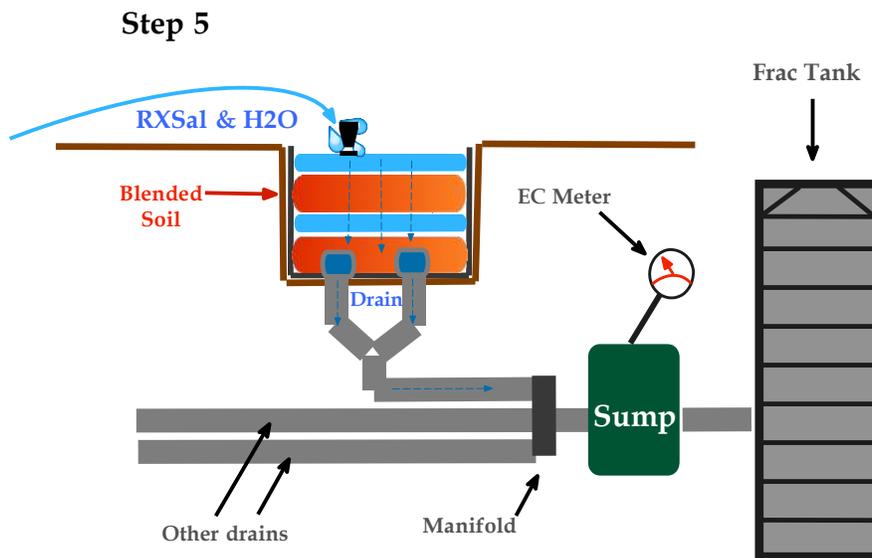
Figure Five

5. *Replacement & Remediation* – Once the soil has been completely blended with the organic matter, it is placed on top of the drain infrastructure in layers (usually 18”-24” lifts). The chemical RXSal is applied between the lifts until saturation is achieved. It takes approximately 30 minutes for the chemical exchange and displacement process to occur. At that point, another layer will be placed and the process repeated. The sodium and chloride contaminant will be collected into frac tanks for secondary recyclable usage.

Note: The piping, sump and frac tank are located adjacent to the trench above ground

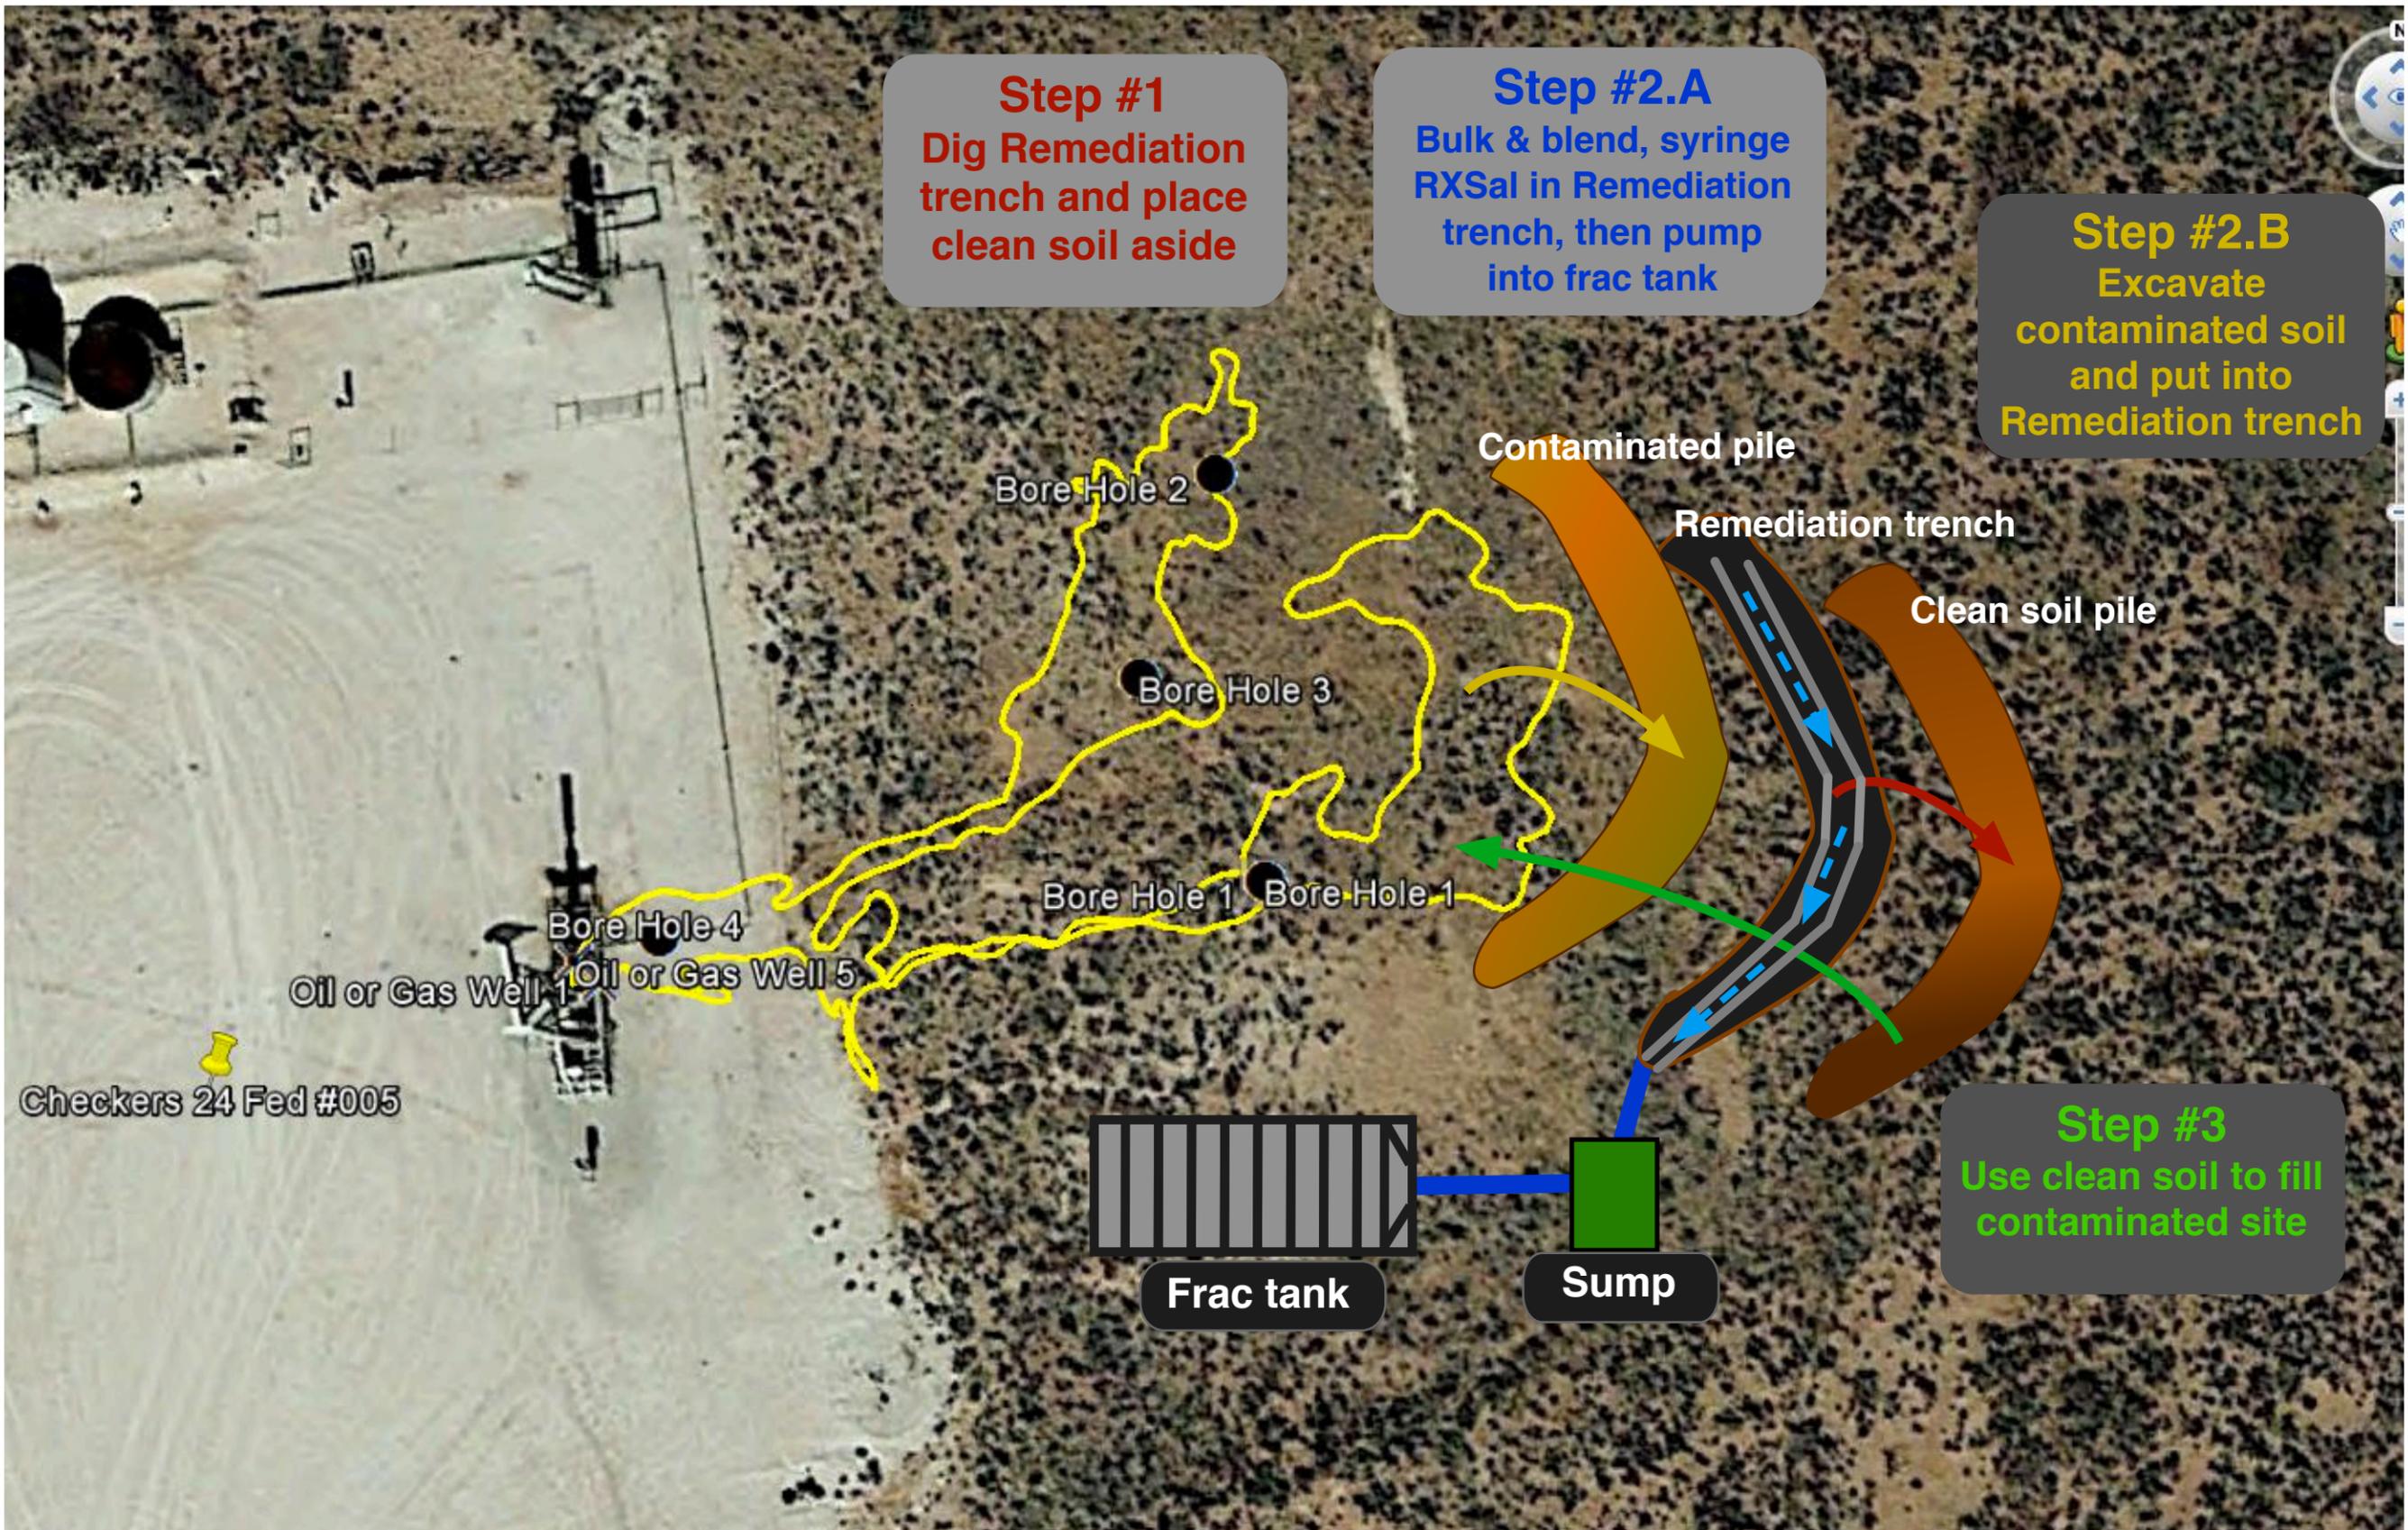
Step #1
Dig Remediation trench and place clean soil aside

Step #2.A
Bulk & blend, syringe RXSal in Remediation trench, then pump into frac tank

Step #2.B
Excavate contaminated soil and put into Remediation trench

Step #3
Use clean soil to fill contaminated site

1. A treatment trench will be installed near the spill area, the size of which will hold the volume of the contaminated soil from the spill area. The material removed from the treatment trench will be stockpiled.

2. The treatment trench will be lined with a 20 mil liner and a drainage system installed in the bottom of the trench above the liner. The bottom of the test trench will be sloped to insure proper drainage at the bottom of the trench (Figure 2). The drainage system will be connected to piping to allow pumping of the leachate from the treatment trench.

3. The leachate will be pumped into a sump place adjacent to the treatment trench. The leachate will be monitored for electrical conductivity (EC) and transferred to frac tanks for recycling.

4. Upon completion of trench preparation the impacted areas would be excavated. The impacted soils would then be thoroughly blended with Sphagnum Peat Moss. The blended mixture of contaminated soils will be placed in the treatment trench in layers of 18" to 24". Rx soil amendment combined with water will be applied to each lift and allowed to leach through the lifts.

5. The drainage of water from the soil treatment will filter down to the drainage system. The leachate will be retained for recycling. Once target levels for the treated soil have been achieved with confirmed laboratory and/or field analysis the treatment trench will be closed.

6. The clean soils stockpiled from the treatment trench will be used to backfill the excavated spill area.
7. Upon confirmed closure of the treatment trench, the entire area will be seeded with the appropriate seed mixture.

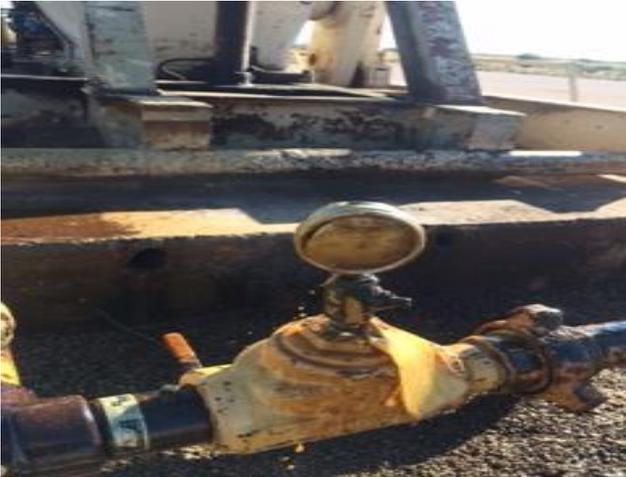
Leak source

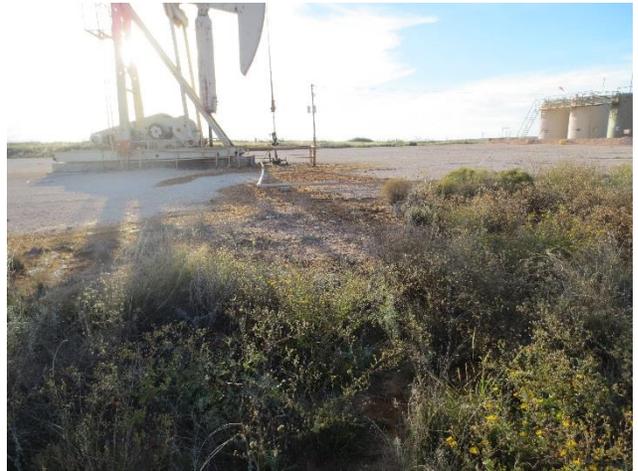
View from west to leak source

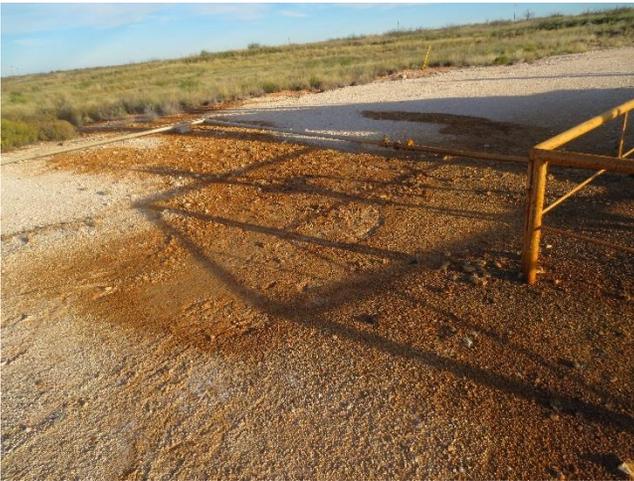
Spill exiting pad to pasture (west)

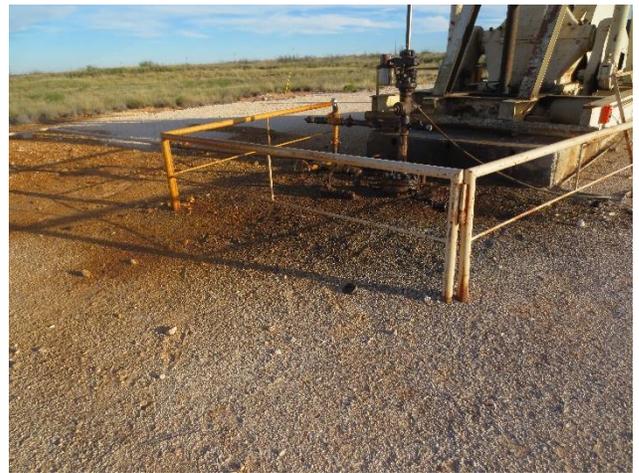
Source of leak

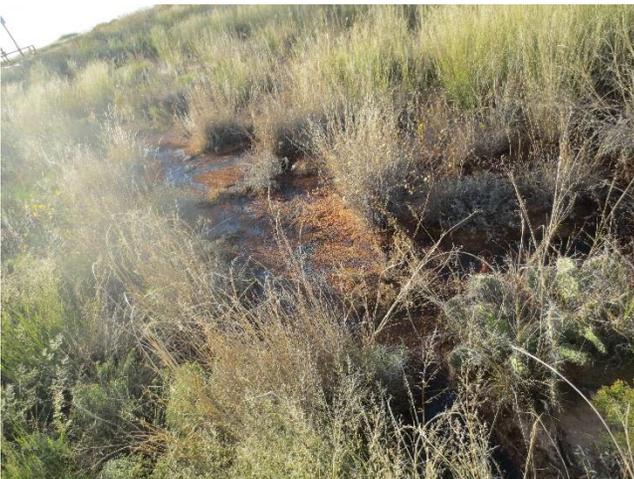
West of location pasture impact

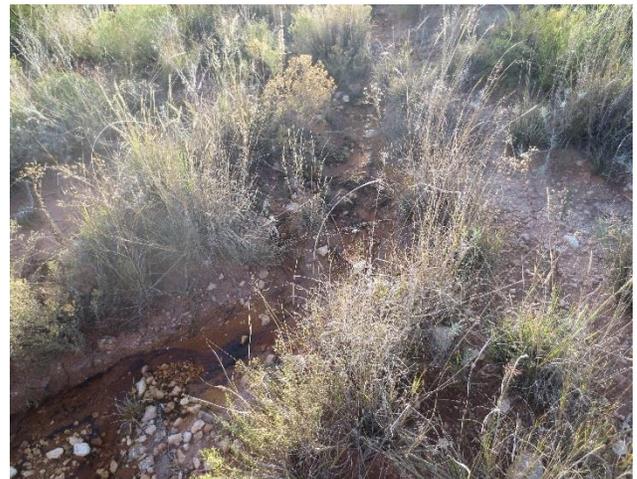
Pasture Impact
