MCA Battery #4 (1RP-3200)

Termination Request

**RE: Termination Request
ConocoPhillips MCA Battery #4 (1RP-3200)
UL/A sec. 26 T17S R32E
API No. 30-025-12709**

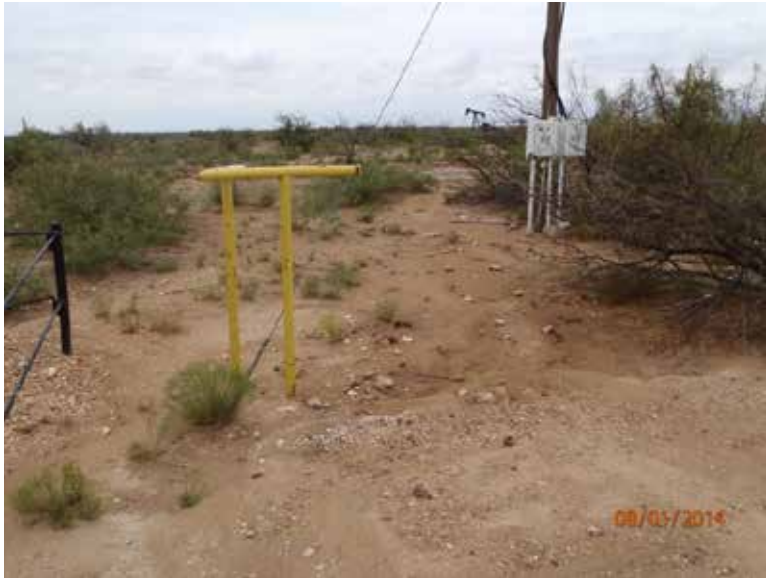
8/1/14

Initial release area, southwest

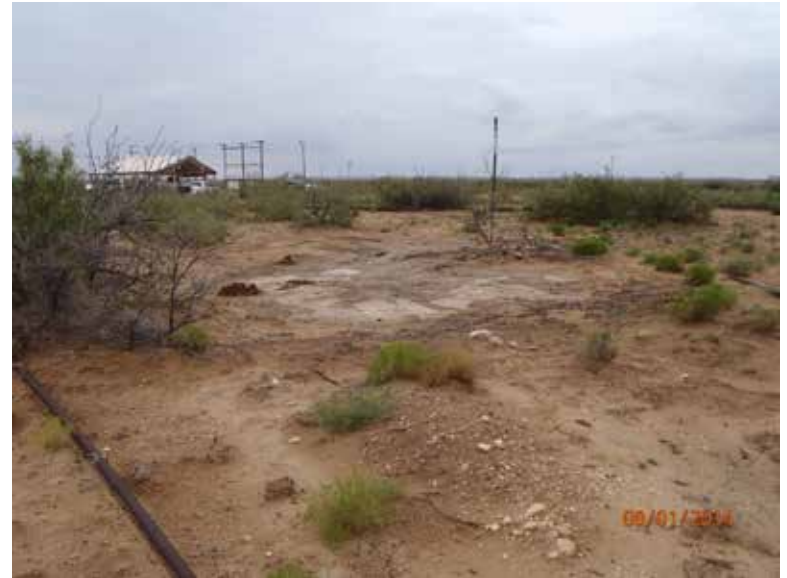
8/1/14

Initial release area, facing east

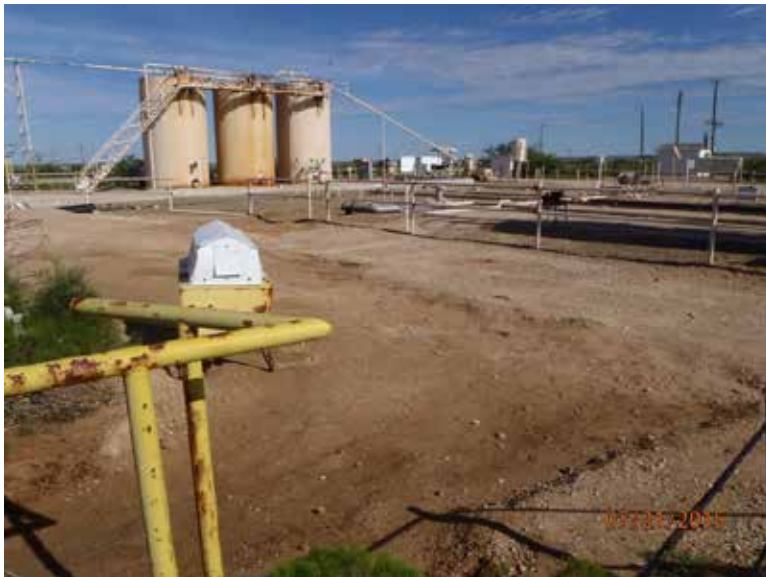
7/21/15

Excavated area, facing northwest

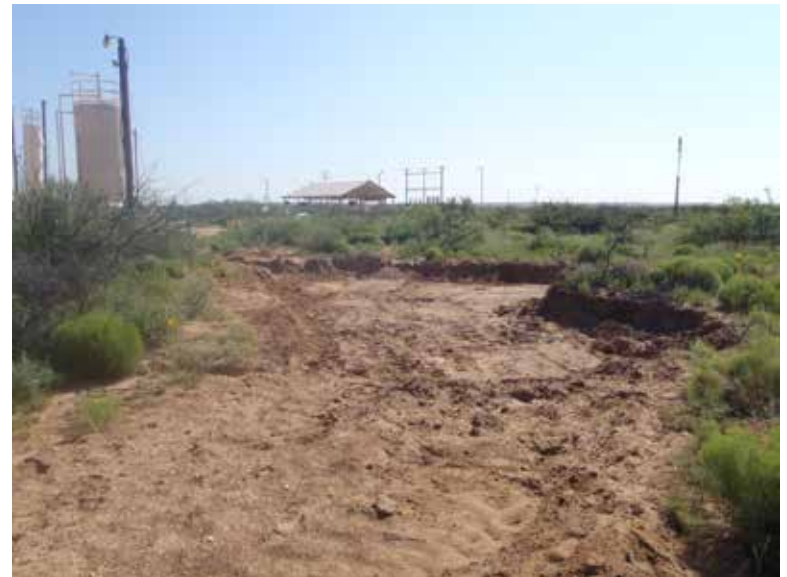
7/24/15

Excavated area, facing northeast

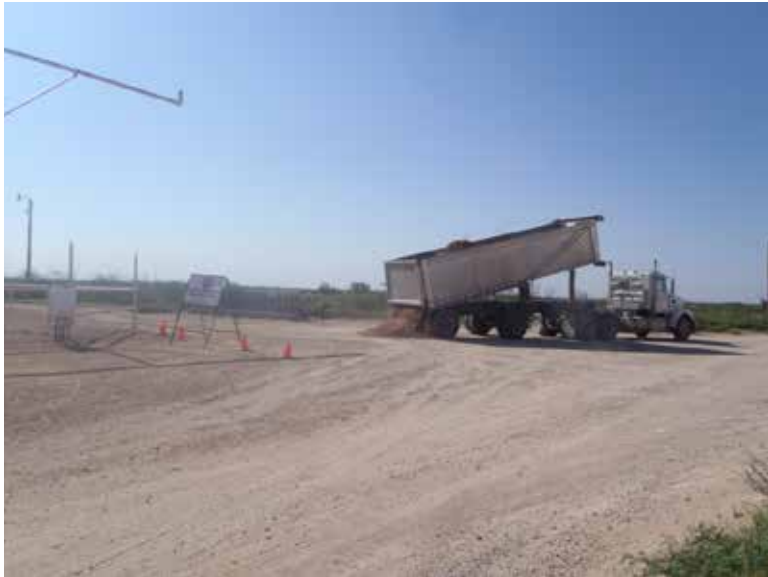
7/24/15

Importing top soil, facing southeast

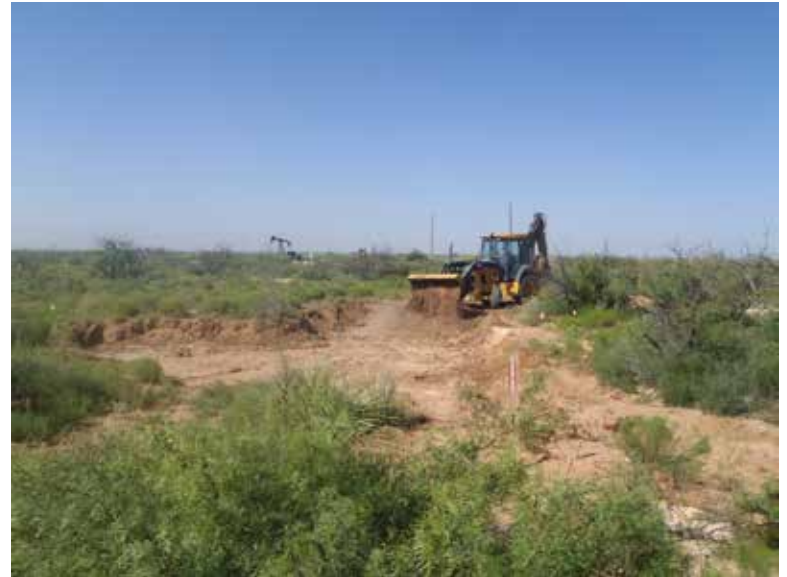
7/24/15

Backfilling excavation, facing southwest

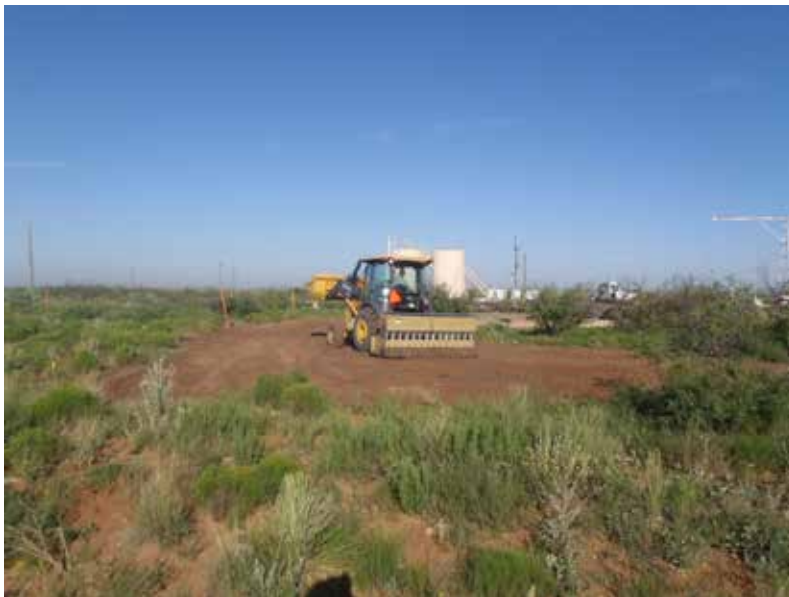
7/28/15

Seeding site, facing west

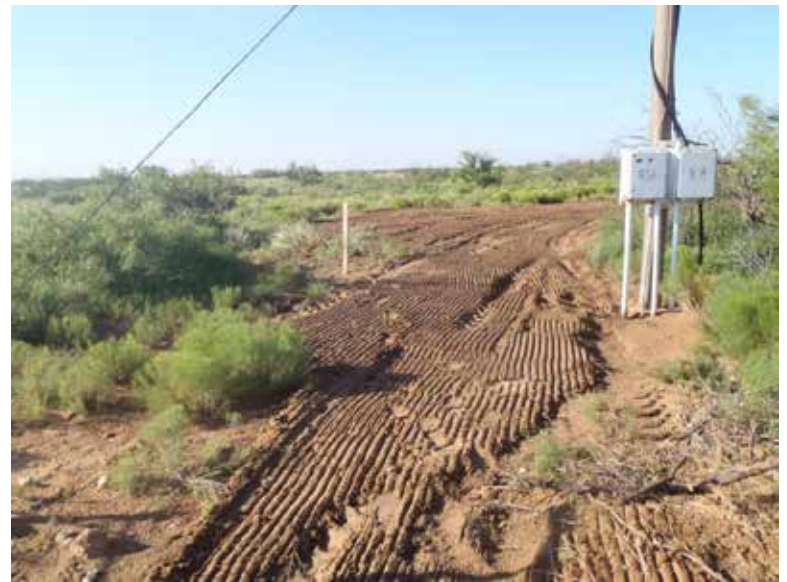
7/28/15

Completed site, facing south
