SUBJECT: WORK PLAN FOR INCIDENT 1RP-4418, CAUDILL # 002, UNIT L SECTION 8-T16S-R37E NMMPM, API# 30-025-30406, LEA COUNTY, NEW MEXICO

SOIL REMEDIATION WORK PLAN FOR INCIDENT 1RP-4418

MATADOR RESOURCES COMPANY

CAUDILL # 002

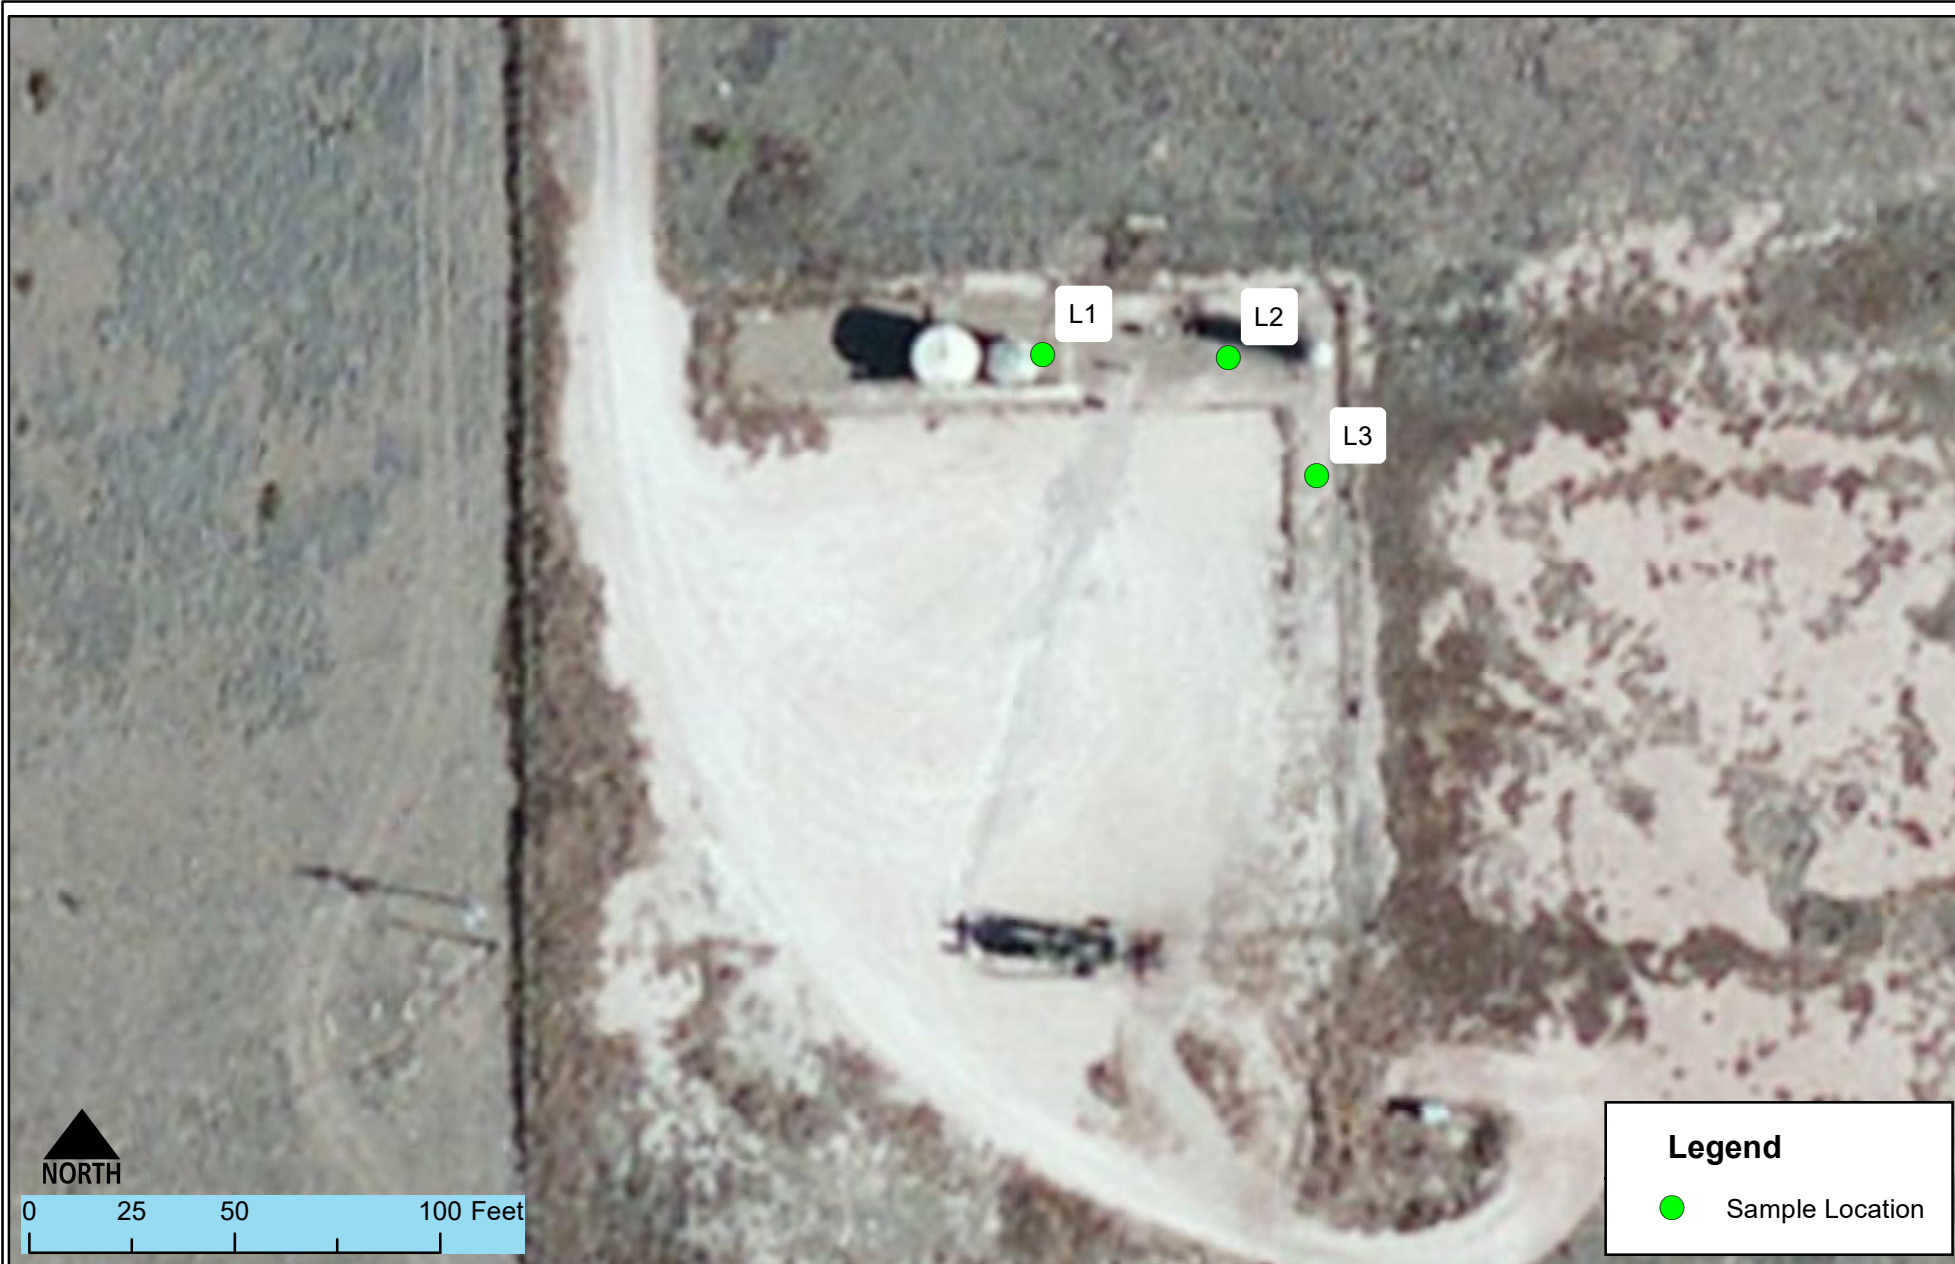
Figure 2

DETAILED SITE AND SAMPLE MAP

Detailed Site and Sample Map
Matador- Caudill # 002
Lovington, New Mexico

Soil contaminant concentrations found during the initial delineation are illustrated in Figure 2. A summary of the laboratory analyses is included in Table 2. Laboratory reports are included in Appendix A.
