**RE: Investigation and Characterization Plan (ICP)
Rice Operating Company – BD SWD System
BD P-4 EOL (Brunson EOL) (1R426-06): UL/P, Sec. 4, T21S, R37E**

Disclosure Report

Current Photodocumentation

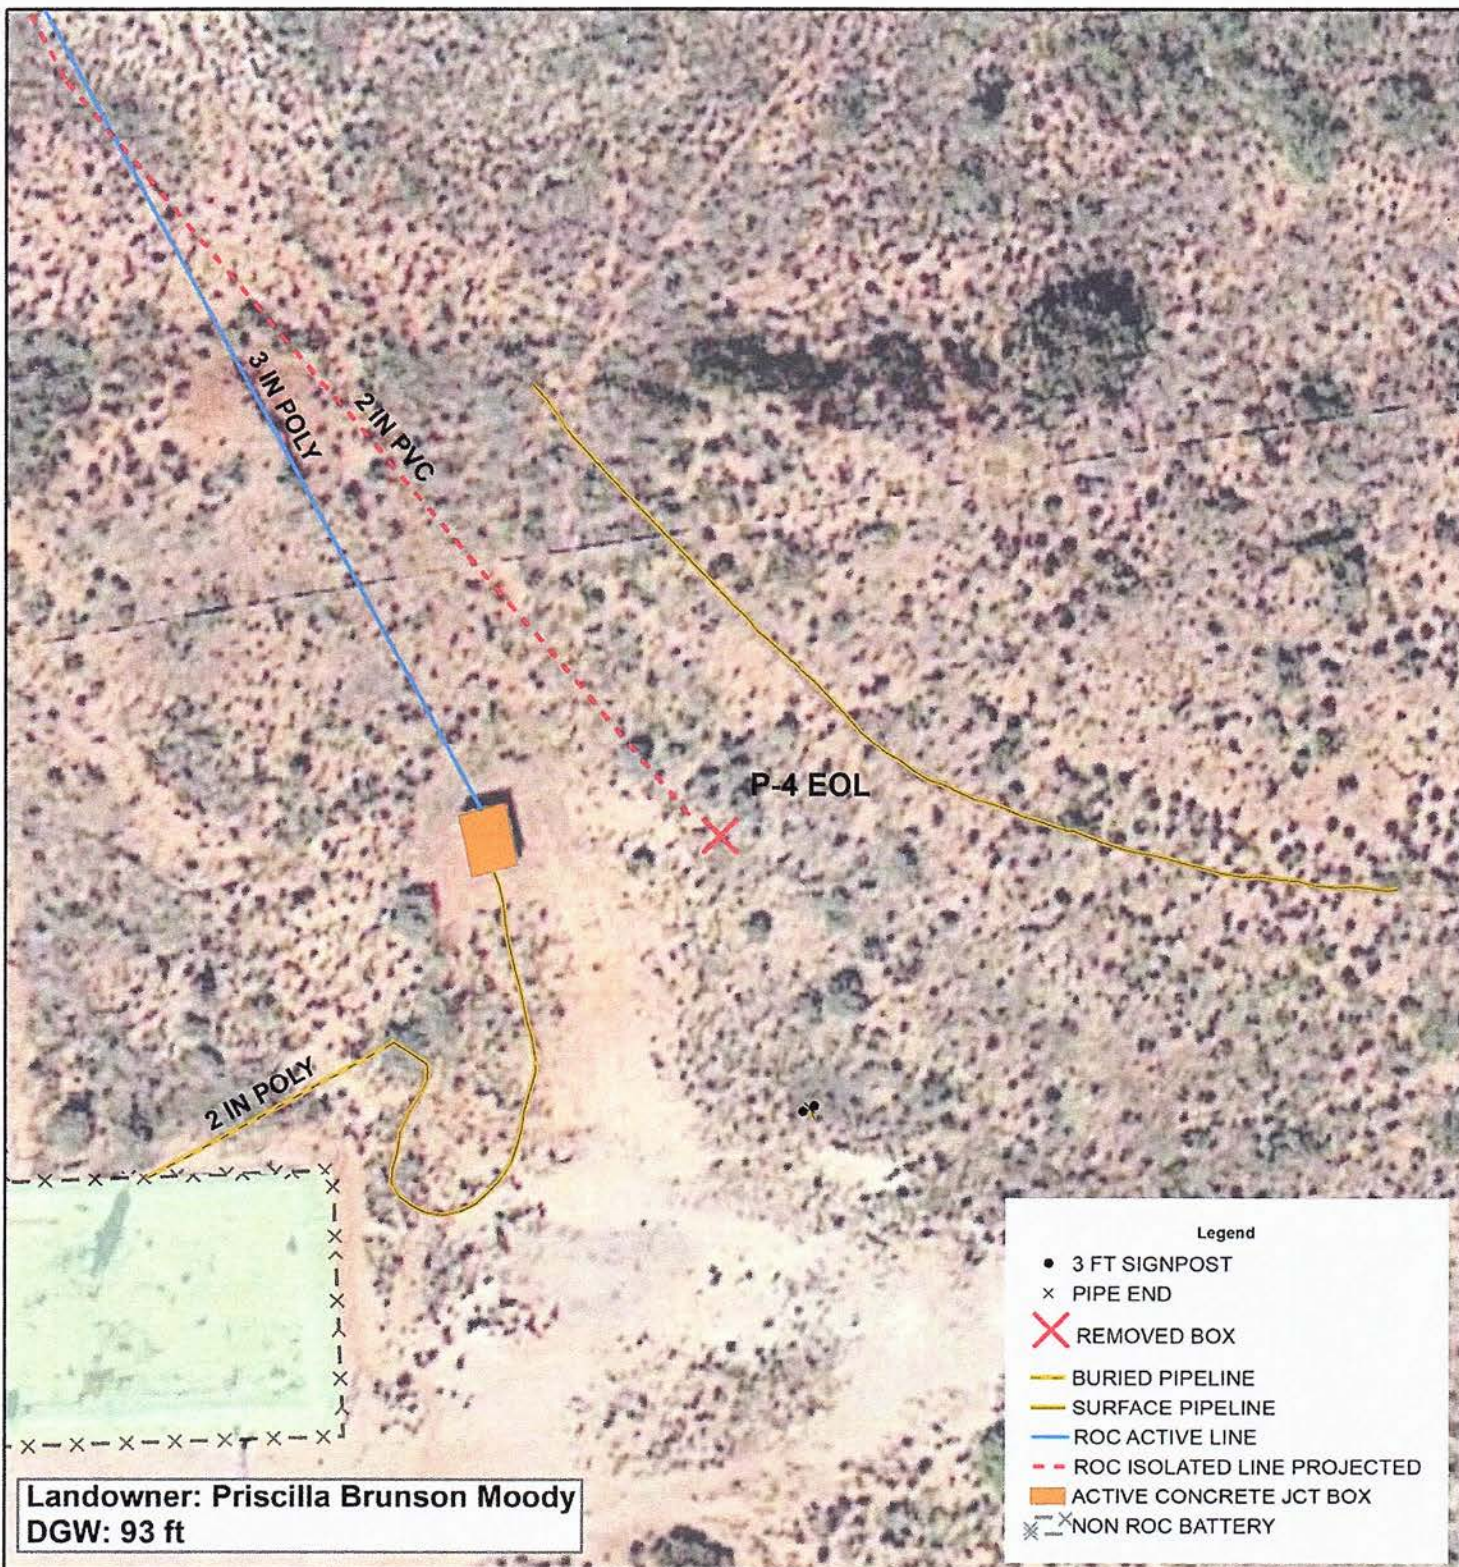
BD
P-4 EOL
1R426-06

UL P SECTION 4
T-22-S R-37-E
LEA COUNTY, NM

GPS date: 5/7/18 TG
Drawing date: 5/8/18
Drafted by: T. Grieco

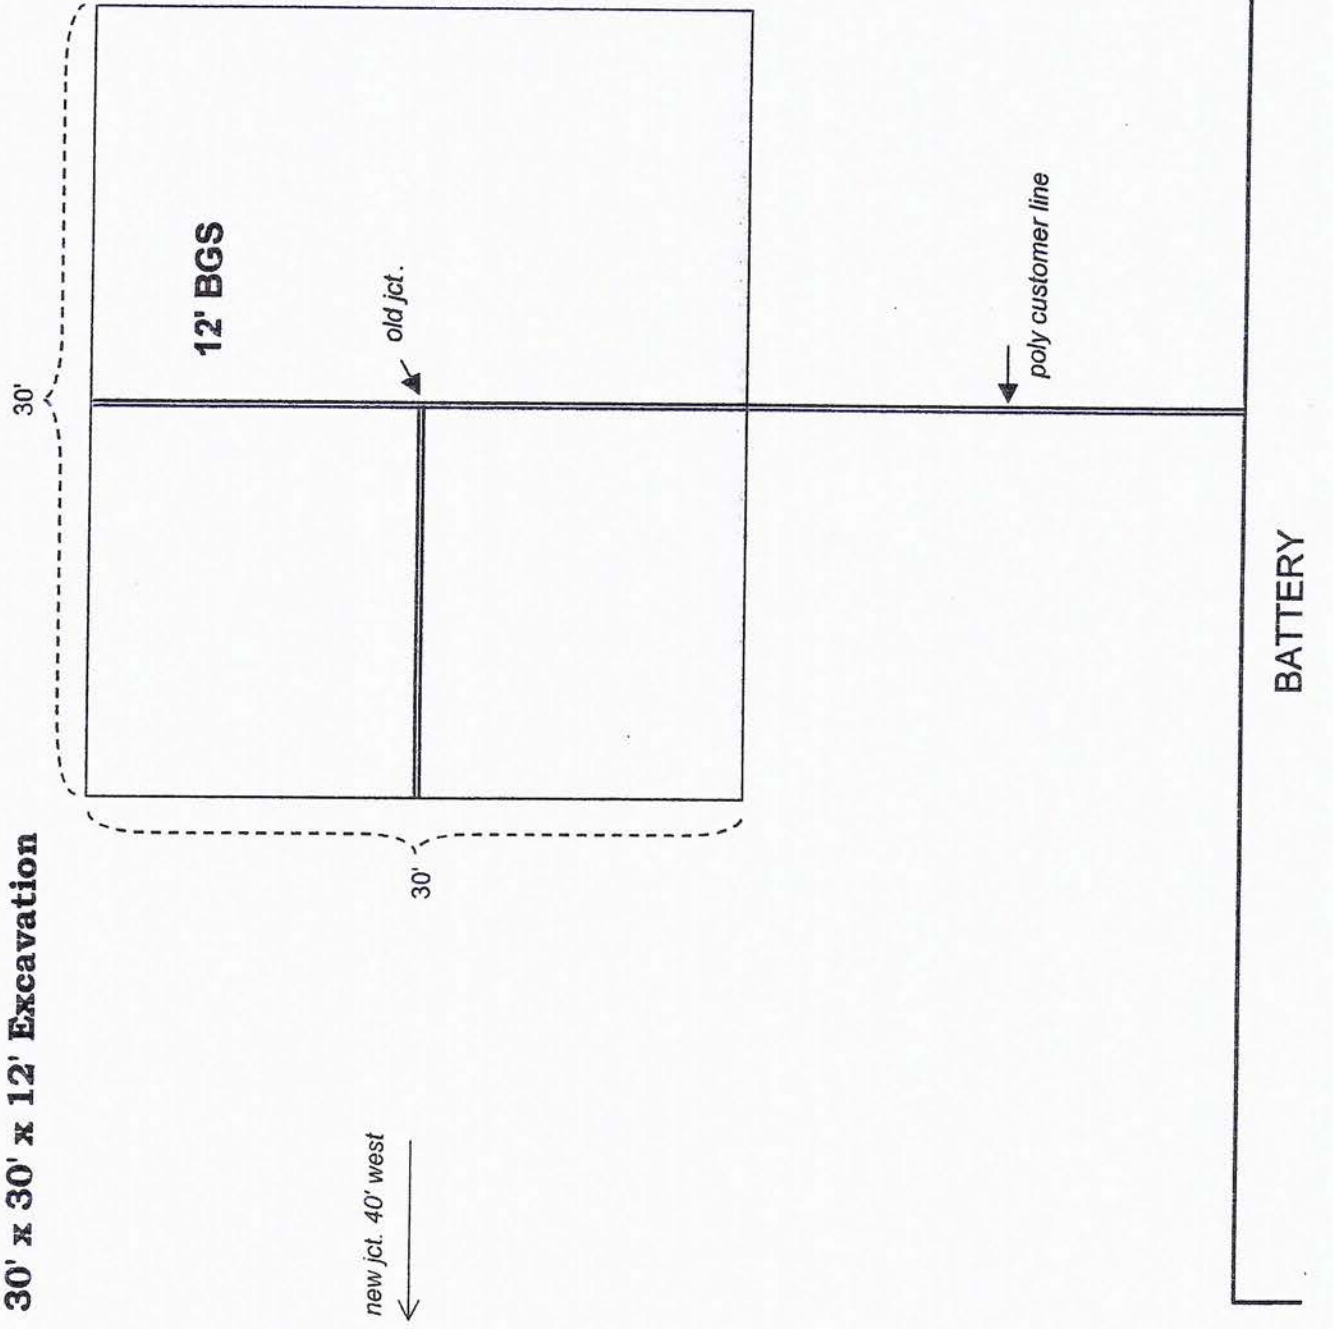
BD Brunson EOL
30' x 30' x 12' Excavation

General Description of Remedial Action: The junction box location was delineated vertically and laterally producing a 30' x 30' x 12' bgs excavation. TPH was well below NMOC guidelines, while chloride concentrations were relatively consistent. A 20 mil poly liner was installed at the bottom of the excavation and extended up the walls to impede impact migration. The hole was then backfilled with the excavated soil that was landfarmed onsite. A new watertight junction box has been built about 40' west of this location. The disturbed area has been re-seeded with native vegetation and will be monitored for growth.

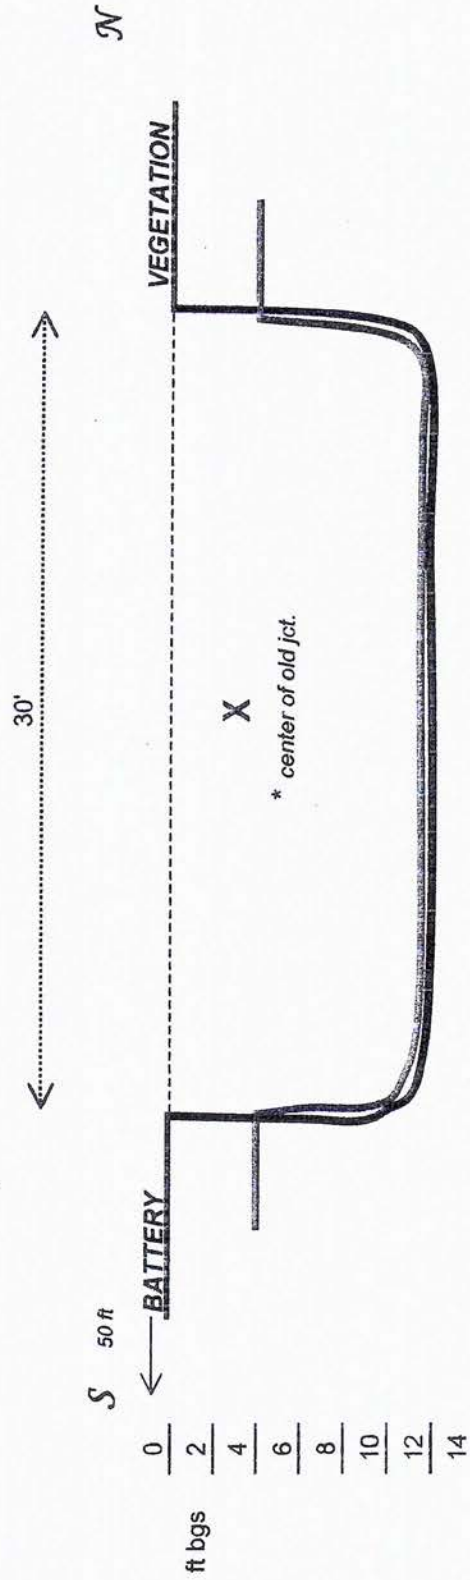
**BD Brunson EOL
Impact Excavation
Cross-Section**

Excavation
Boundary
Poly Liner

SURFACE HAS BEEN RE-SEEDED WITH NATIVE VEGETATION

* New junction is located 40 ft west

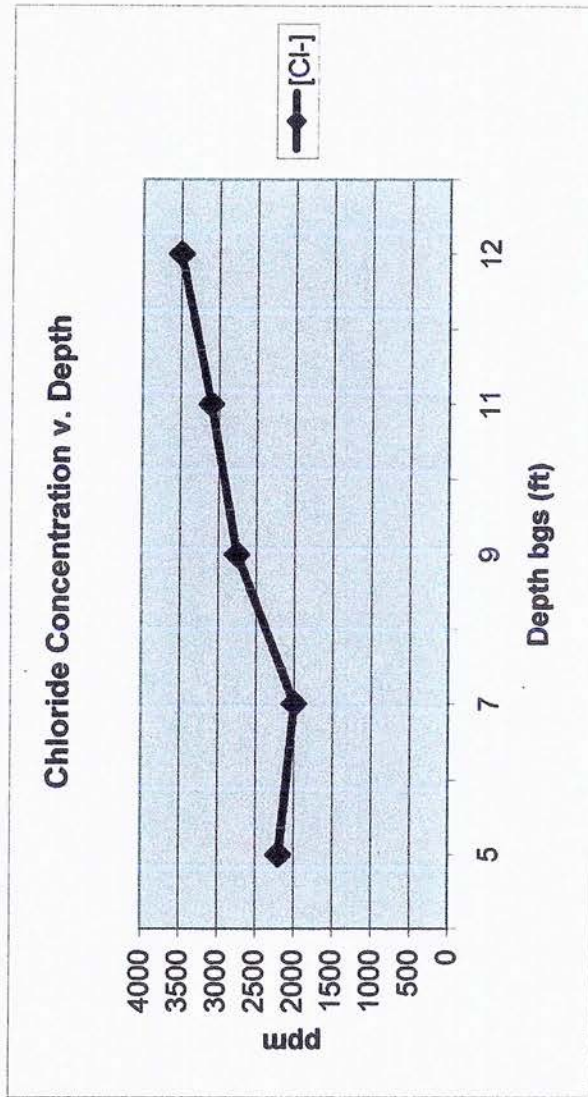
CHLORIDE CONCENTRATION CURVE

Depth bgs (ft)	[Cl-] ppm
5	2200
7	2000
9	2750
11	3100
12	3500

Groundwater = 93 ft

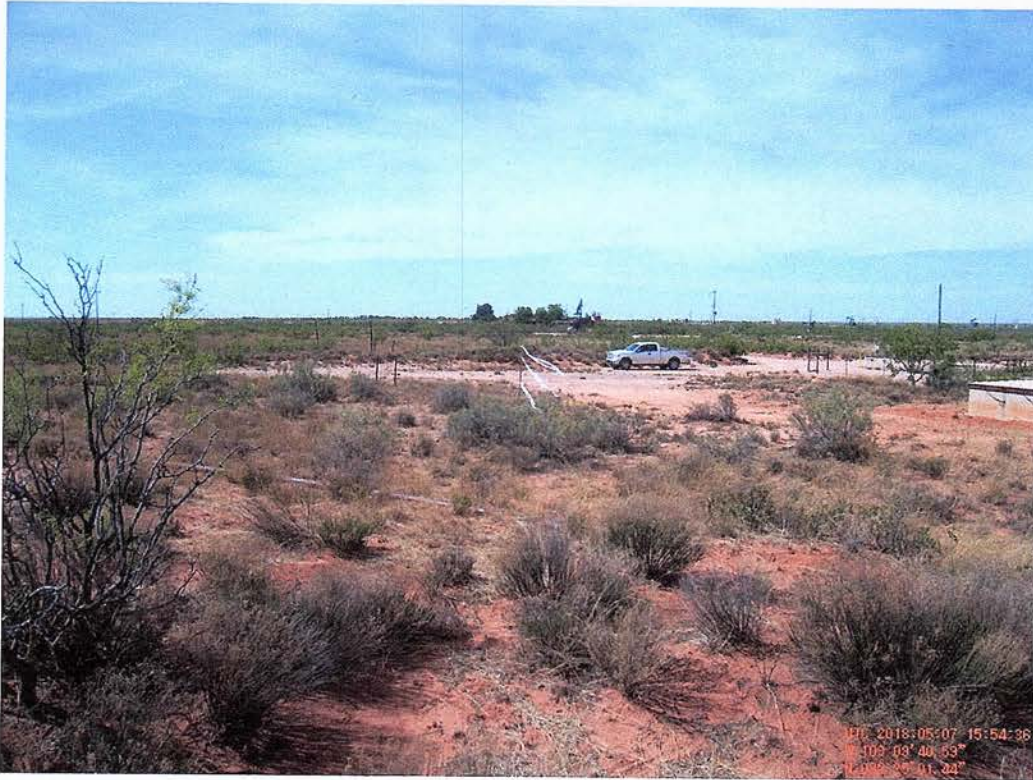
Facing south

5-7-18

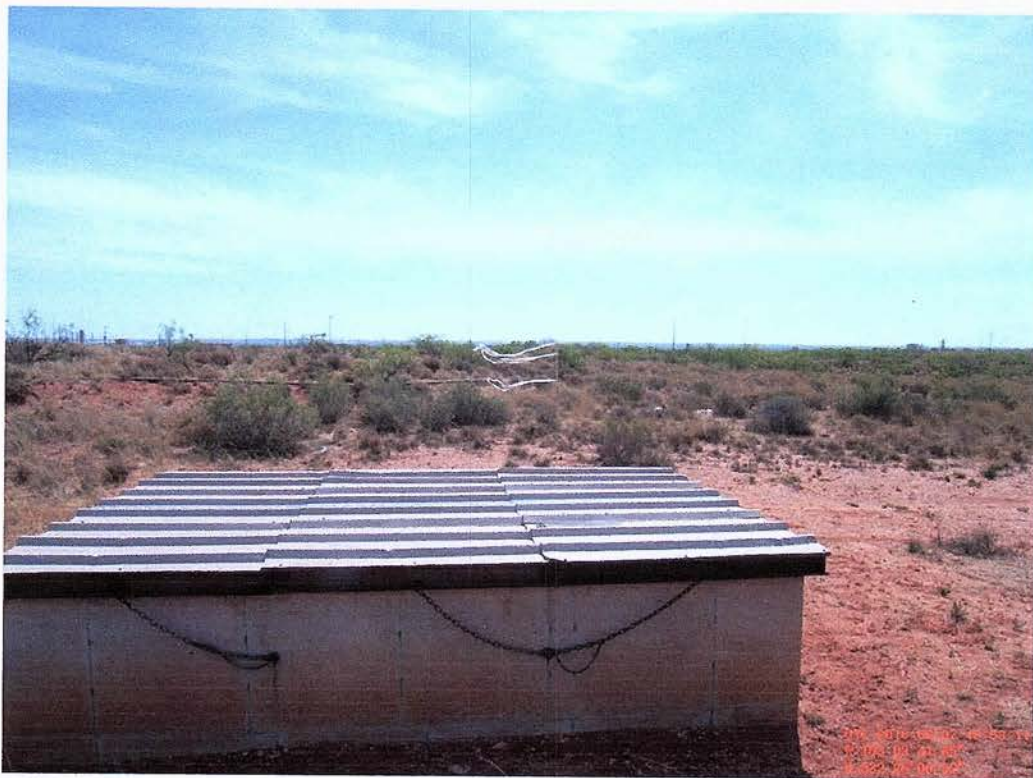
Facing east

5-7-18
