Carter Lease Well #001 Battery

REMEDIATION WORK PLAN

NMOCD Case #: 1RP-4990

RE: Sheridan Production Company, LLC – Carter Lease Well 001

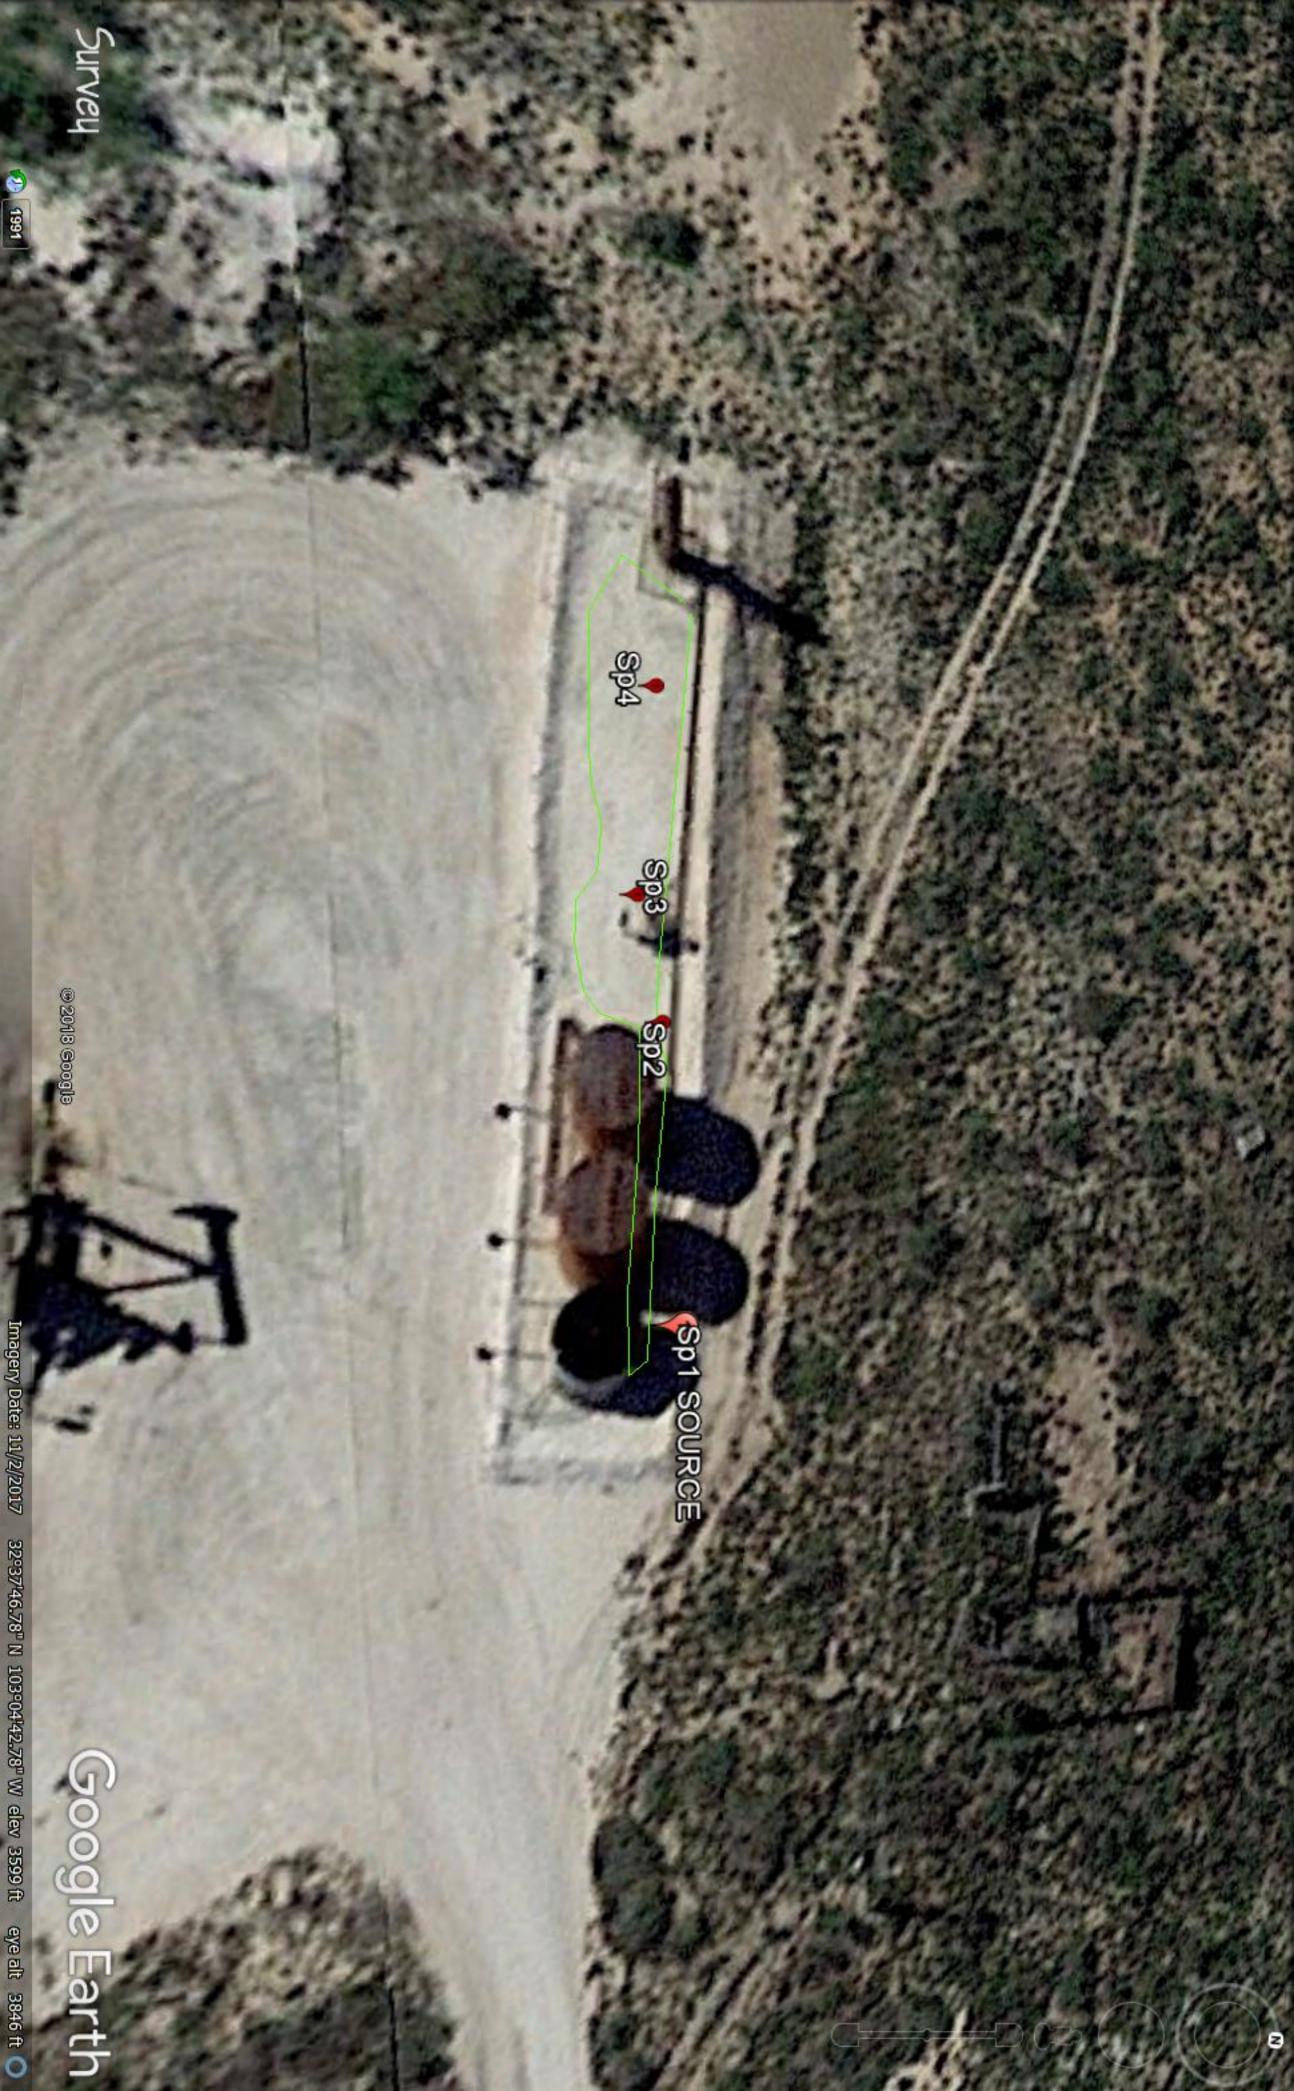
Figures: Site Diagram

On March 27th, 2018 DFSI personnel were on site to obtain samples within the leak area (Figure 1). Four sample points were set, then samples were obtained and field sampled for chloride levels, as well as BTEX (Appendix II). The BTEX samples were performed using a Mini Rae Photoionization Detector (PID). Clean field samples were submitted for laboratory analysis at Cardinal Laboratory of Hobbs, NM to obtain confirmation (Appendix III). Based on analysis, chlorides, TPH and BTEX did have a decline as samples were taken at deeper intervals. Sp1 was not able to be fully delineated due to auger refusal. Mechanical boring was not used due to safety issues with active production lines and the water tank obstructing the sampling area.

Due to safety hazards, which include tanks and underground lines (as depicted in site photos) to maintain tank integrity, the entire release area will be excavated to a depth of 1' bgs. With sidewall lab confirmations before backfill is completed, and a new map documenting sidewalls will be presented to NMOCD/SLO for approval A 20ML liner will be placed and properly seated to insure contamination migration will not incur further and also prevent possible future incidents to not migrate past liner as well. The excavation will be backfilled with clean, imported caliche to ground surface and contoured to the surrounding area. Berms will be rebuilt and compacted as well. Seeding of the site is not warranted due to this location is a tank battery. Any additional remediation on this location would like to be deferred until site abandonment.

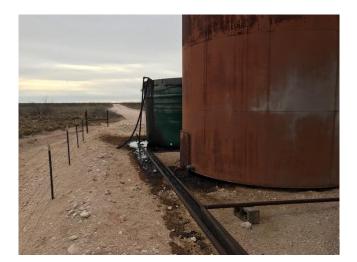
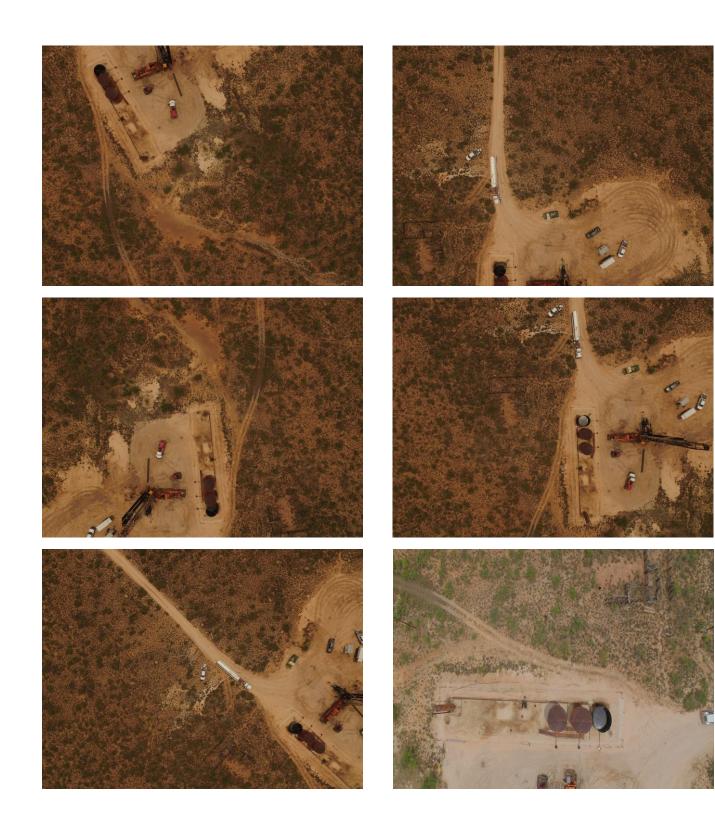
Site Photos:

On 4/30/2018 NMOCD requested full delineation on SP1. On May 29th, 2018 DFSI personnel went to location and used a hydraulic drill to accomplish delineation. Regulatory limits were accomplished past 1' BGS and down to 4'. 10 additional feet were not able to be done due to the area design as seen in the pictures of location. Field tests are included in the appendix to show the decline in contaminates from surface to 4' BGS. Sp1 refers to release point as the tank spilled over from that point.
