Report Type: Closure Report 1RP-4875

Site:	Chili Parlor 17 Federal #3H					
Company:	Marathon Oil Permian, LLC.					
Section, Township and Range	Unit M	Sec. 09	T 22S	R 33E		
Lease Number:	API No. 30-025-43138					
County:	Lea County					
GPS:	32.4022° N			103.5845° W		
Surface Owner:	Federal					
Mineral Owner:						
Directions:	From intersection of Co Rd 27-A and HWY 176 in rural Lea County, travel east on HWY 176 for 2.20 mi, turn southwest onto lease road and continue for 3.75 mi, turn west onto lease road for 6.75 mi, turn south onto lease road for 1.15 mi, turn west for 0.30 mi, turn south for 1.25 mi, turn east onto lease road for 0.90 mi, turn south for 0.50 mi, turn northeast onto two-track/ROW and continue for 1.25 mi to location.

Re: Closure Report for the Marathon Oil, Chili Parlor 17 Federal #3H, Unit M, Section 09, Township 22 South, Range 33 East, Lea County, New Mexico. 1RP-4875.

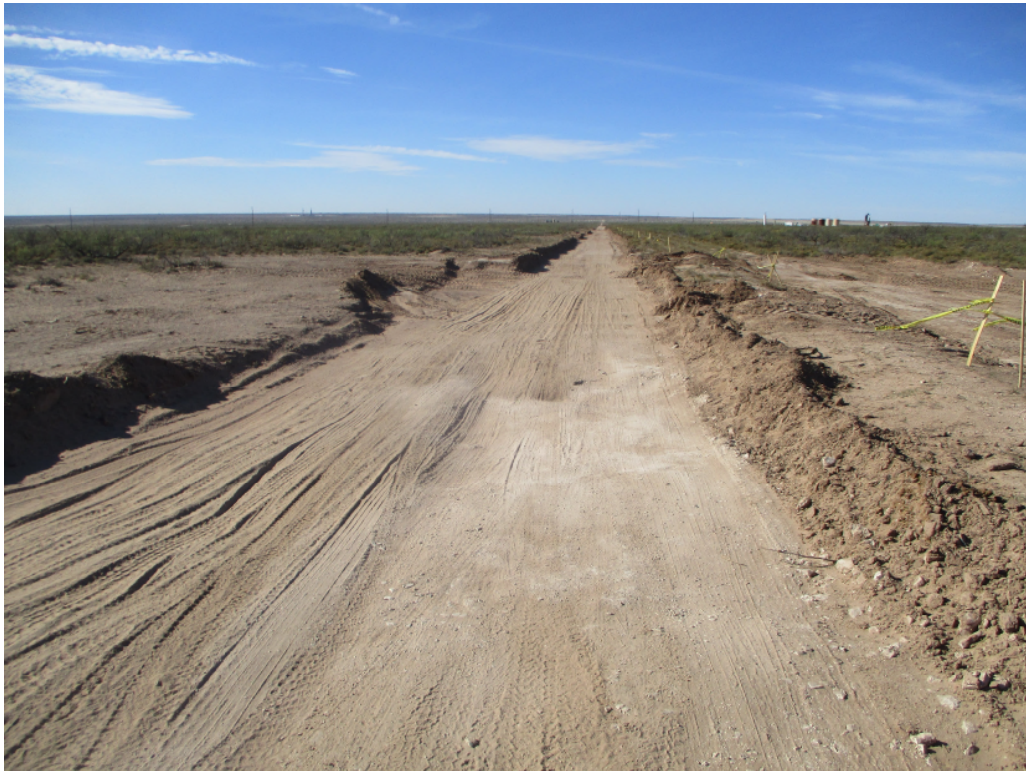
View South – Initial excavation along two-track

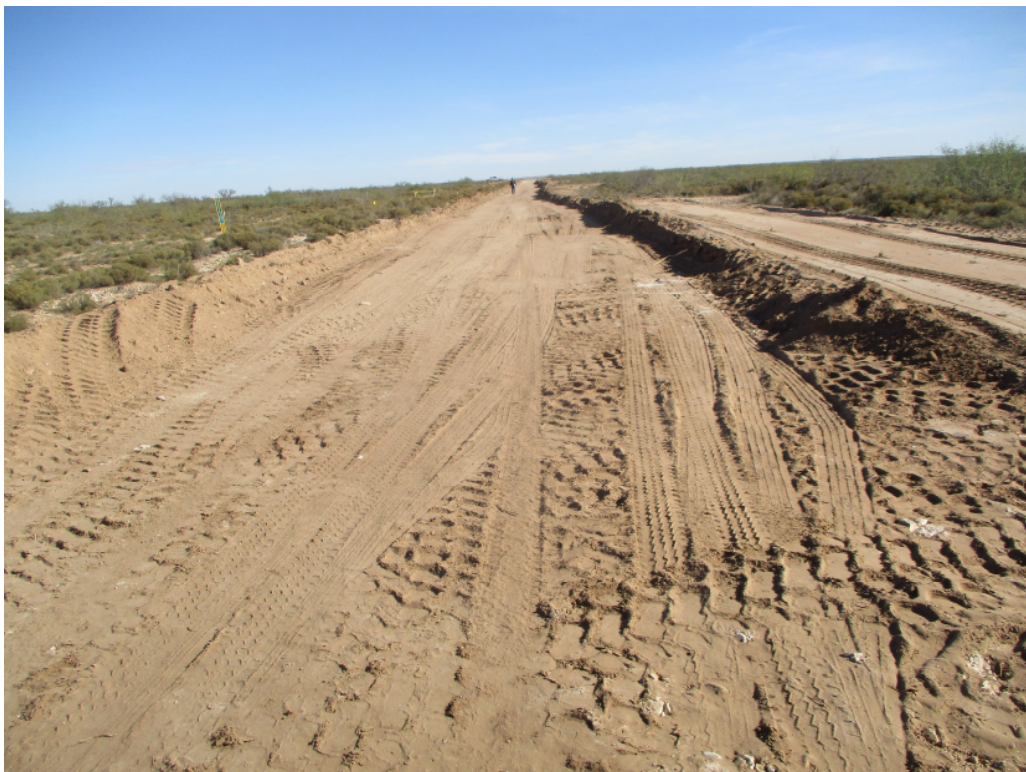
View North – Initial excavation along two-track

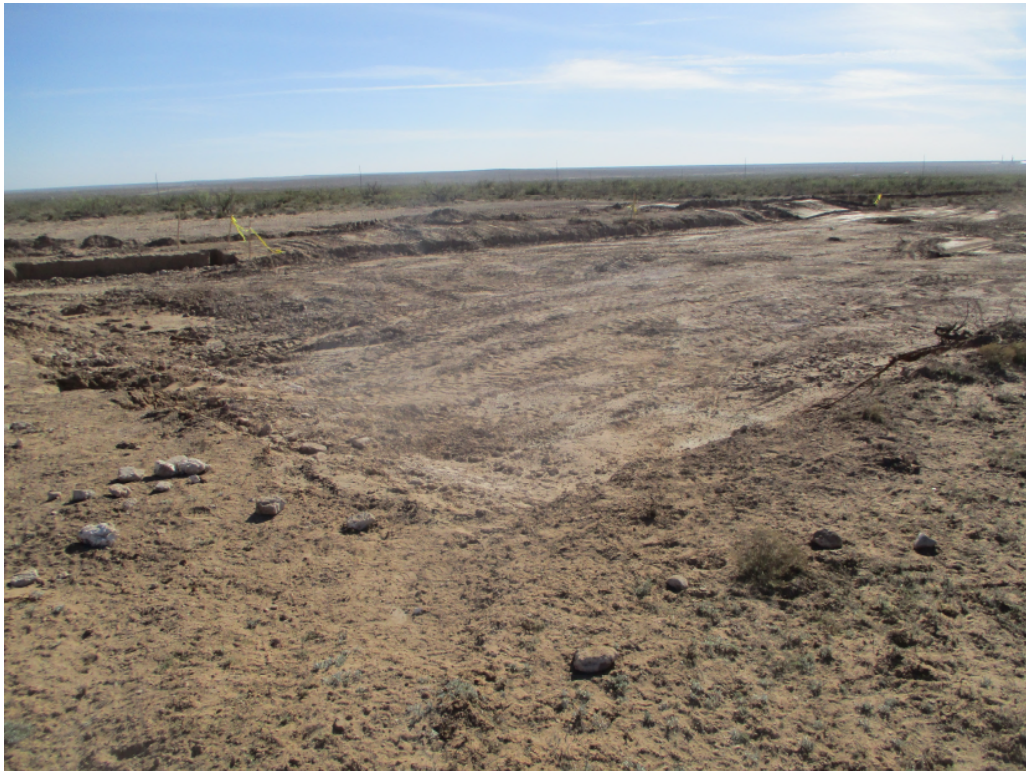
View East – Initial excavation area

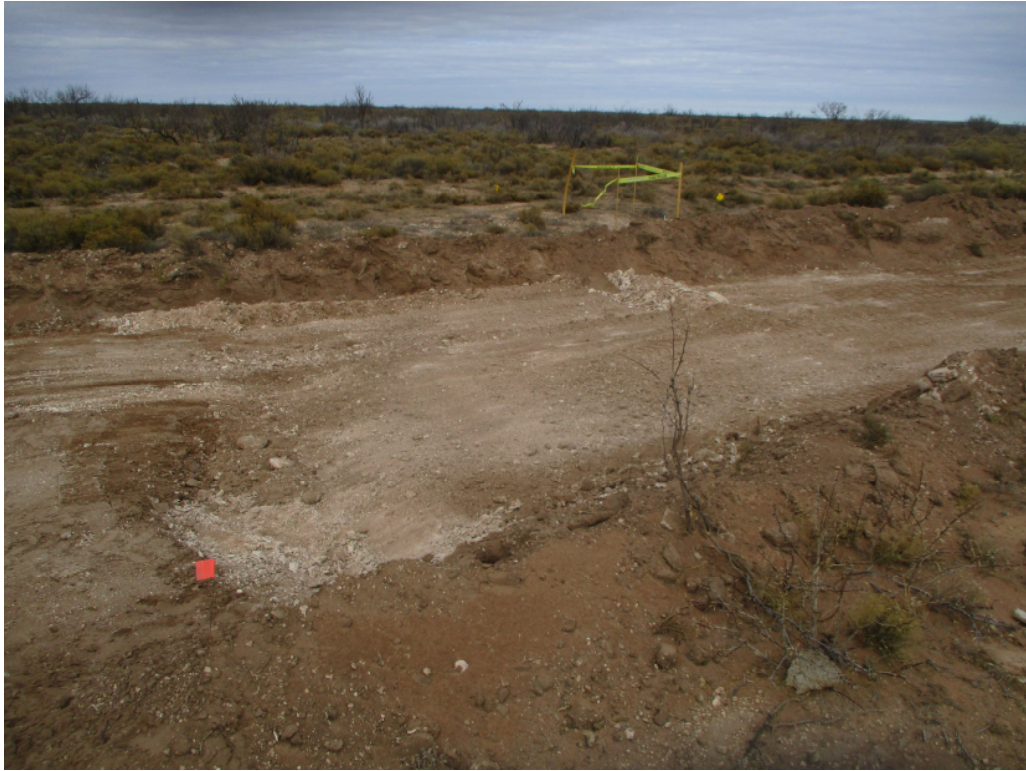
View East – Additional excavation in the area of AH-12

On January 10-11, 2018, Tetra Tech personnel were onsite to supervise the additional excavation of the areas of AH-2, AH-12, AH-15, AH-16, and AH-18. The excavation areas and depths are shown on Figure 4 and highlighted (green) in Table 1. The areas of AH-12 and AH-18 were excavated to a total depth of 2.5' below surface and the areas of AH-2, AH-15 and AH-16 were excavated to a total depth of 3.0' below surface. All of the excavated material was hauled for proper disposal.

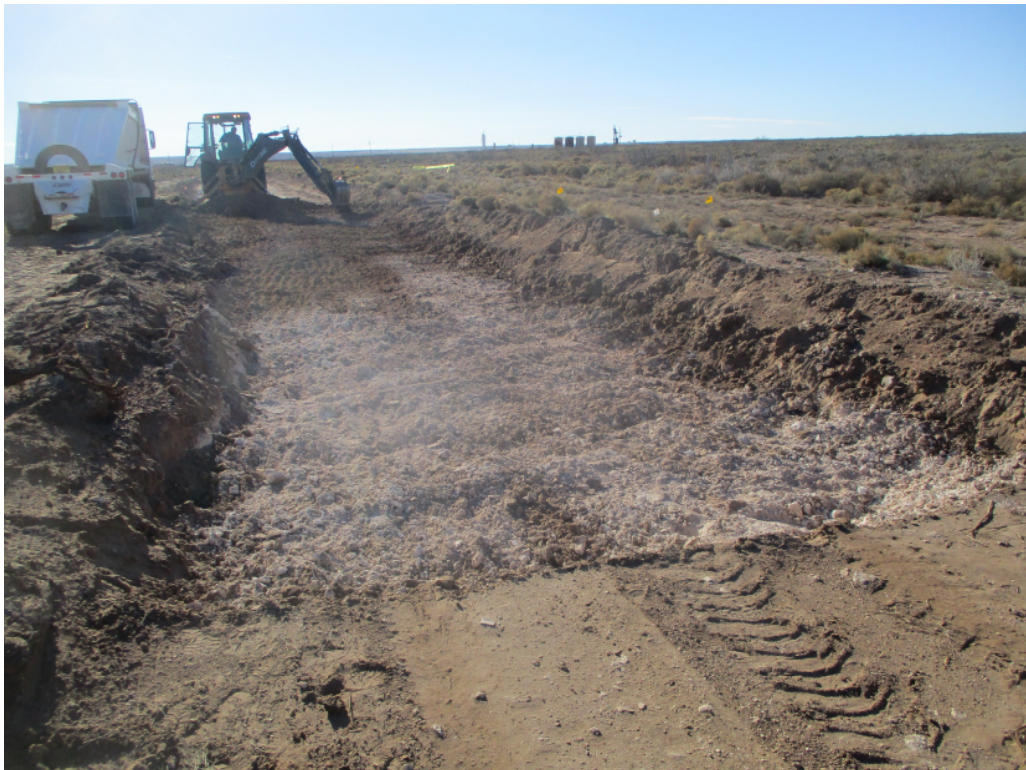
View East – Additional excavation in the areas of AH-15
and AH-16

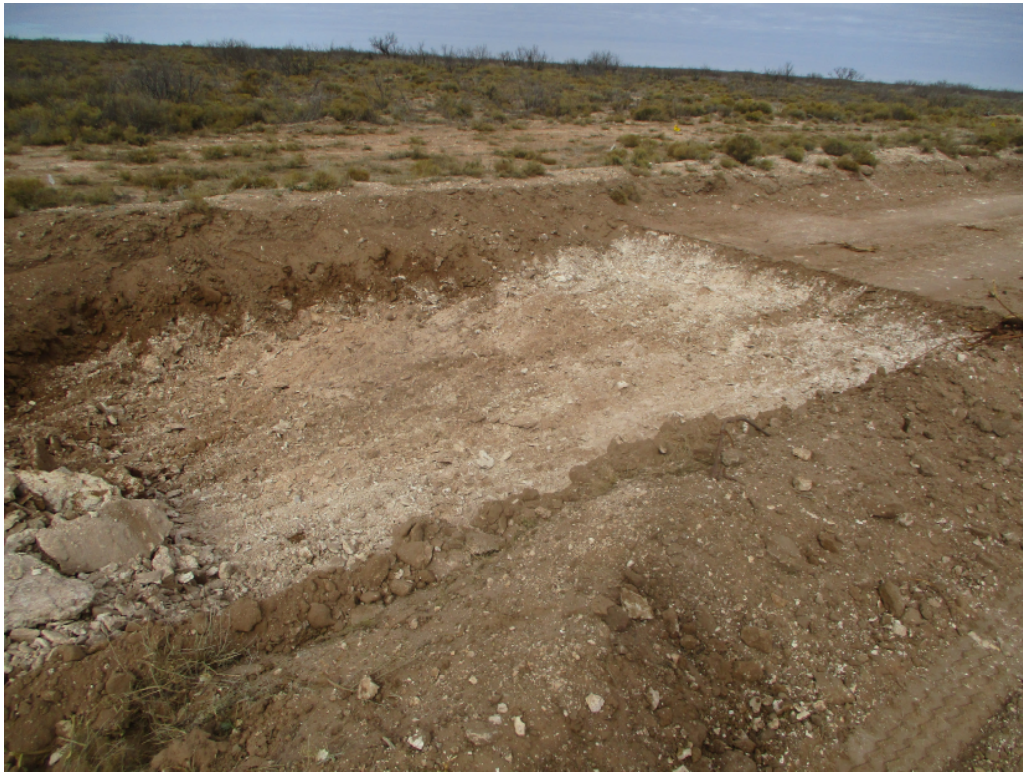
View South – Additional Excavation in the area of AH-18
