## **REMEDIATION SUMMARY & RISK-BASED SITE CLOSURE REQUEST**

**PLAINS PIPELINE, LP  
LEA TO JAL 8-INCH LINE 1 PUMP  
Plains SRS #2014-014  
Lea County, New Mexico  
Unit Letter "F" (SE/NW), Section 28, Township 20 South, Range 37 East  
Latitude 32.546569° North, Longitude 103.258268° West  
NMOCD Reference #1RP-01-14-3011**

**June 2014**

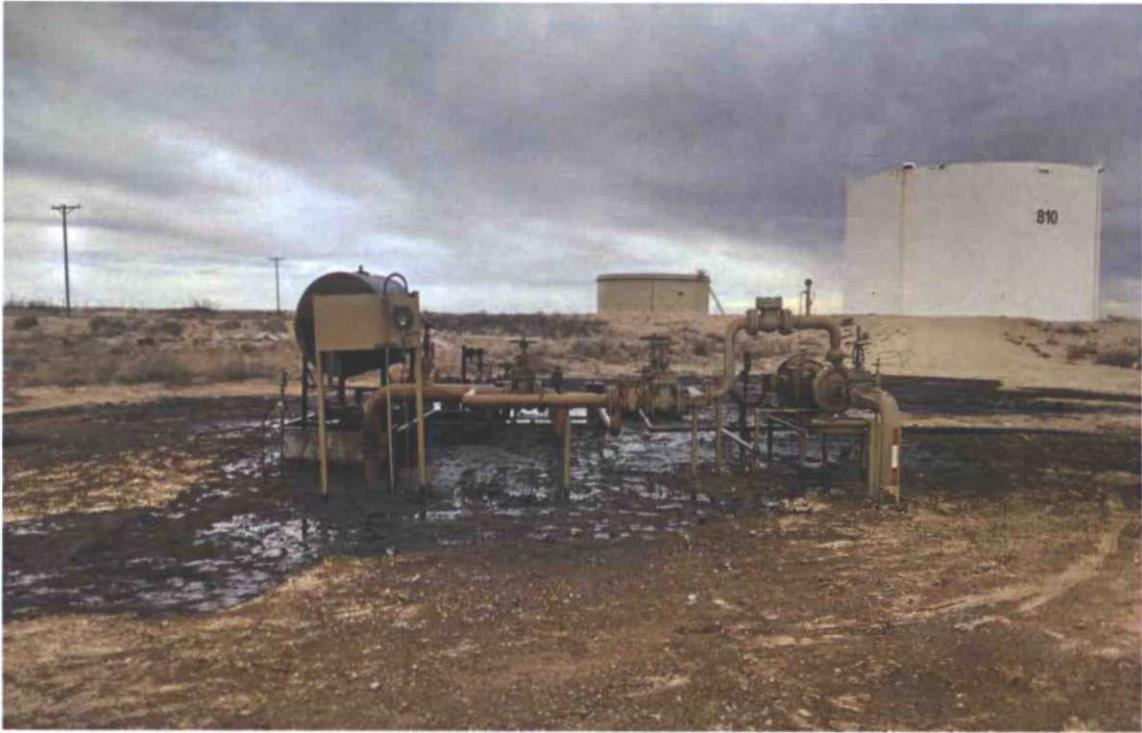
Lea to Jal 8-Inch Line 1 Pump - Release Site (Looking West)

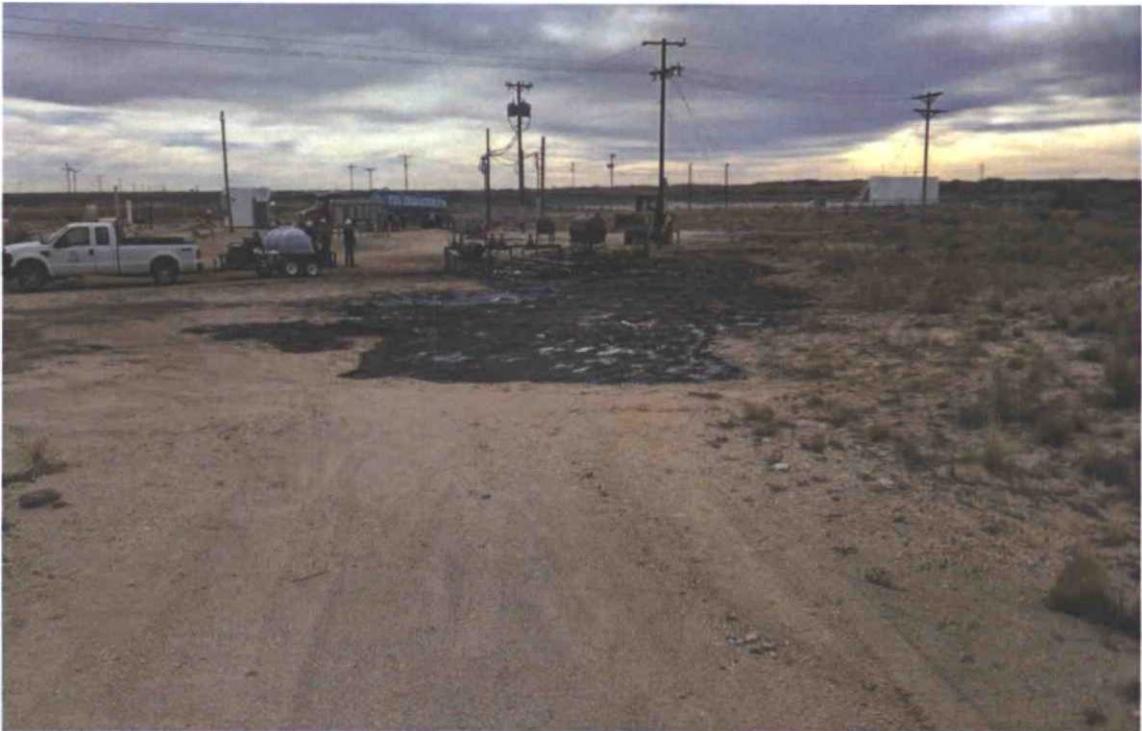
Lea to Jal 8-Inch Line 1 Pump - Release Site (Looking Southwest)

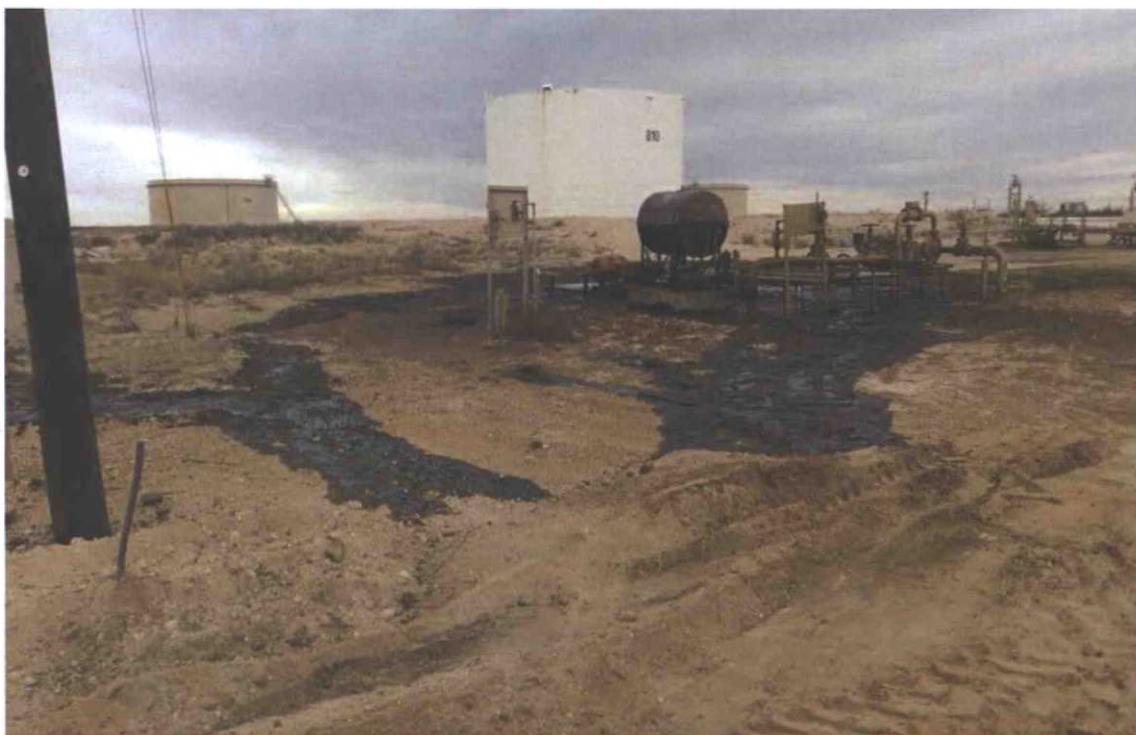
Lea to Jal 8-Inch Line 1 Pump - Release Site (Looking Northwest)

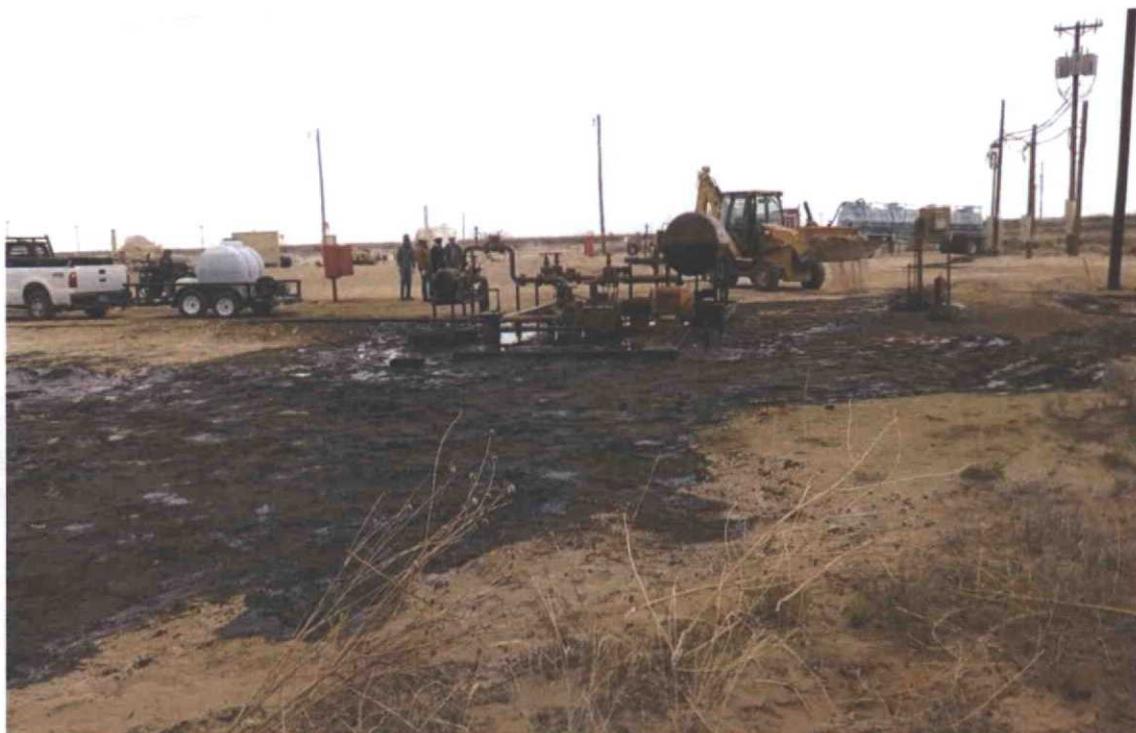
Lea to Jal 8-Inch Line 1 Pump - Release Site (Looking East)

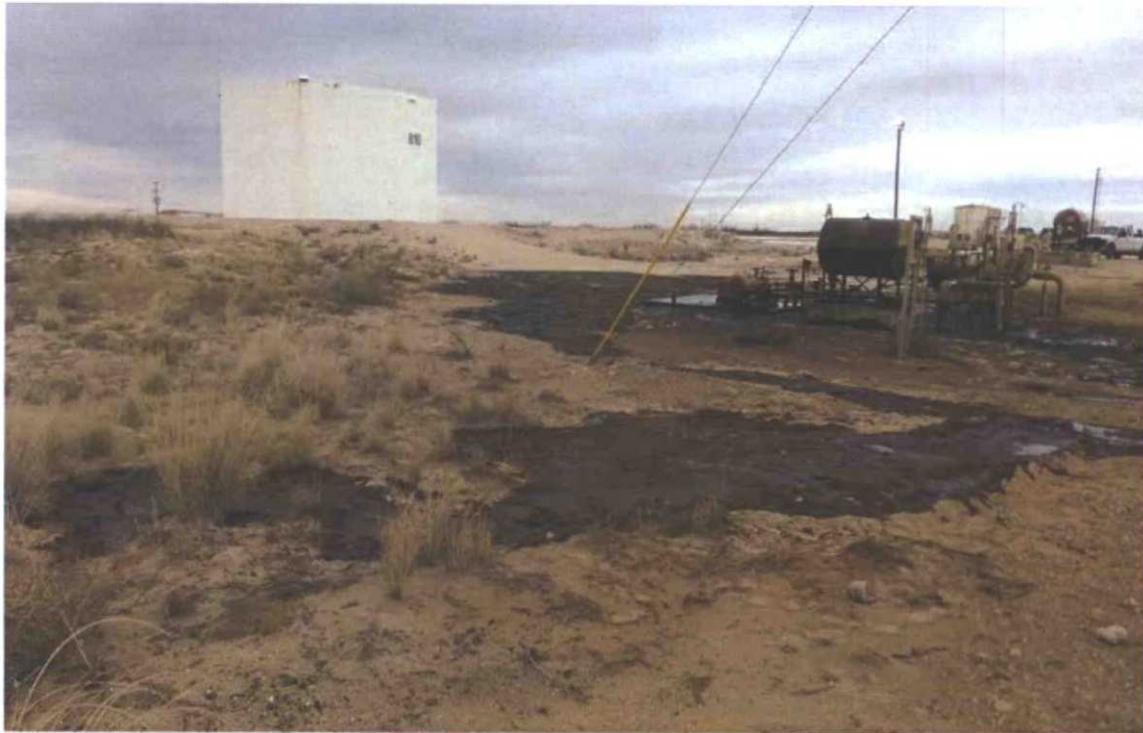
Lea to Jal 8-Inch Line 1 Pump – Runoff Area (Looking Northwest)

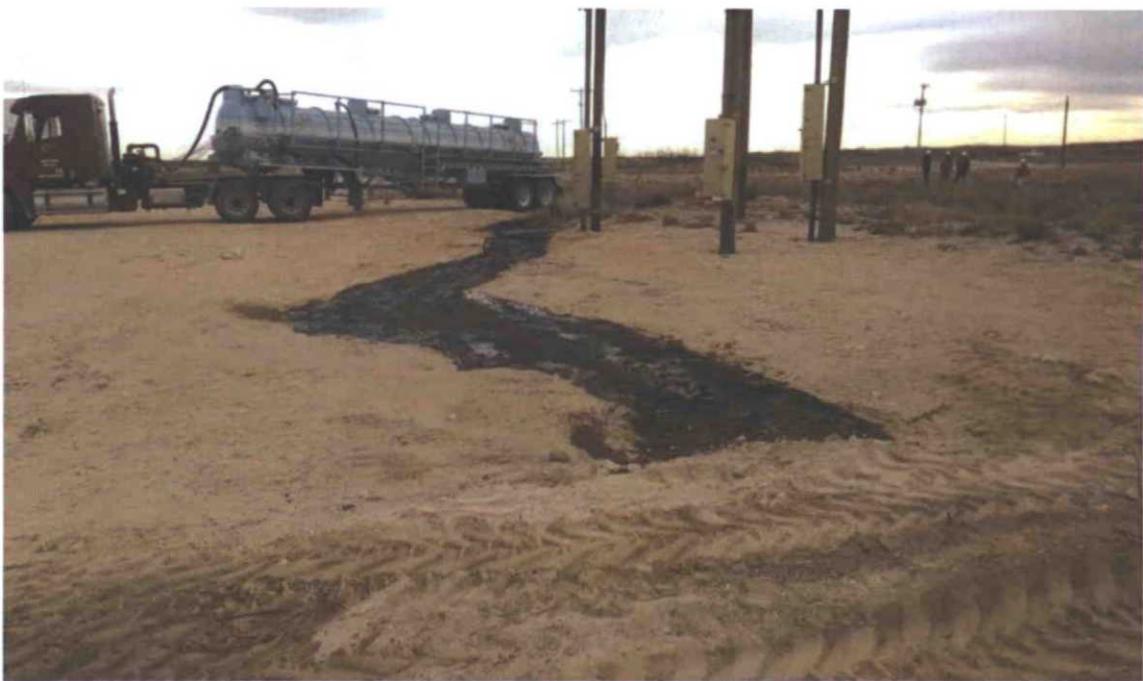
Lea to Jal 8-Inch Line 1 Pump – Flow Path (Looking East)

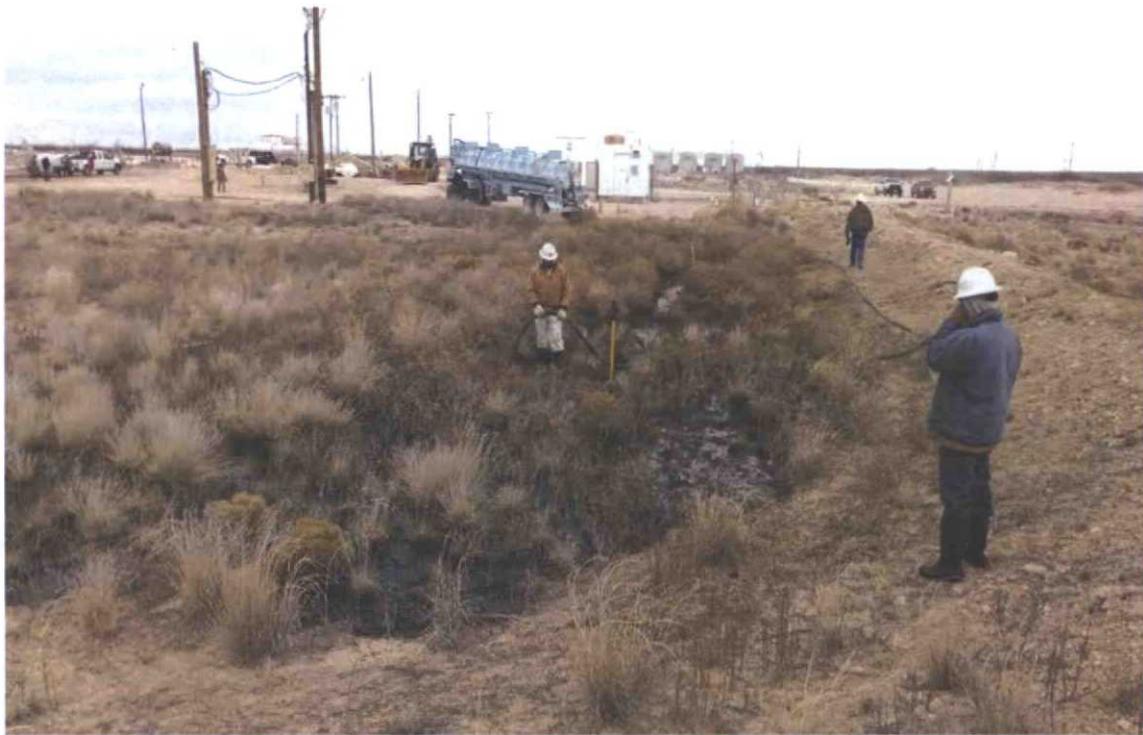
Lea to Jal 8-Inch Line 1 Pump – Primary Pooling Area (Looking North)

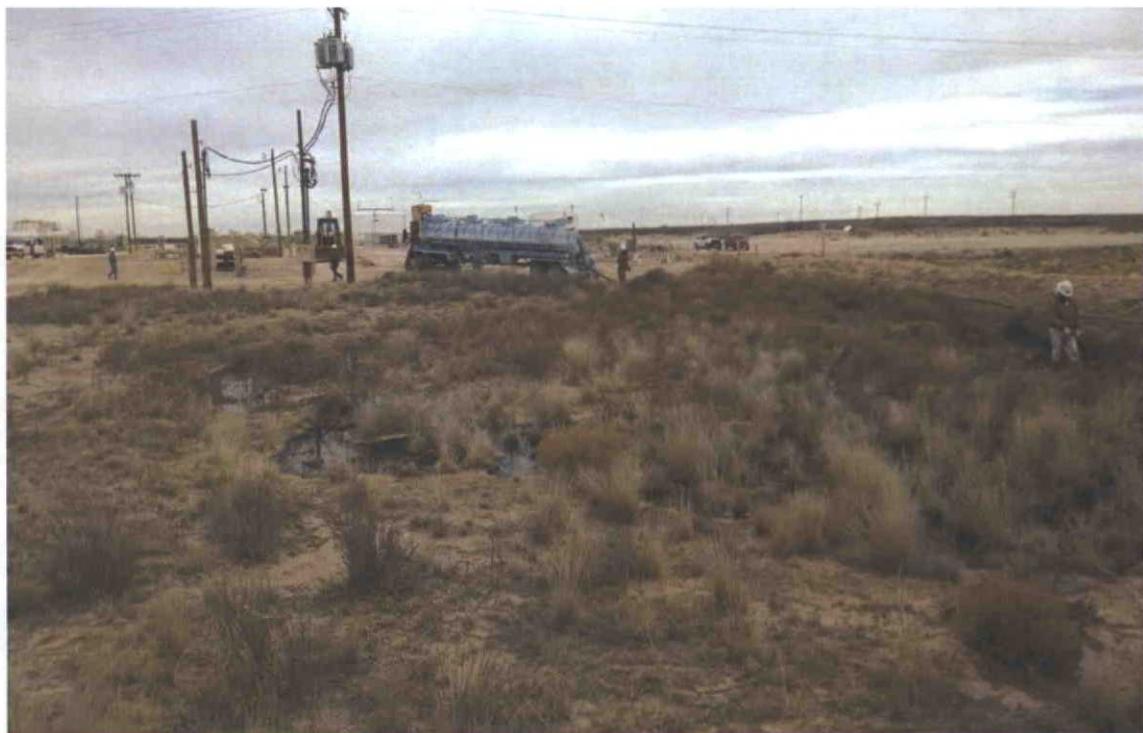
Lea to Jal 8-Inch Line 1 Pump – Primary & Secondary Pooling Areas (Looking North)

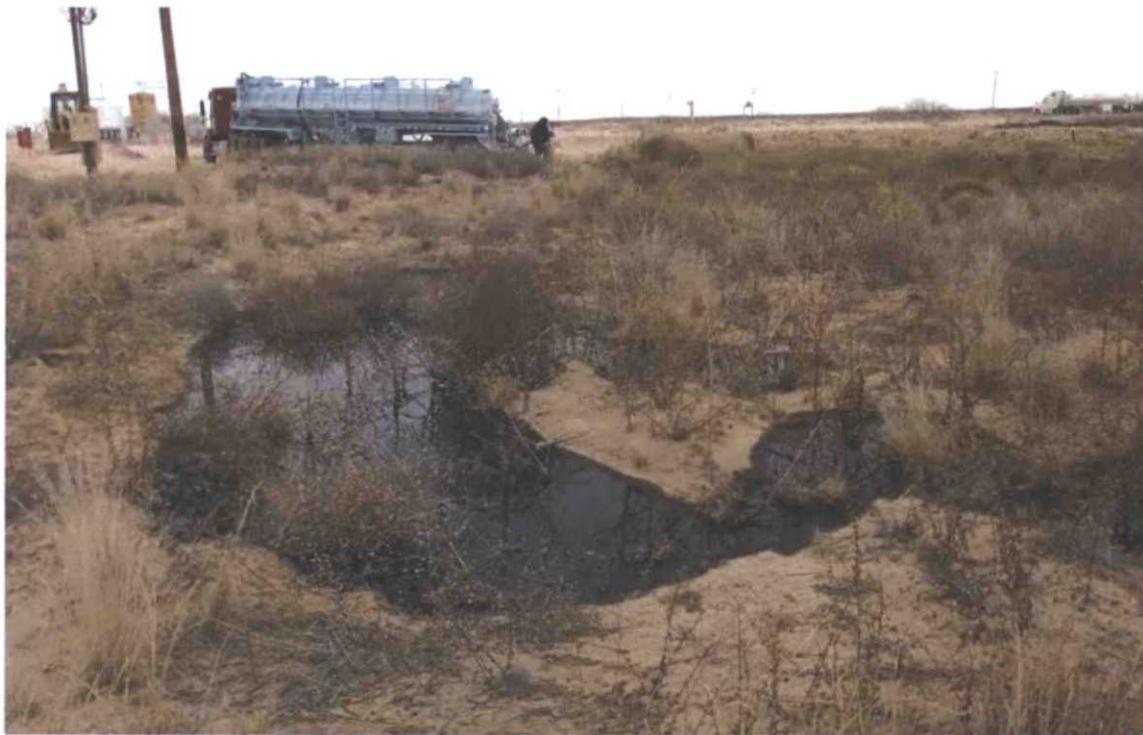
Lea to Jal 8-Inch Line 1 Pump – Secondary Pooling Area (Looking Northeast)

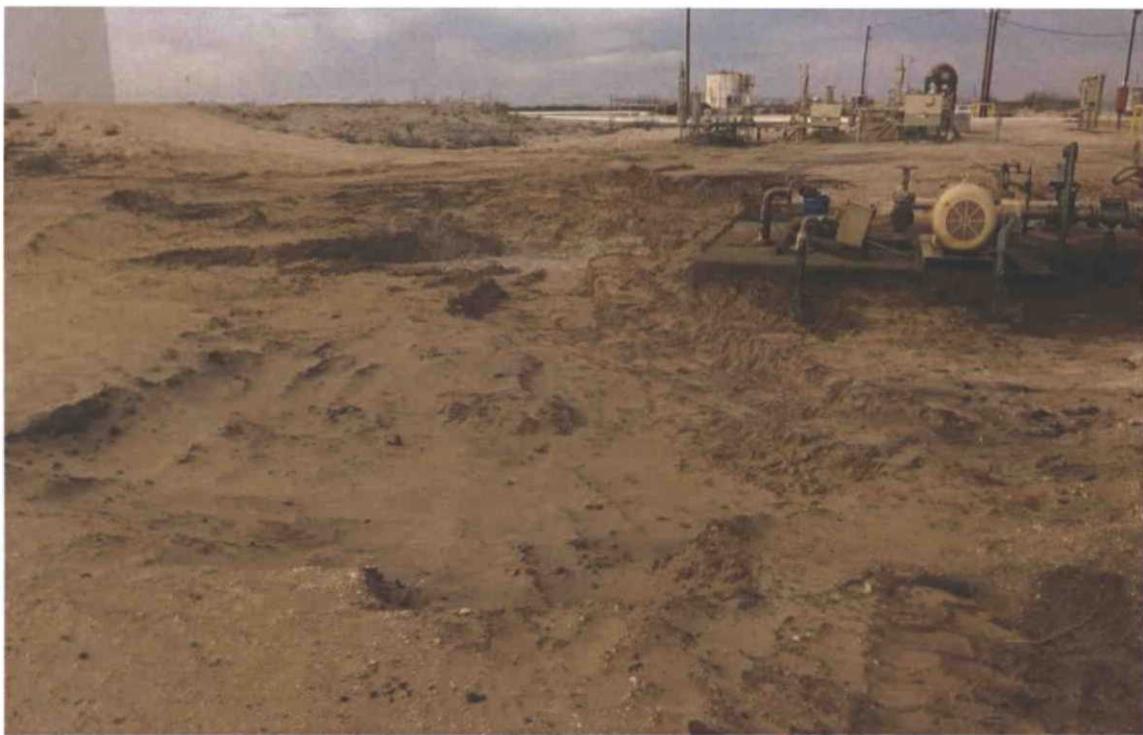
Lea to Jal 8-Inch Line 1 Pump – Excavation, Release Point  
(Looking North-Northwest)

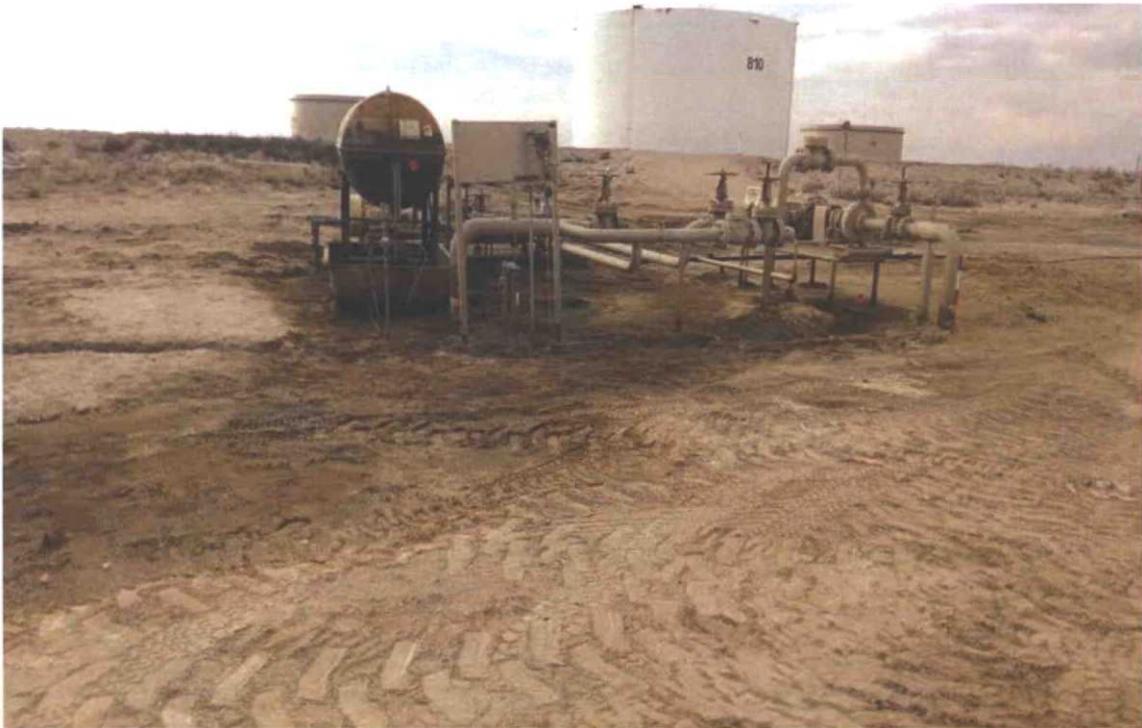
Lea to Jal 8-Inch Line 1 Pump – Excavation, Release Point (Looking West-Northwest)

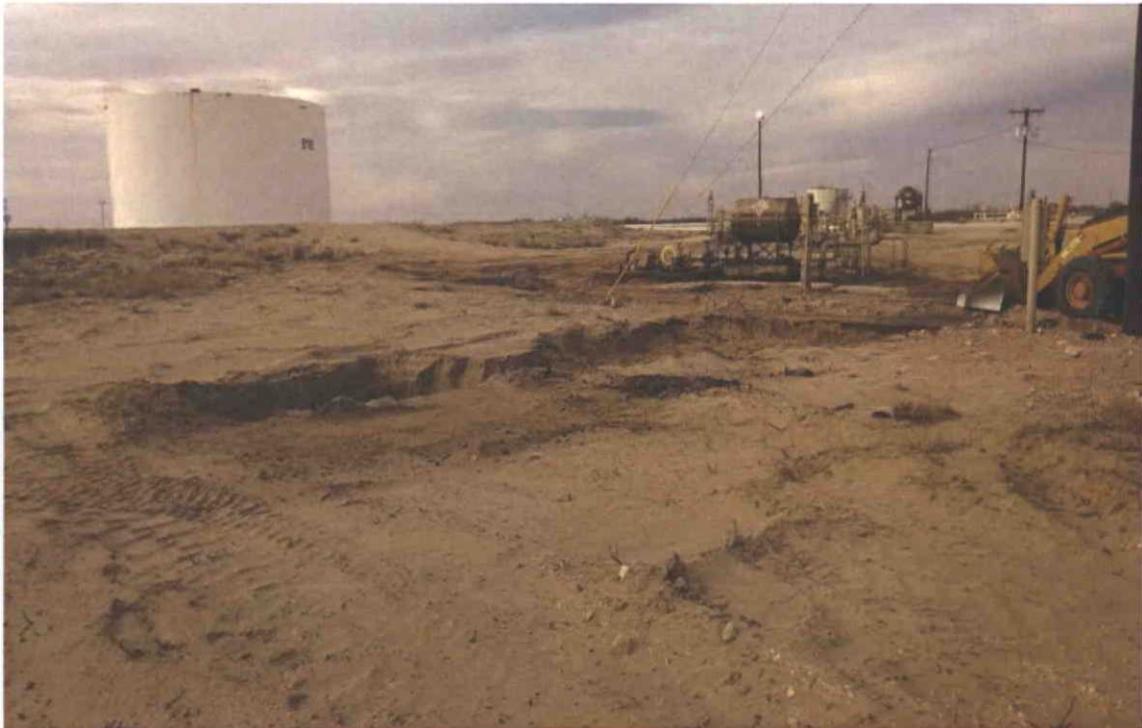
Lea to Jal 8-Inch Line 1 Pump – Excavation, Runoff Area (Foreground) & Release Point (Background; Looking North-Northwest)

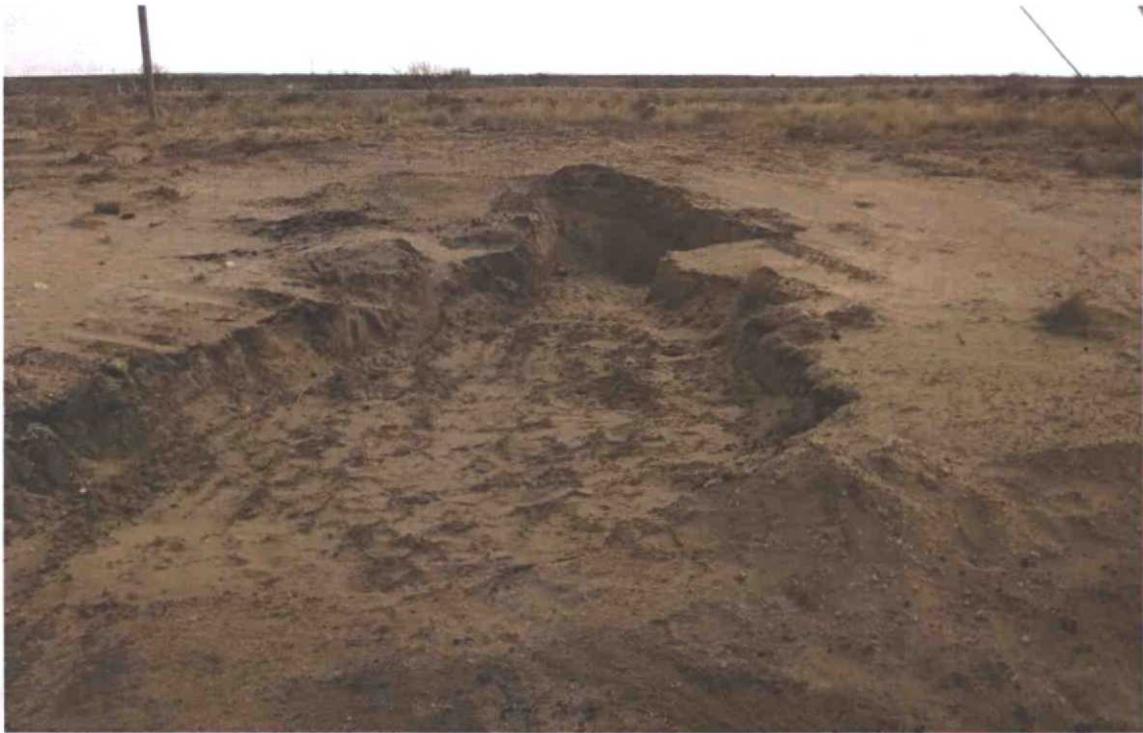
Lea to Jal 8-Inch Line 1 Pump – Excavation, Runoff Area (Looking South)

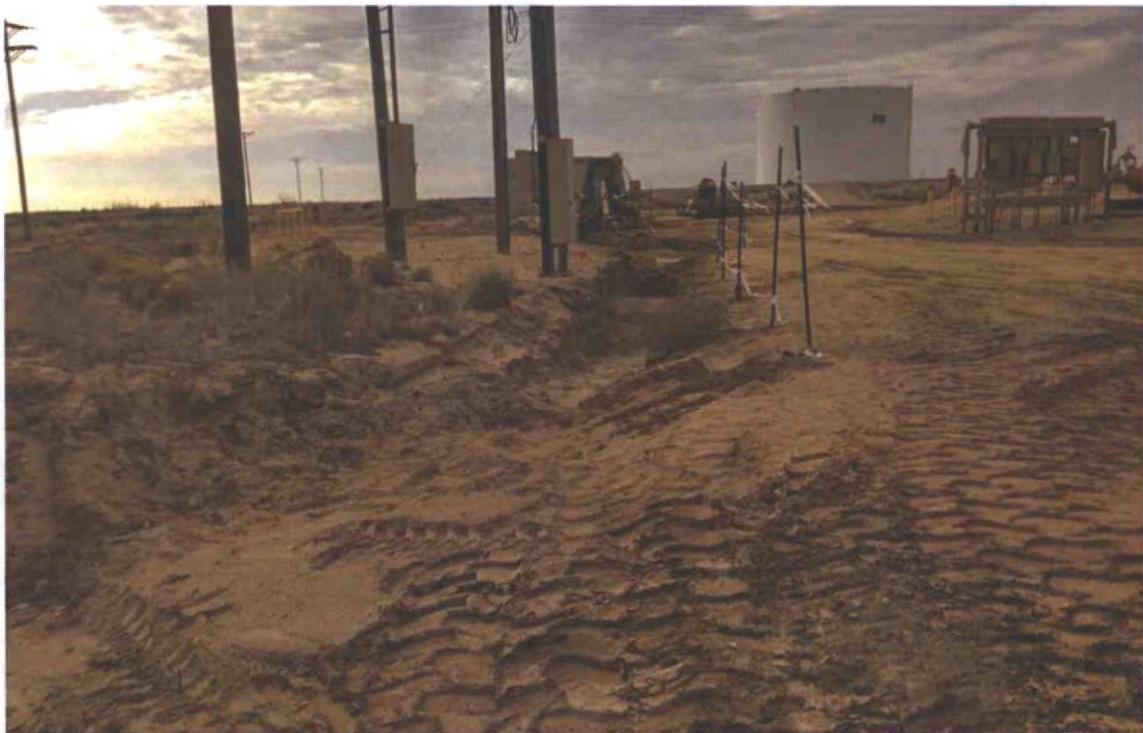
Lea to Jal 8-Inch Line 1 Pump – Excavation, Flow Path (Looking West)

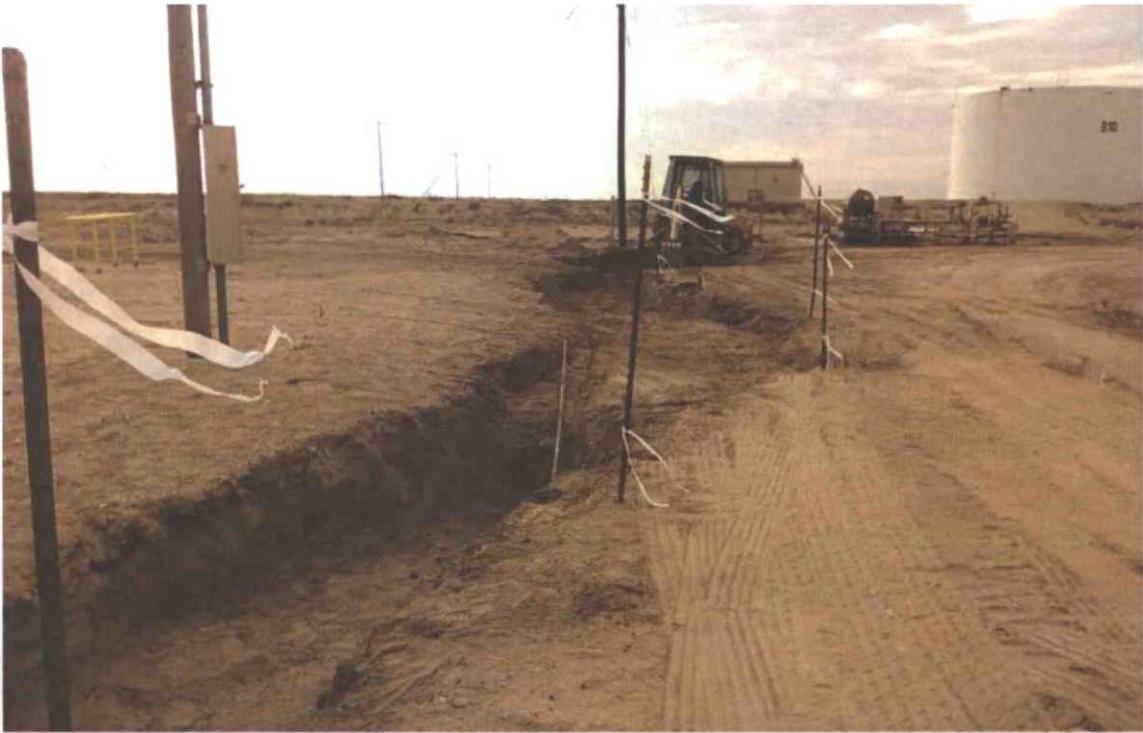
Lea to Jal 8-Inch Line 1 Pump – Excavation, Flow Path (Looking West)

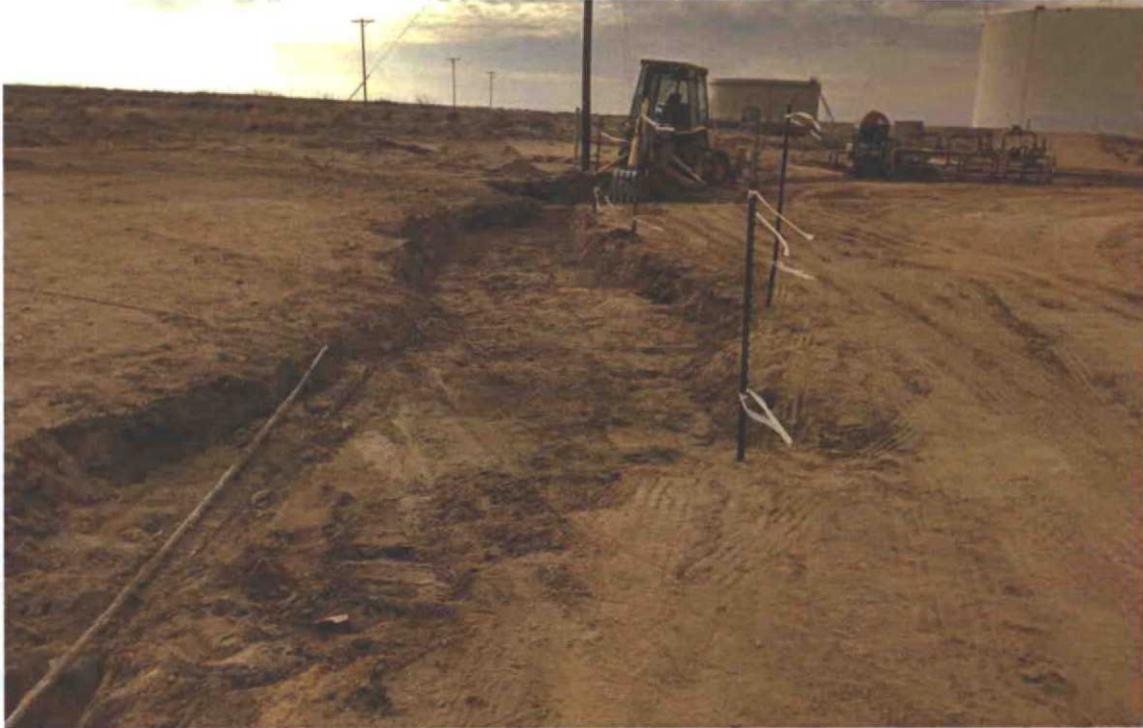
Lea to Jal 8-Inch Line 1 Pump – Excavation, Flow Path (Looking West)

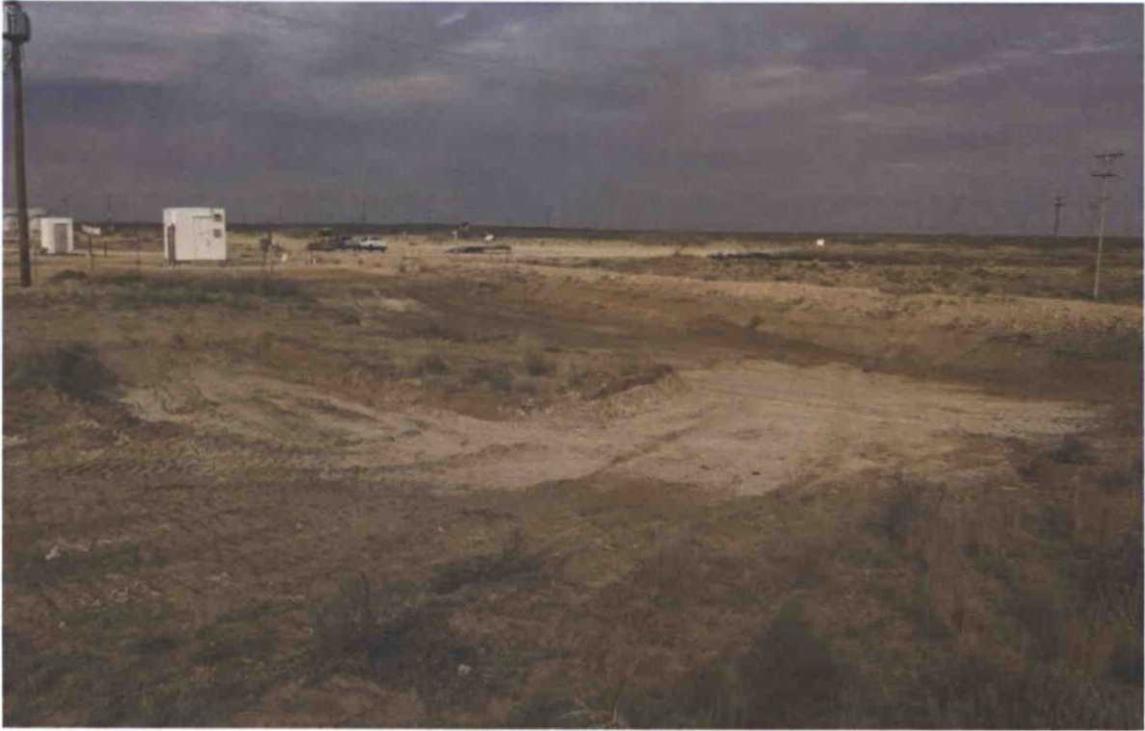
Lea to Jal 8-Inch Line 1 Pump – Main Excavation (Background) & Pooling Area (Foreground; Looking Northeast)

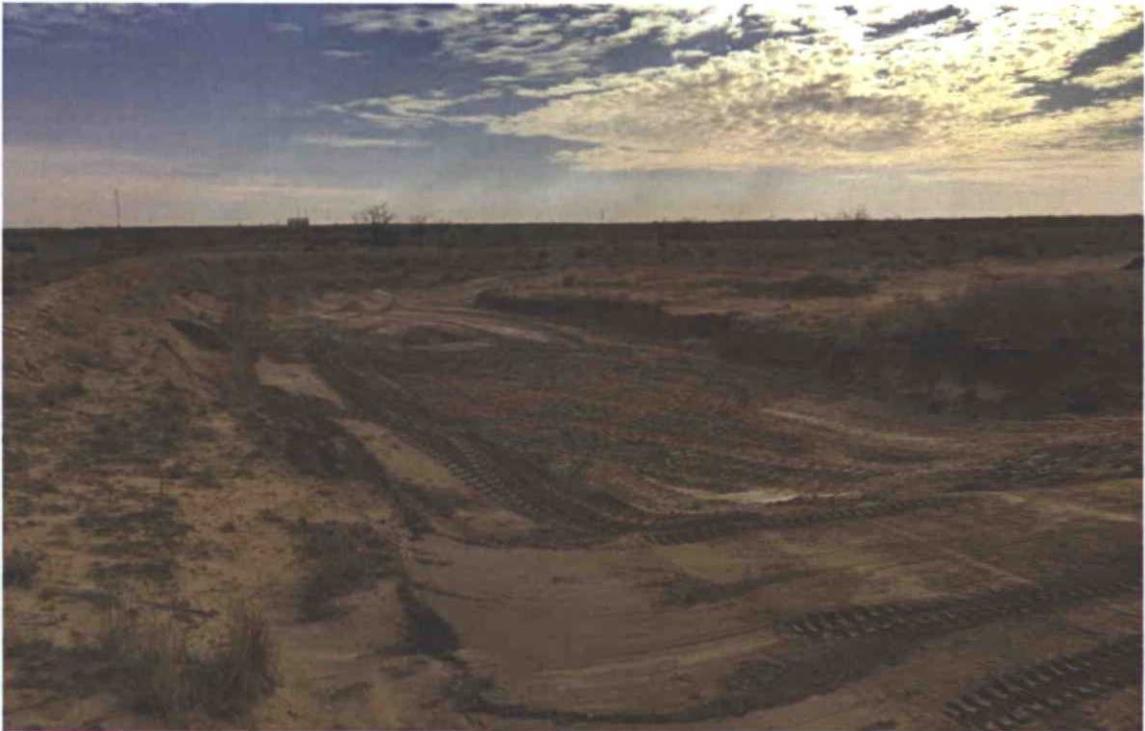
Lea to Jal 8-Inch Line 1 Pump – Main Excavation (Looking South-Southwest)

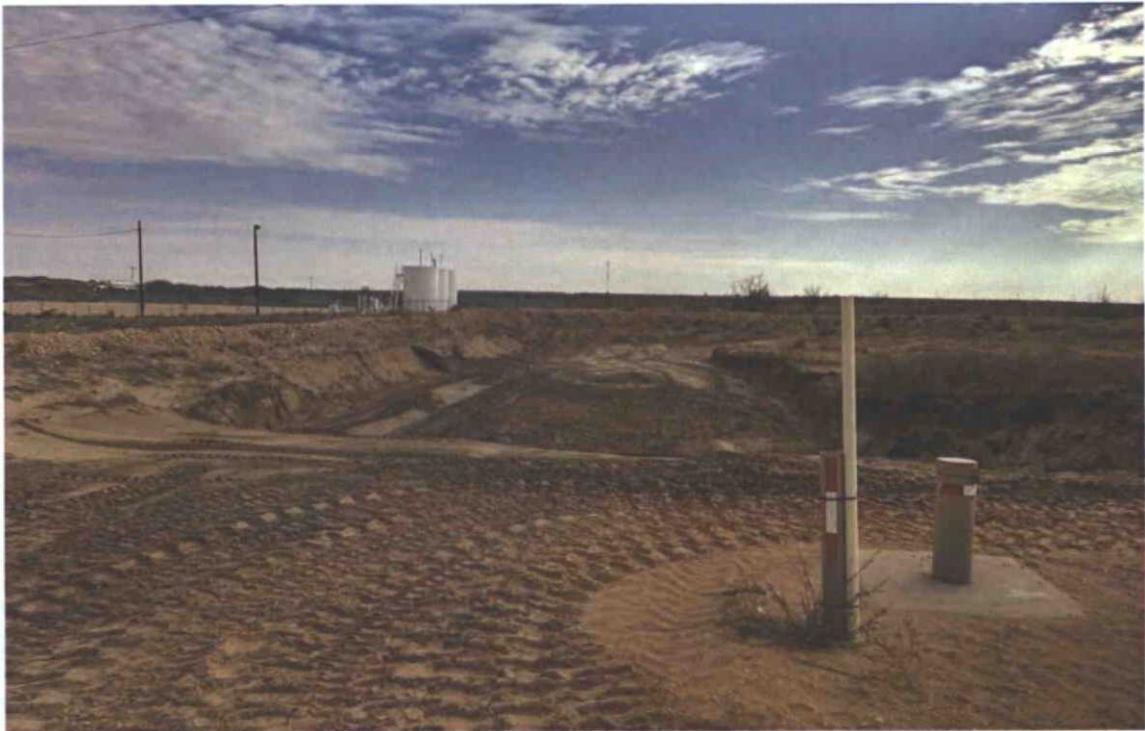
Lea to Jal 8-Inch Line 1 Pump – Main Excavation (Looking South)

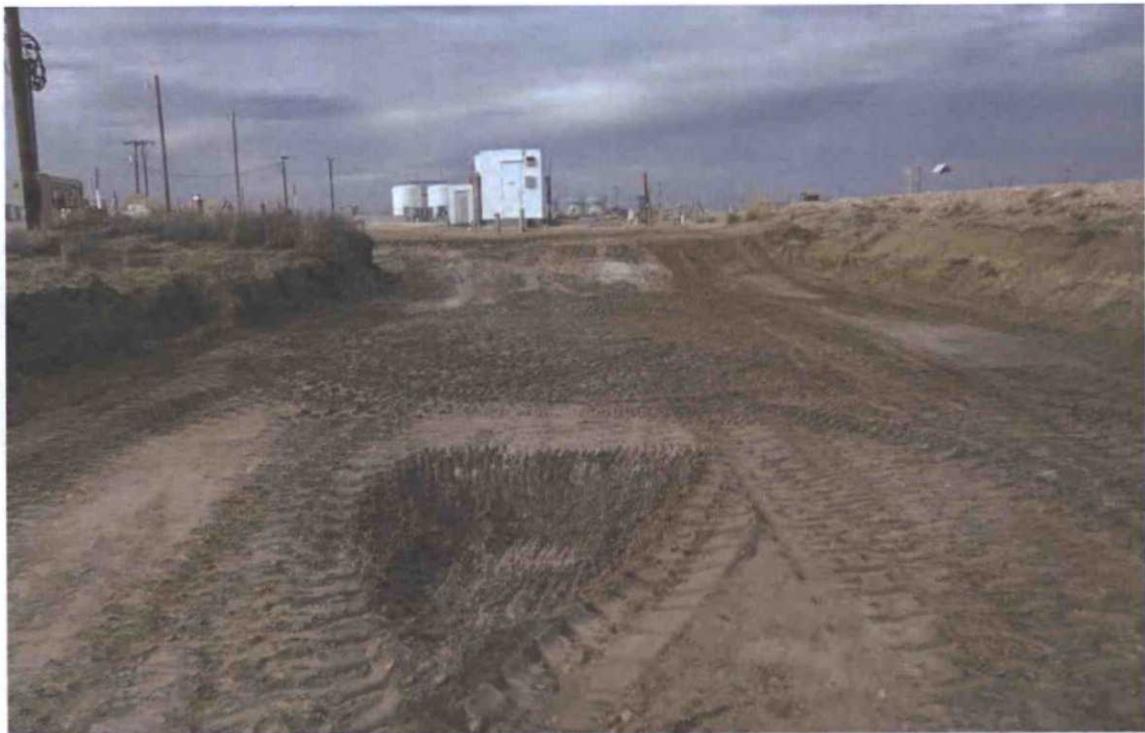
Lea to Jal 8-Inch Line 1 Pump – Floor of Main Excavation (Looking North)

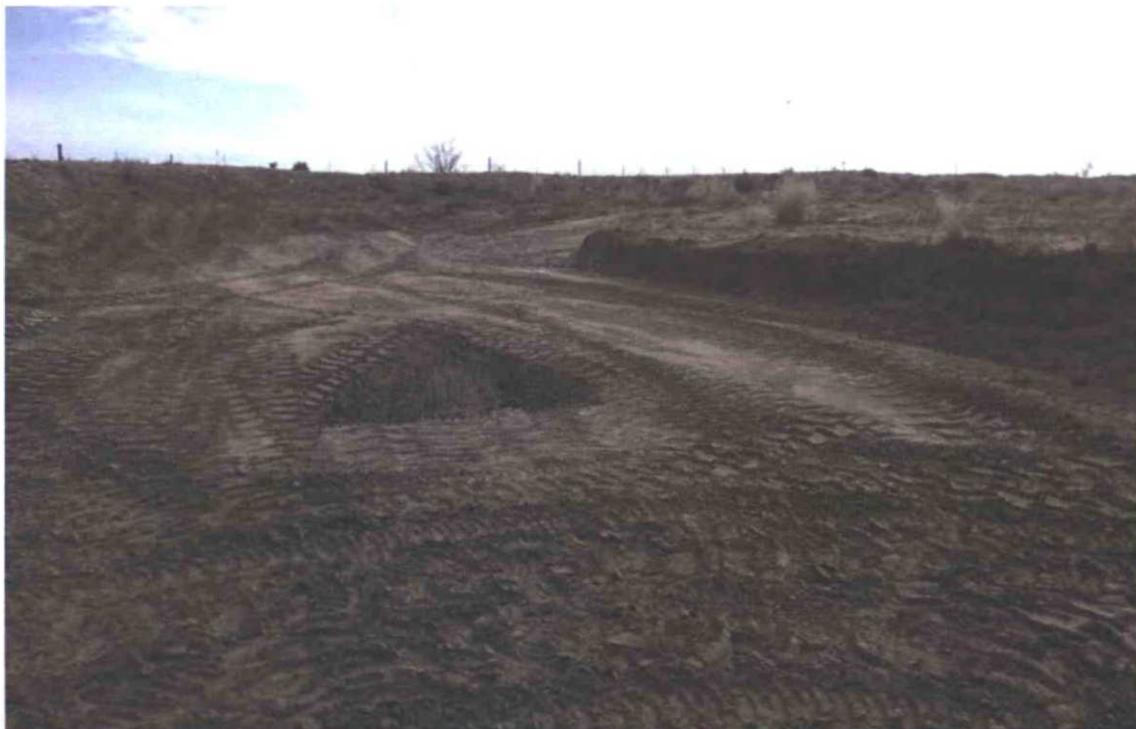
Lea to Jal 8-Inch Line 1 Pump – Floor of Main Excavation (Looking South-Southwest)

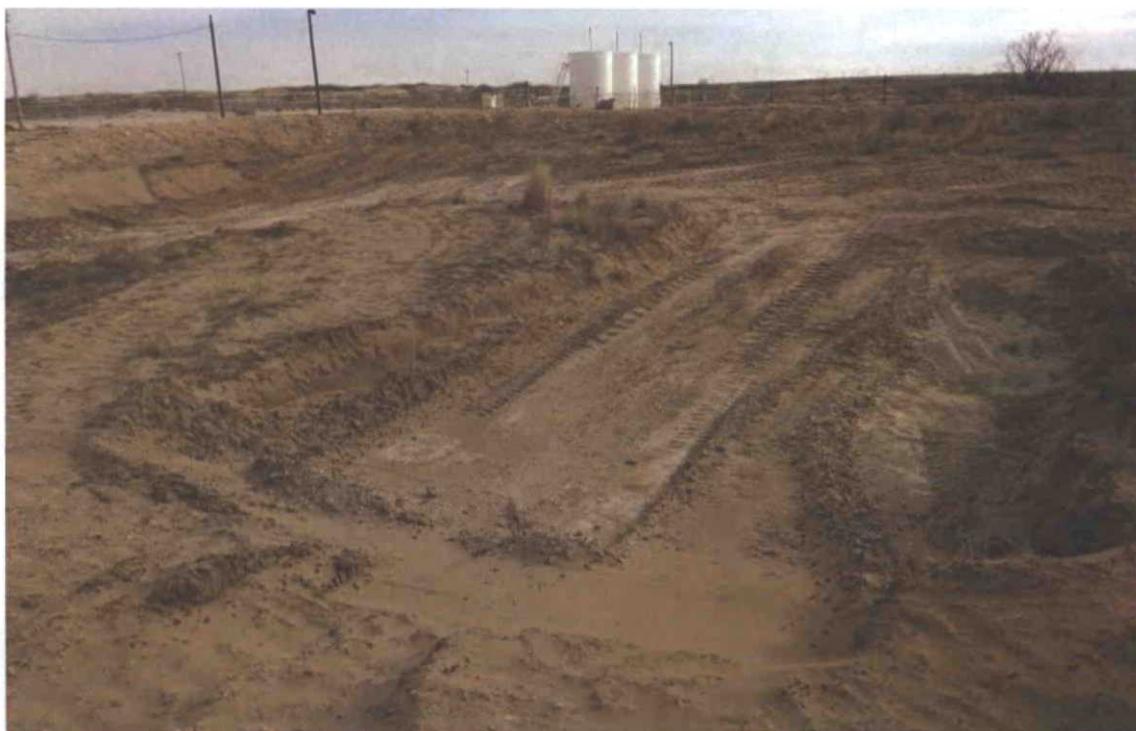
Lea to Jal 8-Inch Line 1 Pump – Excavation, Pooling Area (Looking Southeast)

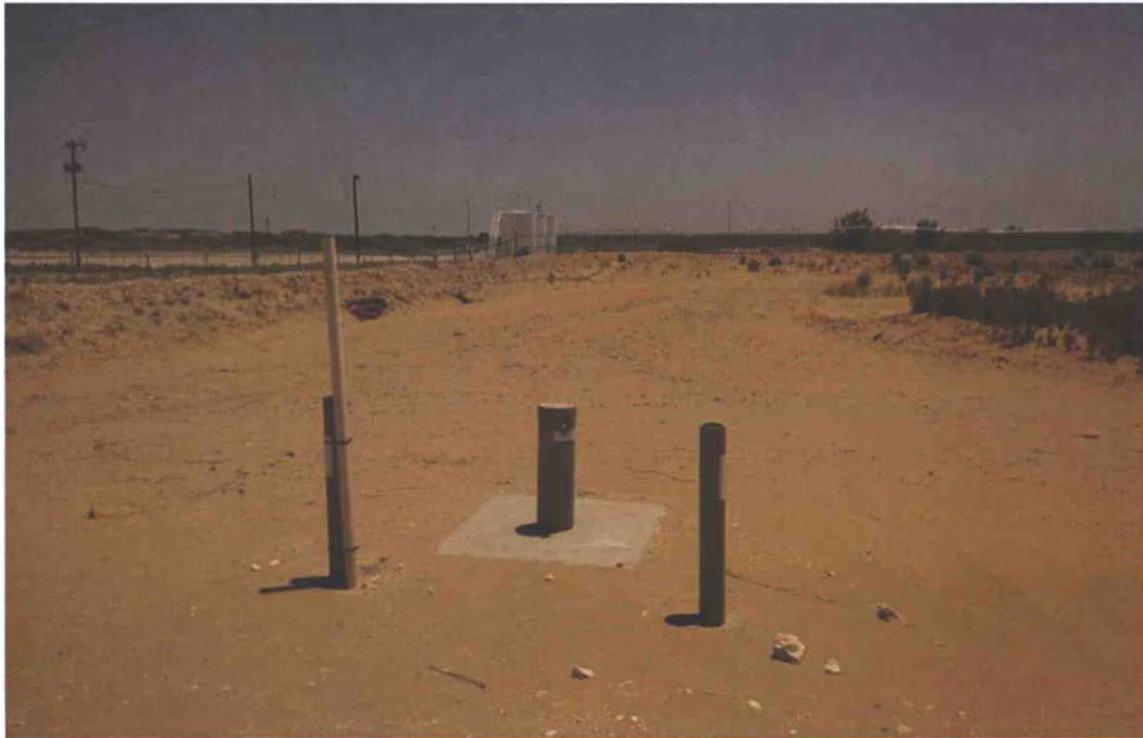
Lea to Jal 8-Inch Line 1 Pump – Main Excavation, Following Backfill (Looking South)

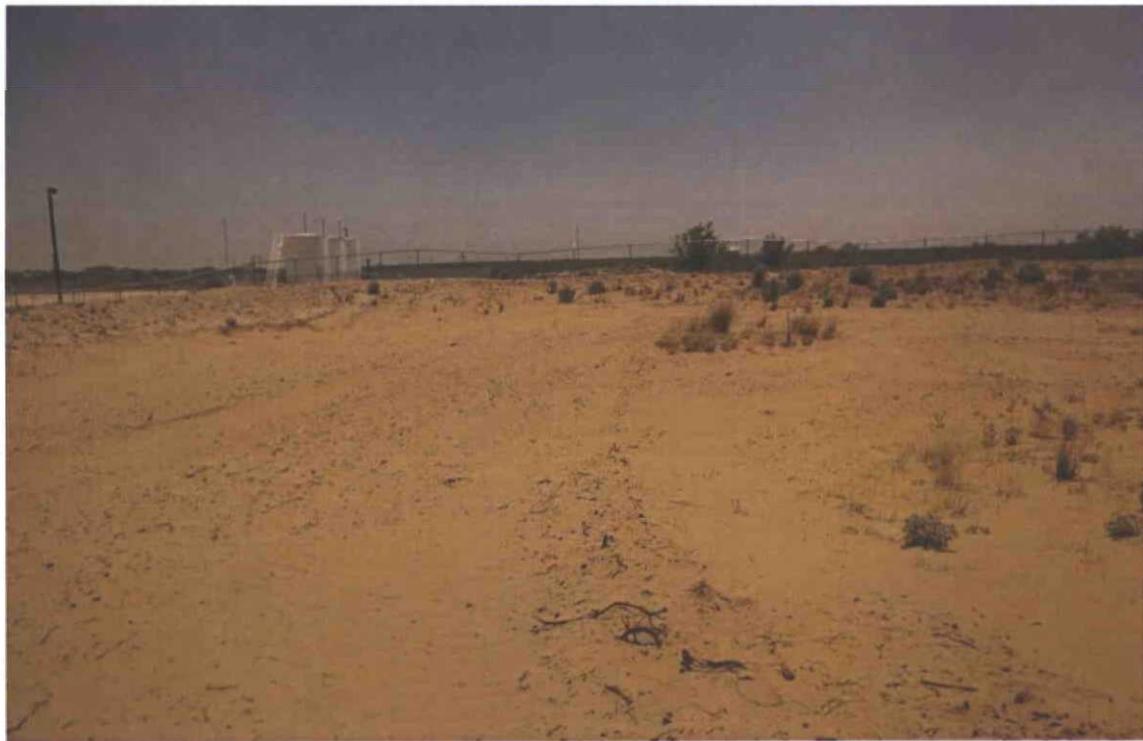
Lea to Jal 8-Inch Line 1 Pump – Main Excavation (Left) & Pooling Area (Right),  
Following Backfill (Looking Southeast)

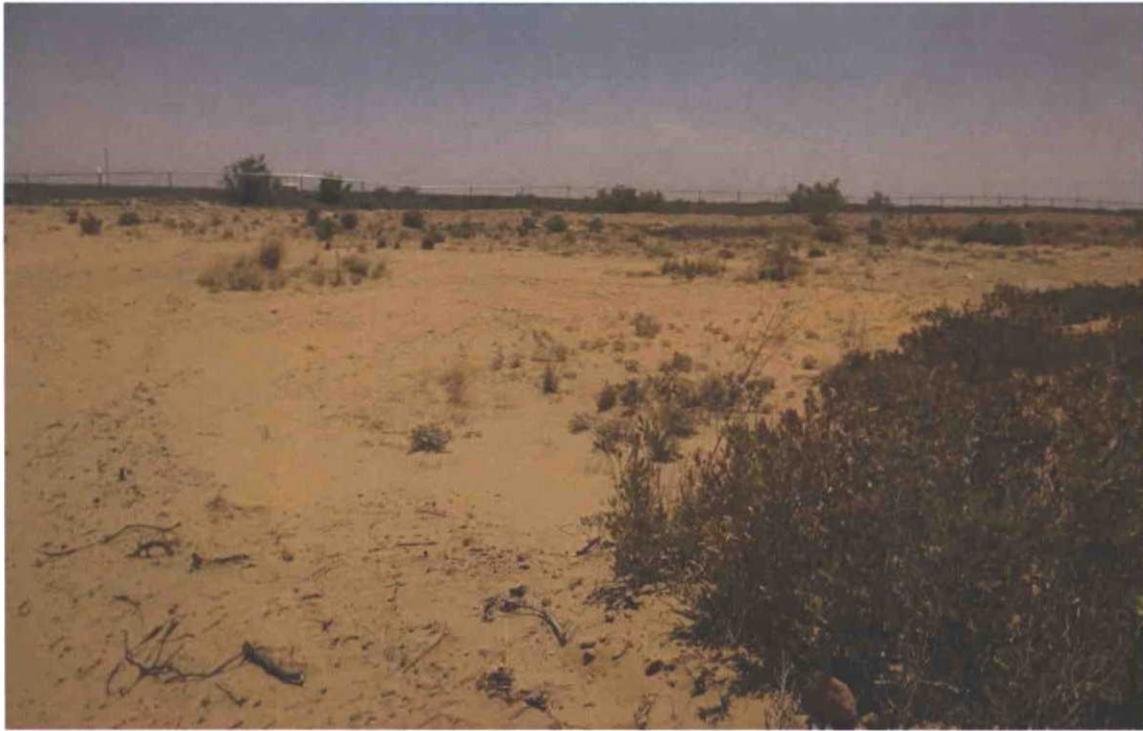
Lea to Jal 8-Inch Line 1 Pump – Pooling Area, Following Backfill (Looking South)

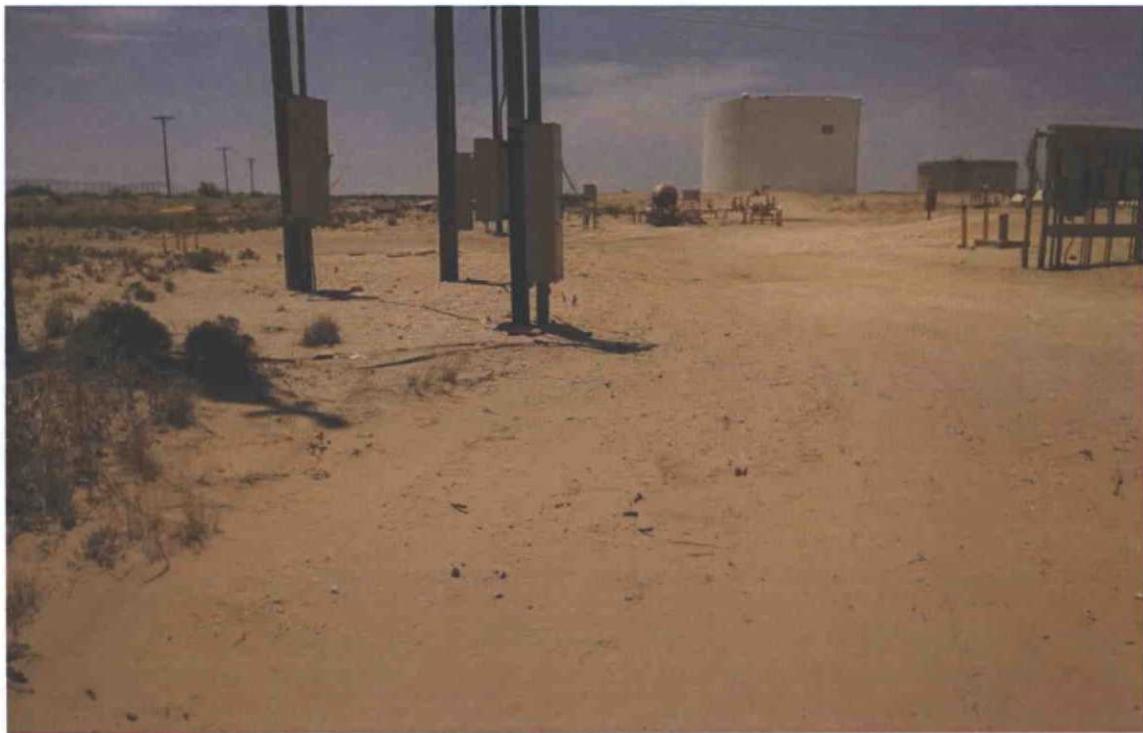
Lea to Jal 8-Inch Line 1 Pump – Flow Path, Following Backfill (Looking West)

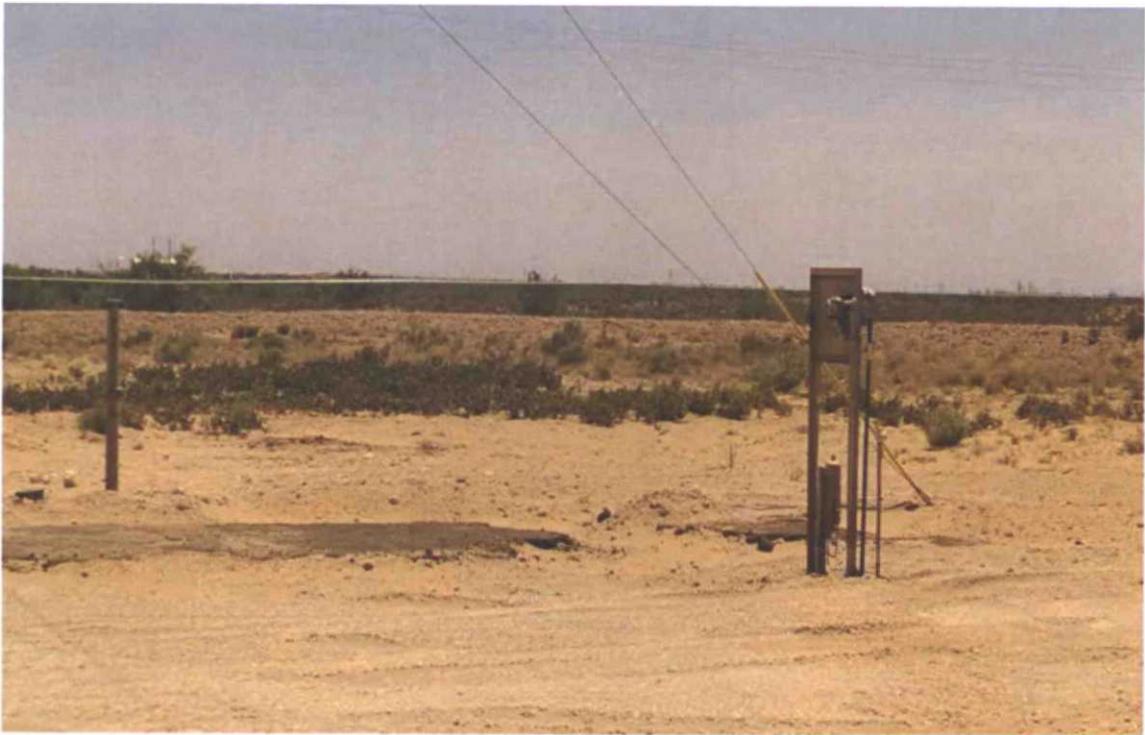
Lea to Jal 8-Inch Line 1 Pump – Runoff Area, Following Backfill (Looking South)
