## **REMEDIATION SUMMARY & RISK-BASED SITE CLOSURE REQUEST**

**PLAINS PIPELINE, LP  
LEA TO JAL 8-INCH LINE 1 PUMP  
Plains SRS #2014-014  
Lea County, New Mexico  
Unit Letter "F" (SE/NW), Section 28, Township 20 South, Range 37 East  
Latitude 32.546569° North, Longitude 103.258268° West  
NMOCD Reference #1RP-01-14-3011**

**June 2014**

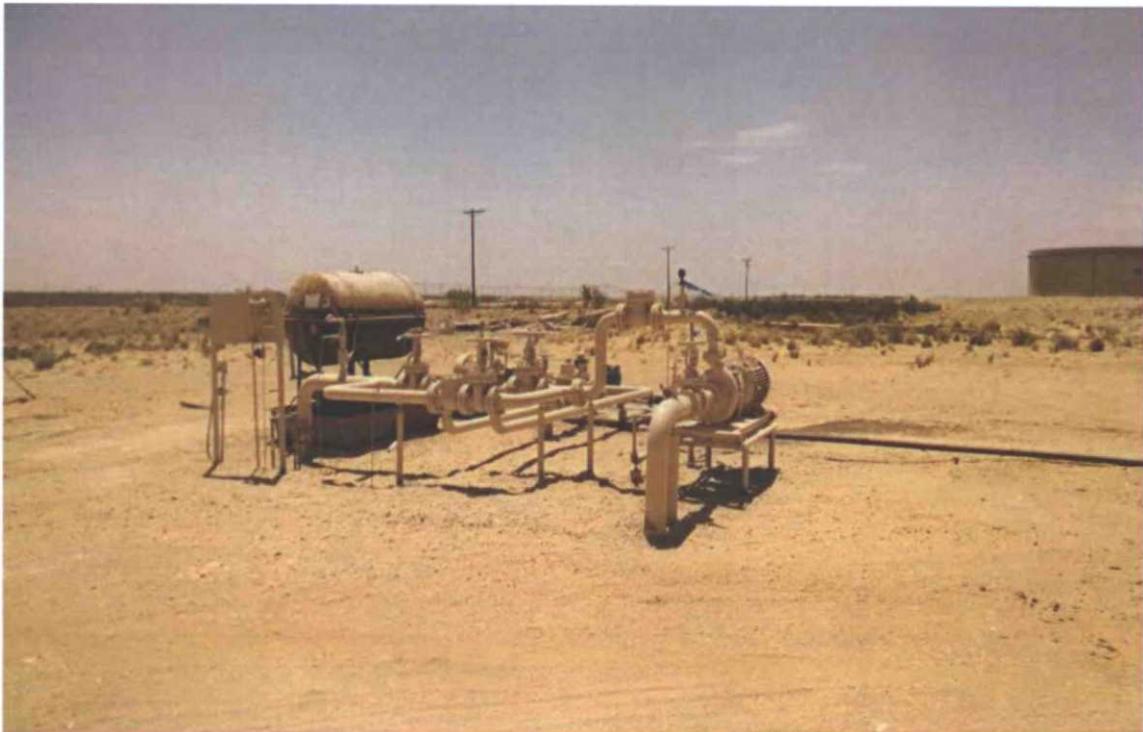
Lea to Jal 8-Inch Line 1 Pump – Release Point, Following Backfill (Looking West-Southwest)

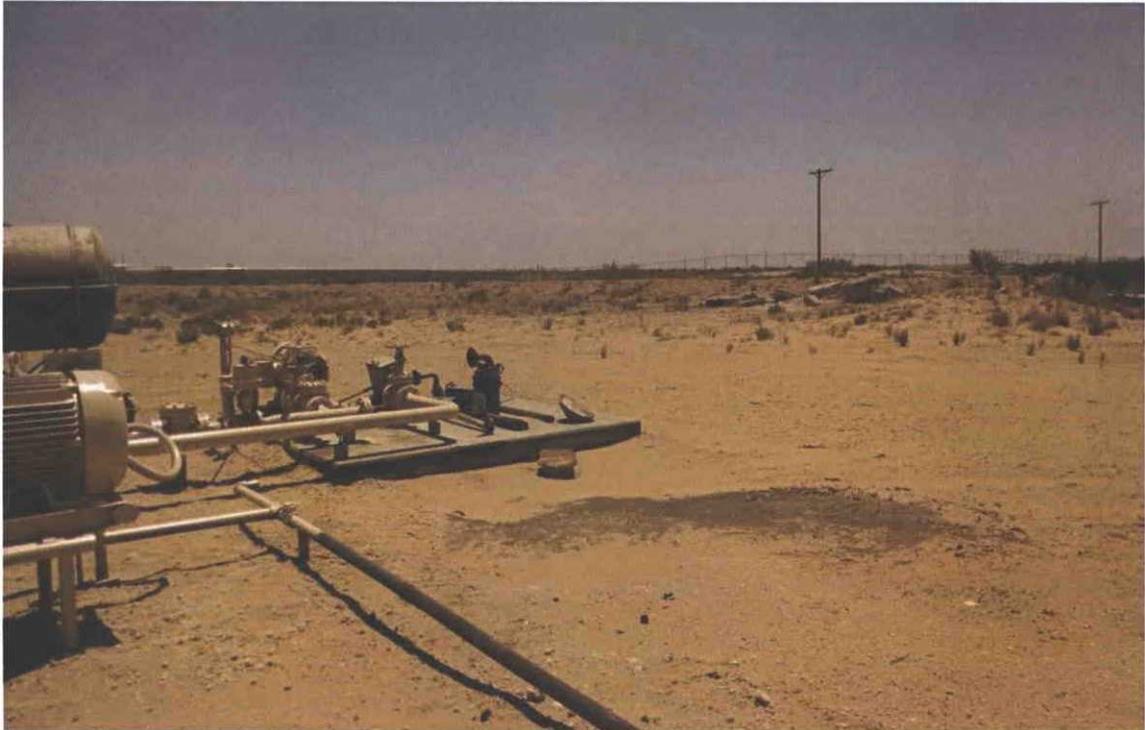
Lea to Jal 8-Inch Line 1 Pump – Release Point, Following Backfill (Looking Southwest)

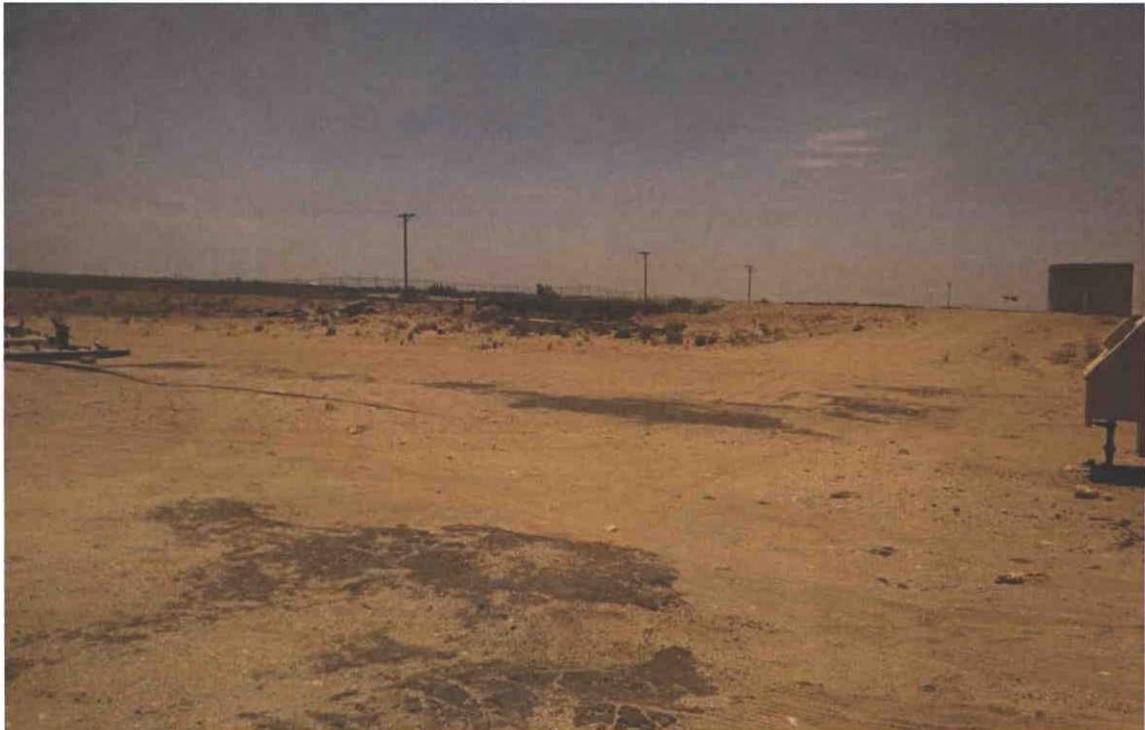
Lea to Jal 8-Inch Line 1 Pump – Release Point, Following Backfill (Looking Southwest)
