1RP-4166
CLOSURE REPORT
LMPSU #286 Flowline
Crude Oil Spill
Lea County, New Mexico

LAI Project No. 17-0175-19

February 8, 2019

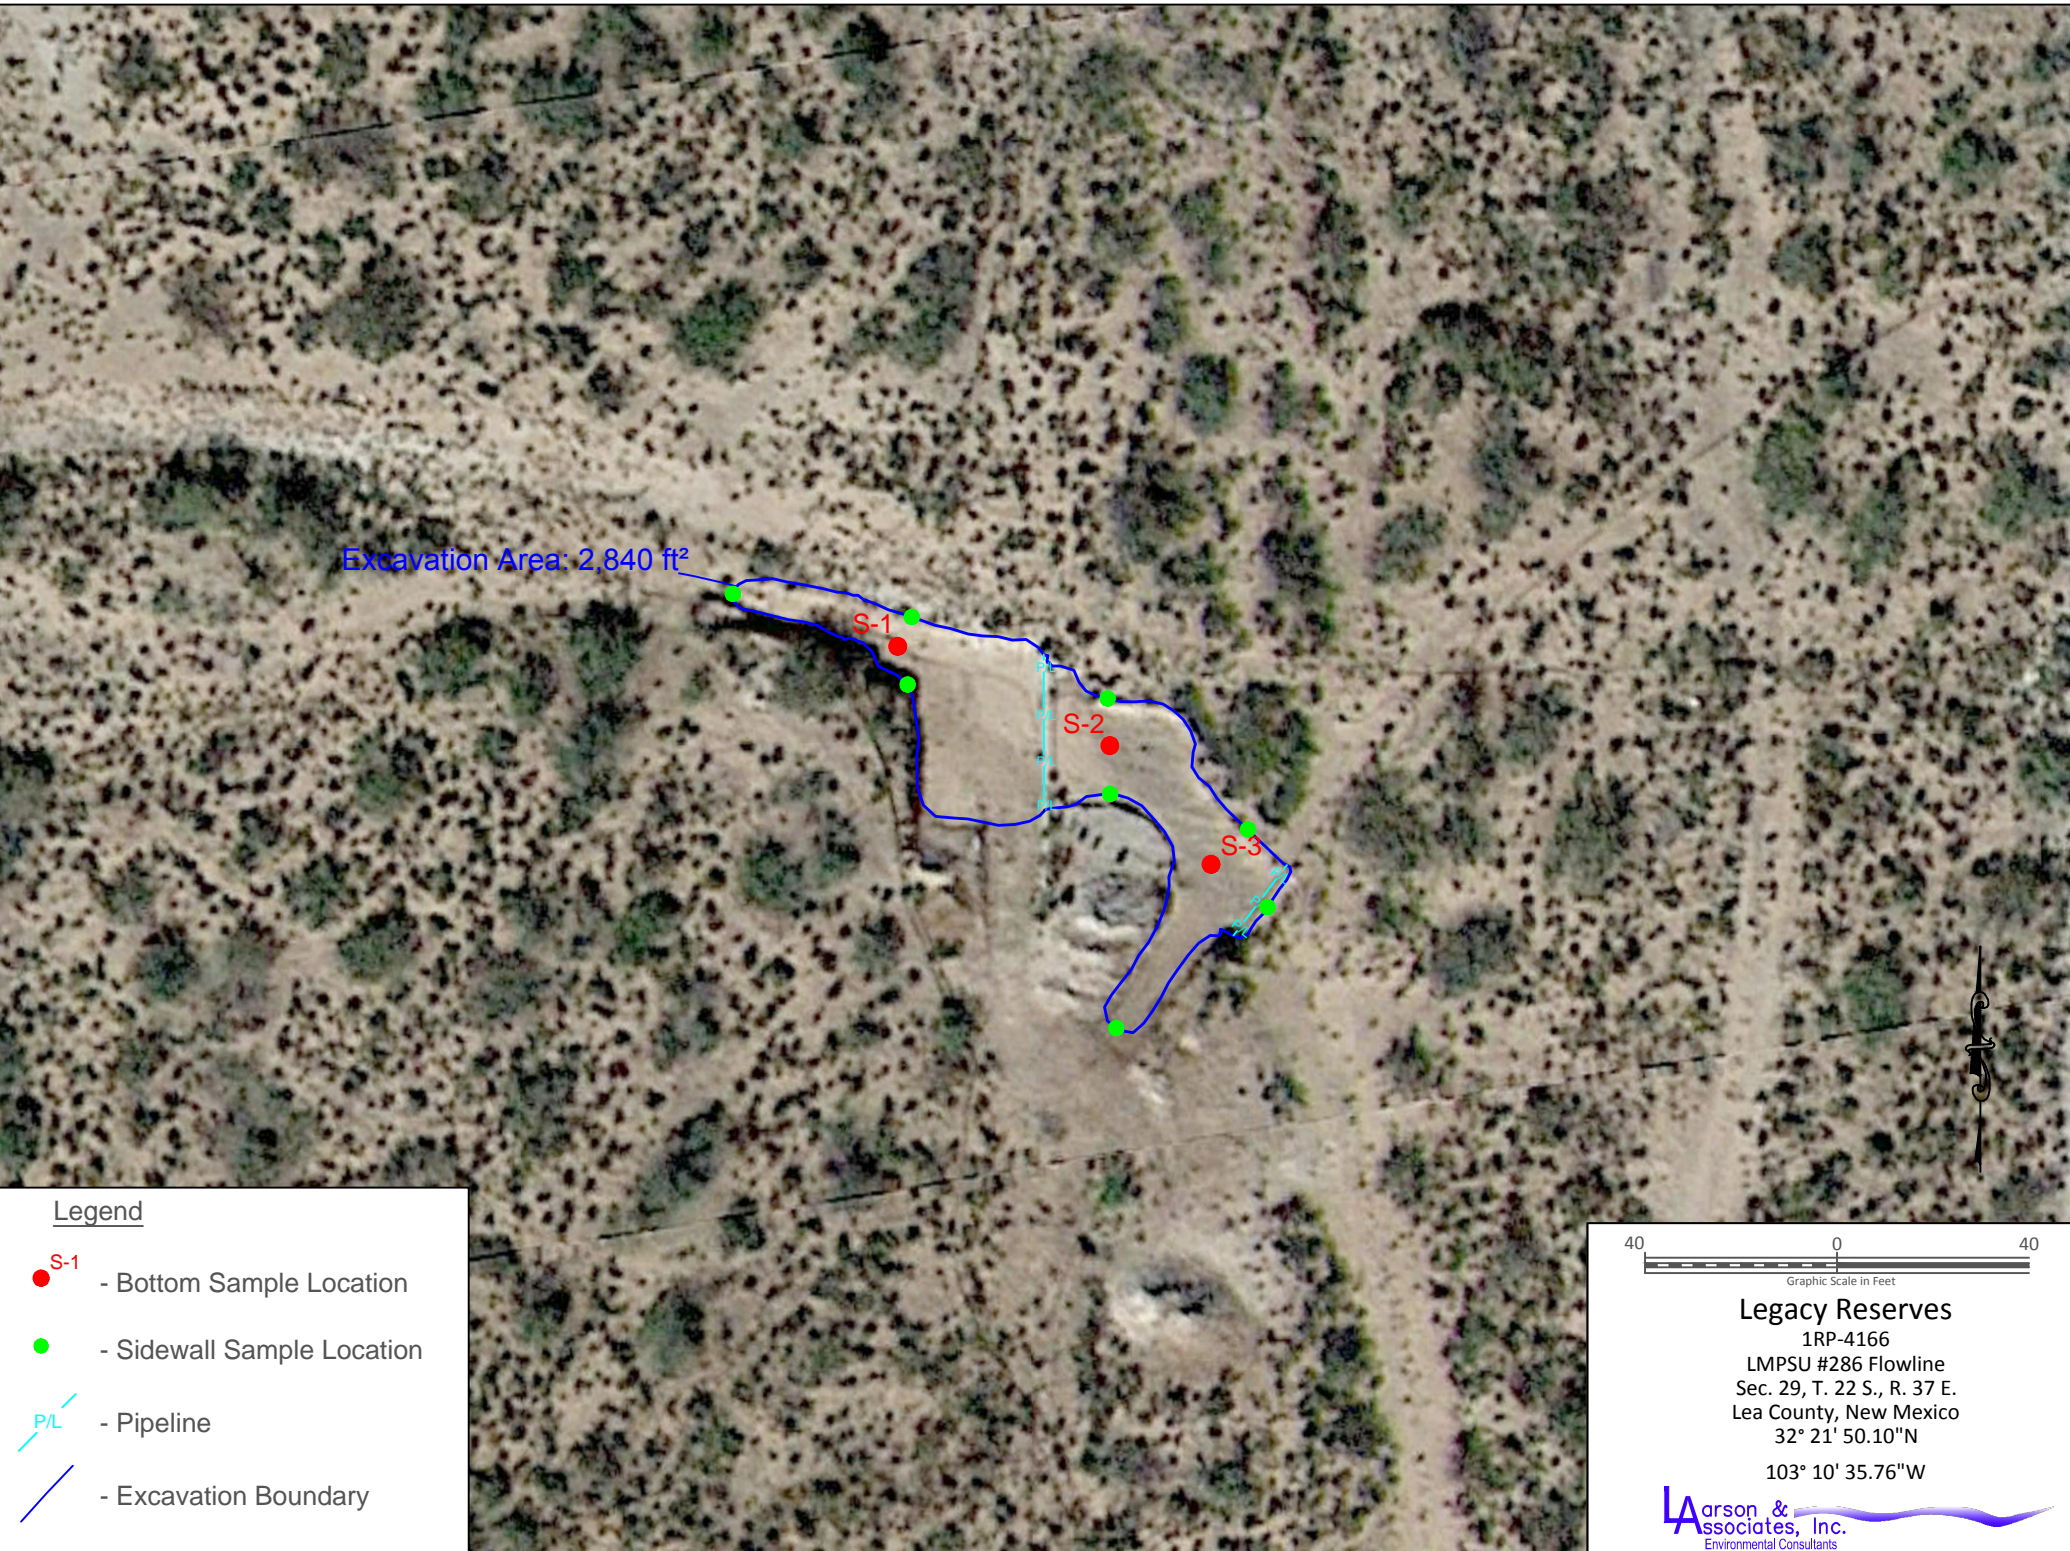
Figure 2 - Aerial Map Showing Sidewall Sample Locations

On January 5, 2018, LAI personnel collected confirmation soil samples at three (3) locations (S-1 through S-3) in the bottom of the excavation. The samples were collected with a stainless steel hand auger at 1 foot intervals to a depth of approximately 7 feet bgs (S-1), 10 feet bgs (S-2), and 4 feet bgs (S-3). Sidewall samples were collected at a mid-excavation depth of about 2 feet bgs e north and south of each bottom sample, as well as the east and west sidewalls. The samples were delivered under chain of custody and preservation to Permian Basin Environmental Lab (PBEL) in Midland Texas. The upper samples were analyzed for BTEX and TPH by EPA SW-846 8021B and 8015M, respectively. All samples were analyzed for chloride by EPA Method 300. The laboratory reported benzene, BTEX and TPH and chloride below the OCD remediation action levels in Table 1 (19.15.29 NMAC) Chloride was delineated to 600 mg/Kg in all samples. Table 1 presents an analytical soil data summary. Figure 2 presents an aerial map with soil sample locations. Appendix C presents the laboratory report.

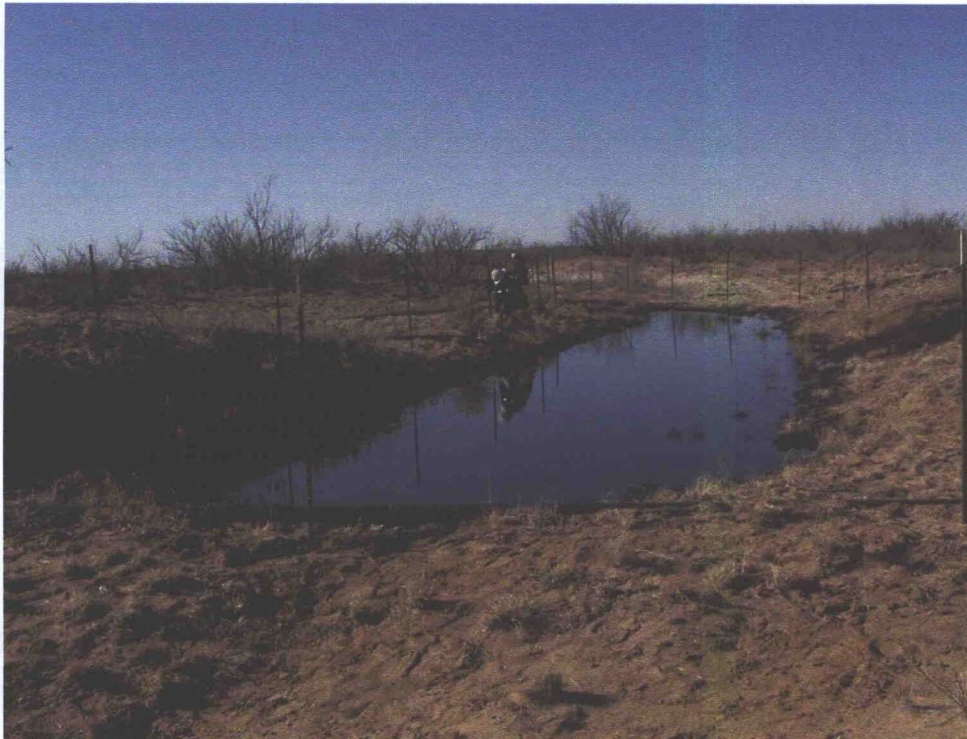
Photograph #1- Looking north-west across release area.

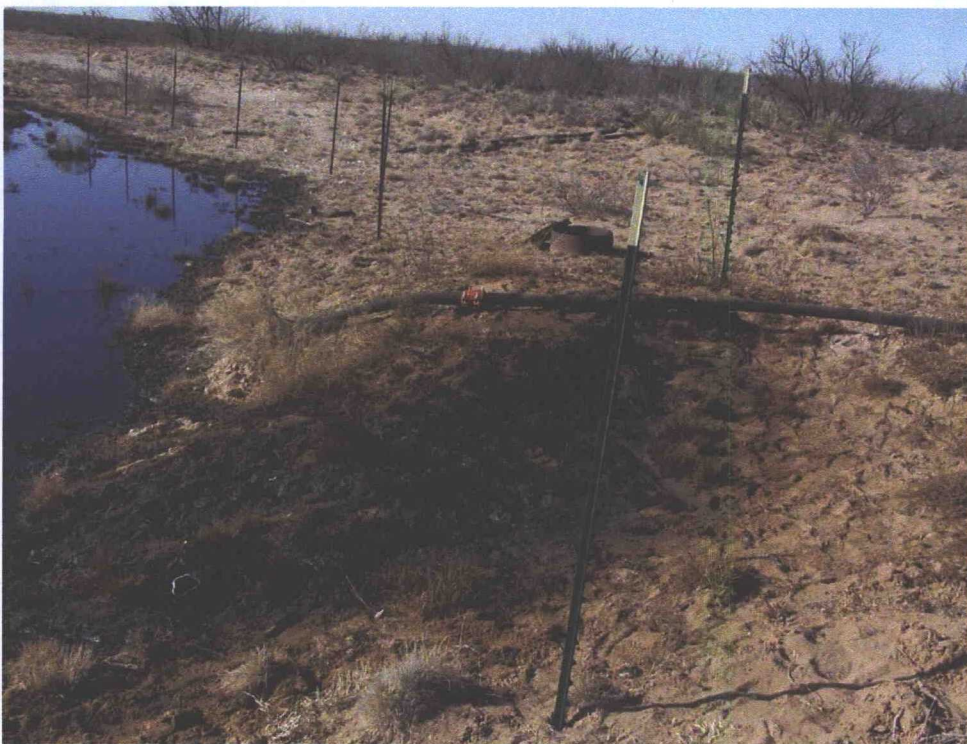
Photograph #2- Looking northerly toward release point.

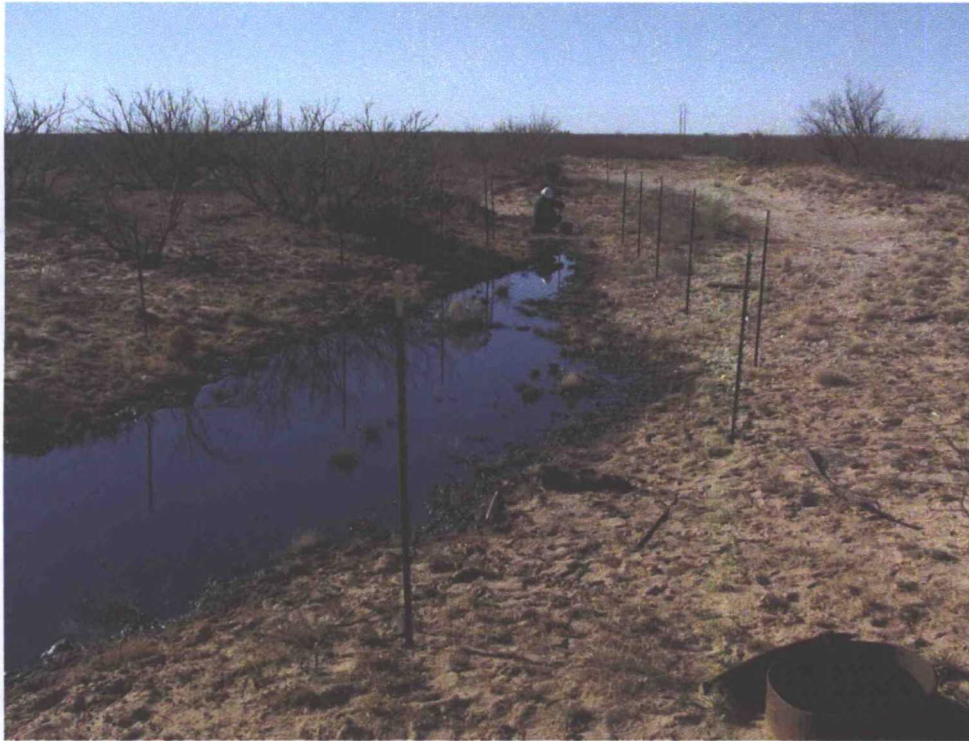
Photograph #3- Looking westerly across release area.

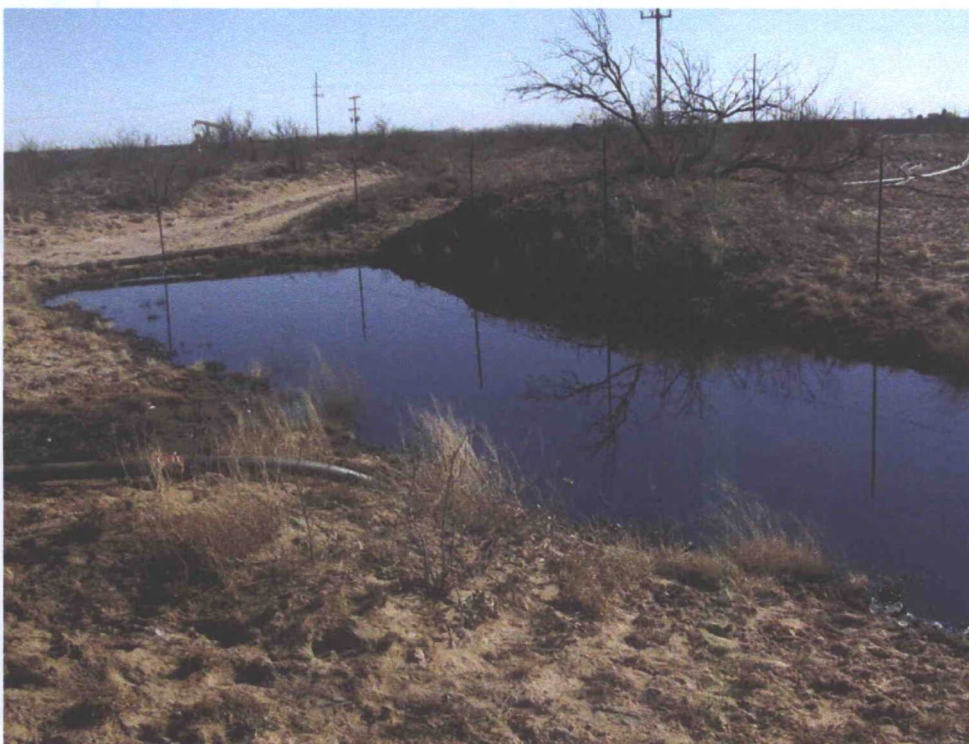
Photograph #4- Looking south-easterly across release area.

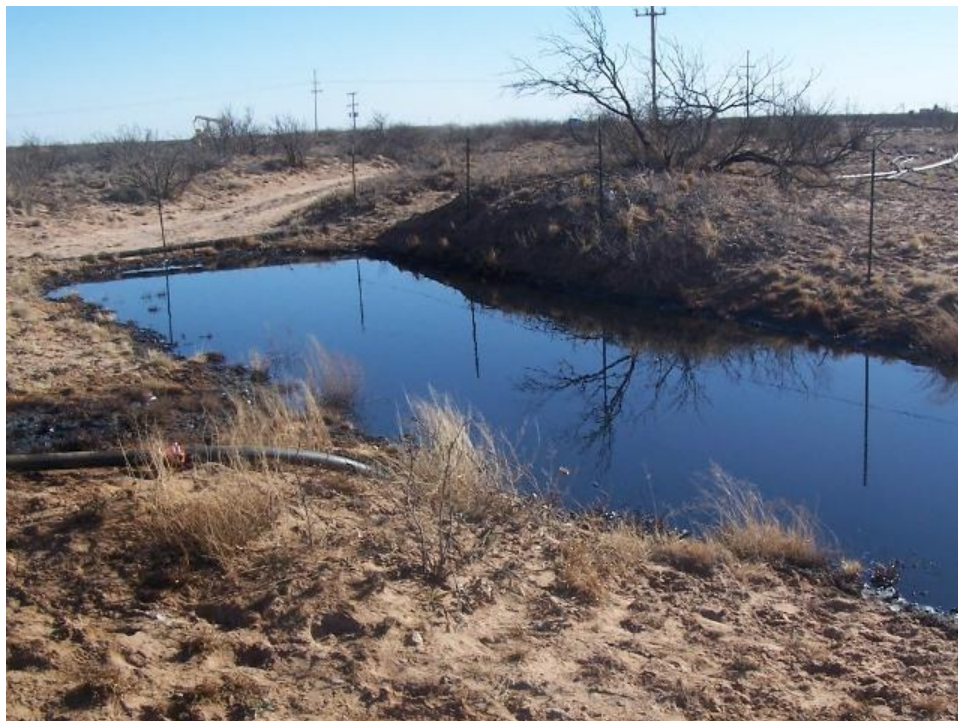
The release occurred on January 12, 2014 due to ruptured flowline allowing for approximately 100 barrels (bbl) of crude oil to be released. Approximately 70 bbl were recovered. The spill area measured about 2,200 square feet at the time of release. The spill was reported to the OCD on January 21, 2014 (verbal communication with Geoff Leking). The initial C-141 was submitted and assigned remediation permit number 1RP-4166. Appendix A presents the initial C-141.

Initial Spill Area Viewing Northwest, January 12, 2014

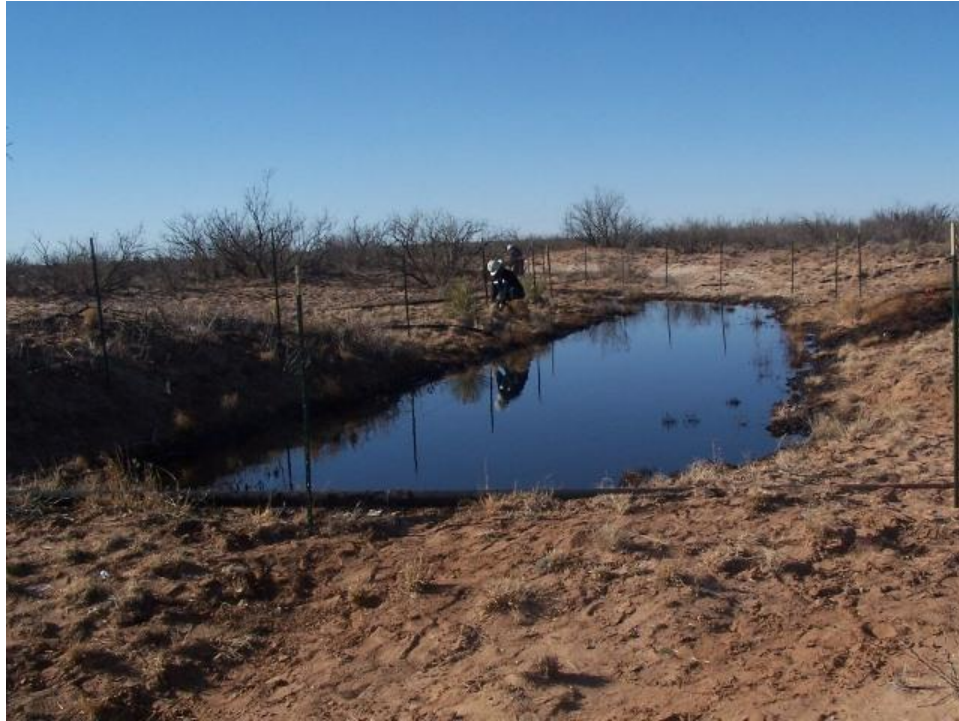
Initial Spill Area Viewing East, January 12, 2014

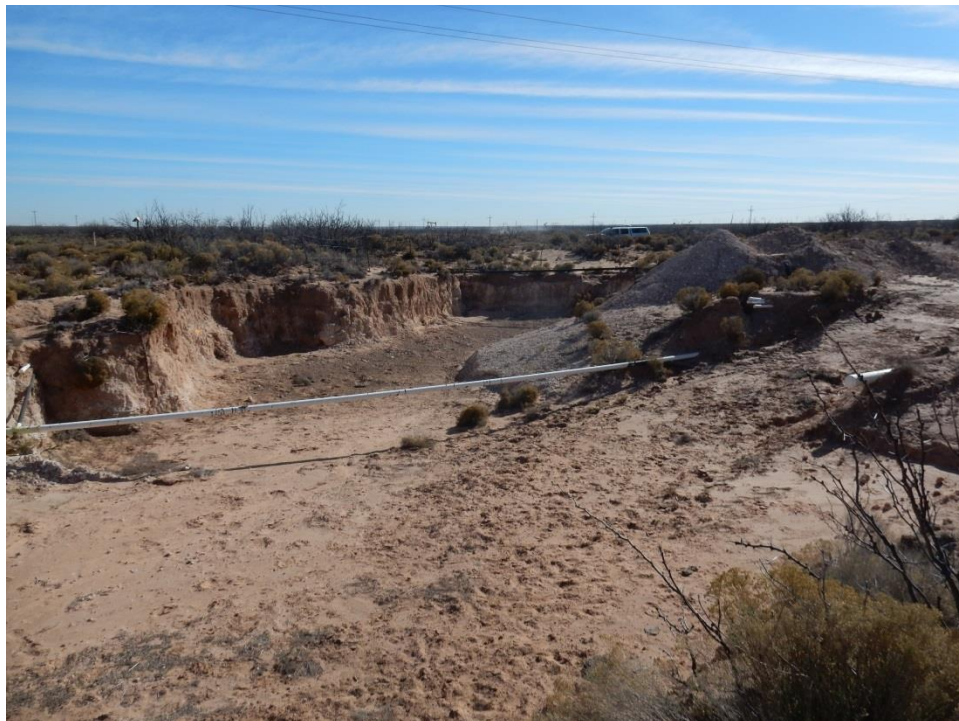
Excavation Viewing Southeast, January 5, 2018

In January 2014, soil was excavated from the spill area to approximately 5 feet bgs on the east end, 3 feet bgs on the west end and 8 feet bgs in the middle. The excavation measured approximately 2,700 square feet. The contaminated soil was hauled to an OCD approved disposal facility. Appendix B presents EPI work plan.

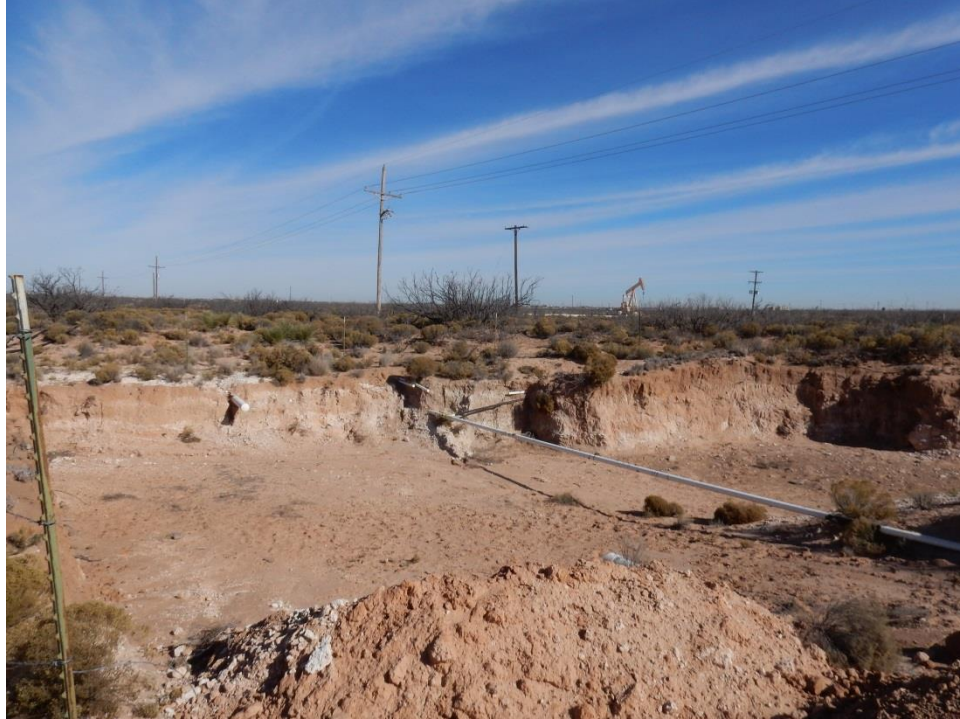
Excavation Viewing Northeast, January 5, 2018

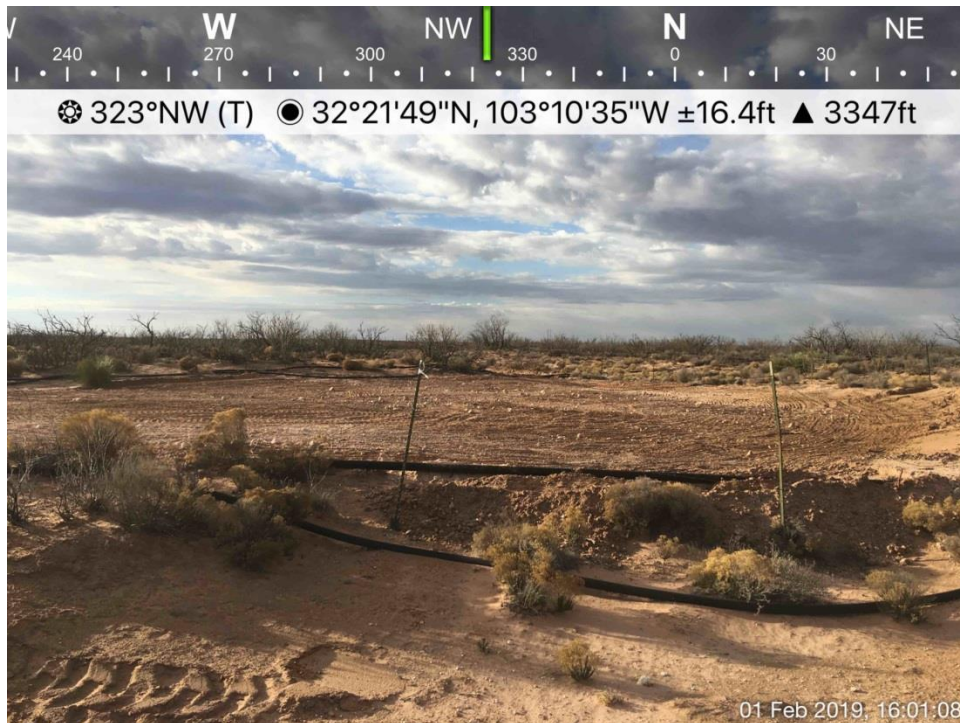
Backfilled and Seeded Area Viewing Northwest, February 1, 2019

In December 2018 a Legacy contractor filled the excavation to approximately 1 foot bgs with caliche and to surface with topsoil. On February 1, 2019, LAI personnel seeded the location to SLO requirements. Appendix E presents the grass seed receipt. Legacy requests no further action for 1RP-4166. Appendix F presents photographs. Appendix G presents the final C-141.

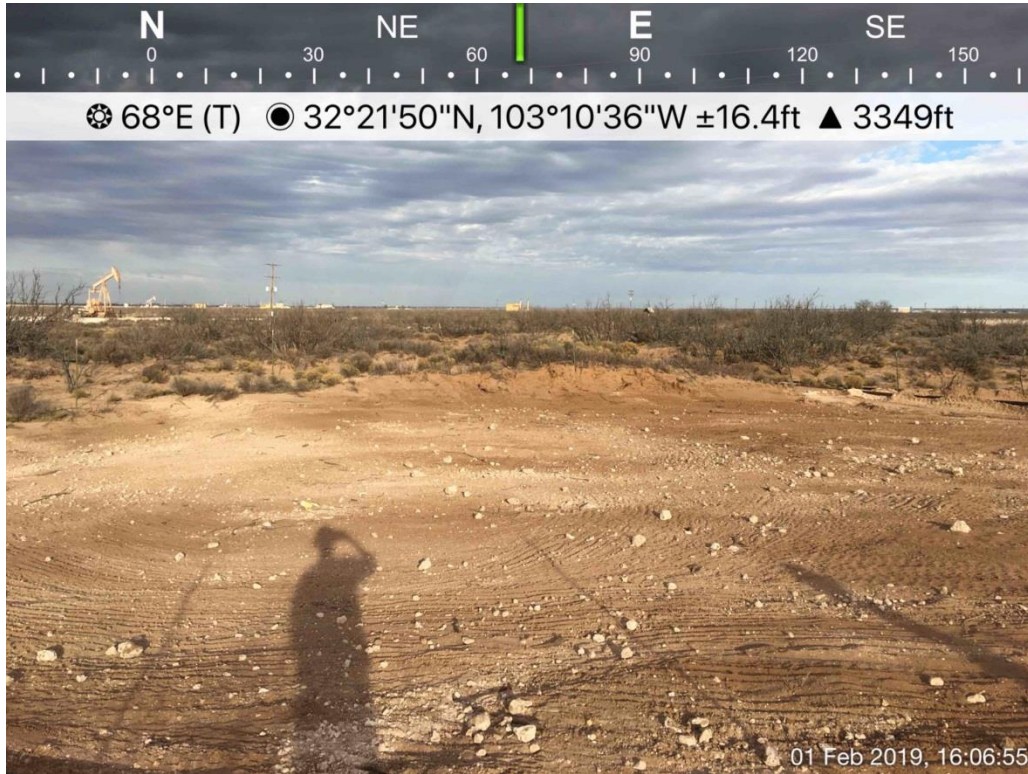
Backfilled and Seeded Area Viewing Northeast, February 1, 2019
