RE: 1RP-4516 Warn State AC Battery

**1RP-4516**  
**DELINEATION AND DEFERRAL REPORT**  
**Warn State AC Battery**  
**Crude Oil and Produced Water Release**  
**Lea County, New Mexico**

LAI Project No. 19-0112-47

September 27, 2019

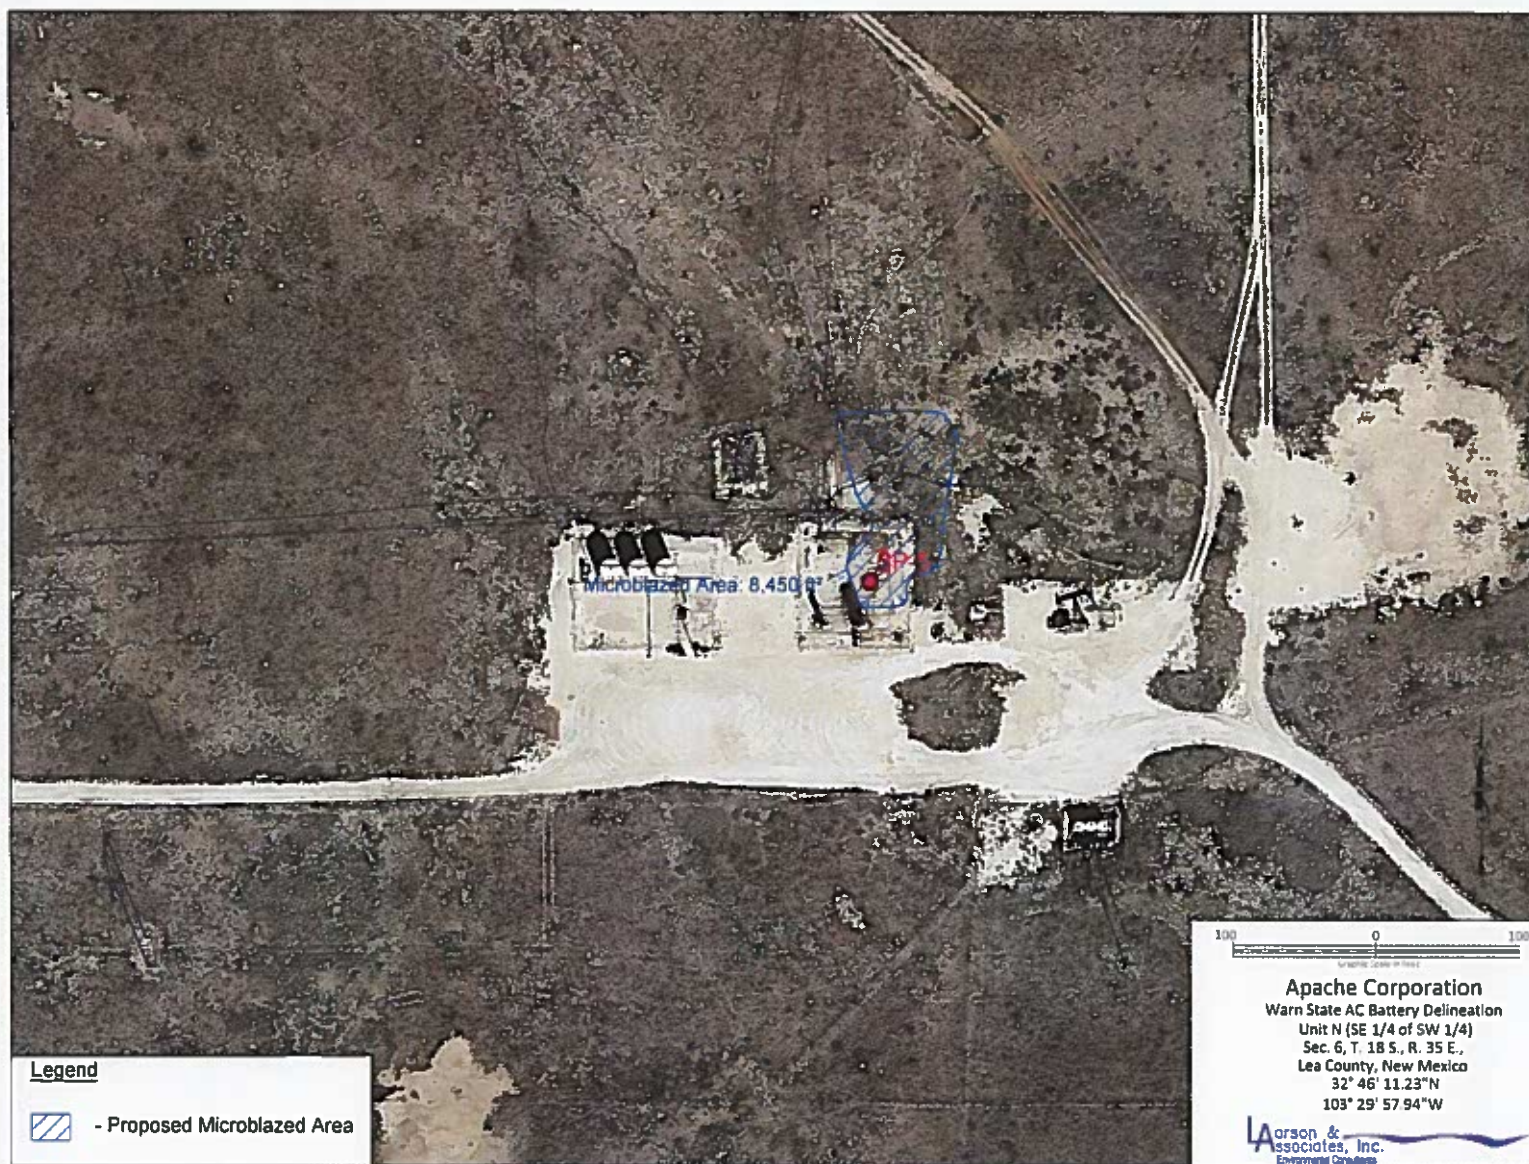
Figure 2 - Aerial Map Showing Soil Sample Locations and Proposed Microblazed Area

Figure 2 presents the soil sampling location. Appendix D presents the PBEL laboratory data. Appendix E presents photographs.

Apache has delineated BTEX, TPH and chloride below the remediation limits of 50 mg/Kg, 2,500 mg/Kg and 10,000 mg/Kg, respectively. Apache proposes to apply a 6% solution of Microblaze® microbial amendment and water to the affected soil and vegetation in the overspray area northeast of the facility to remediate DRO concentrations in the upper foot of soil. The overspray area measures approximately 8,450 square feet. Due to the spill area being in close proximity to production equipment and underground lines, Apache respectfully requests a deferral to complete delineation on the caliche road and remediation of the Warn State AC Battery (1RP-4516) until abandonment.

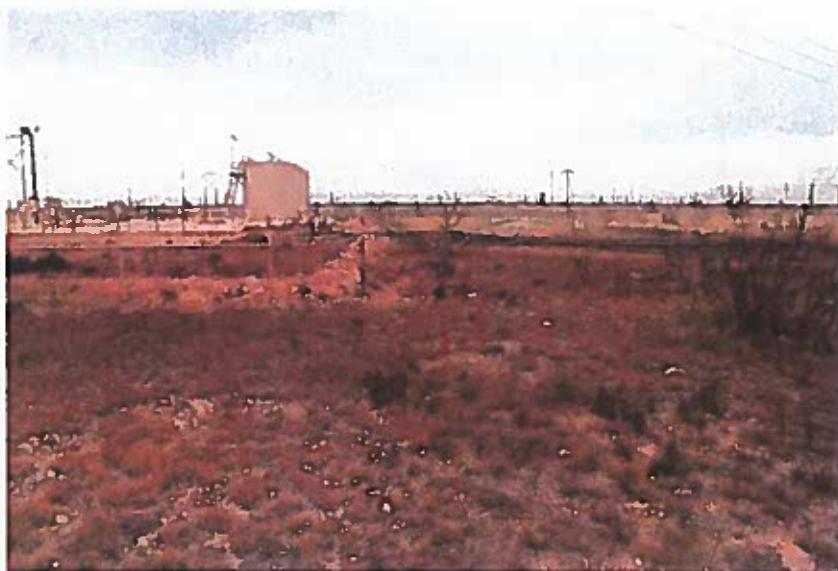
**Photograph: 1****Description:**  
Facing west viewing  
mist in pasture**Location:**  
Warn State A/C Battery**Photograph taken by:**  
Jennifer Van Curen**Date:** 10/24/2016

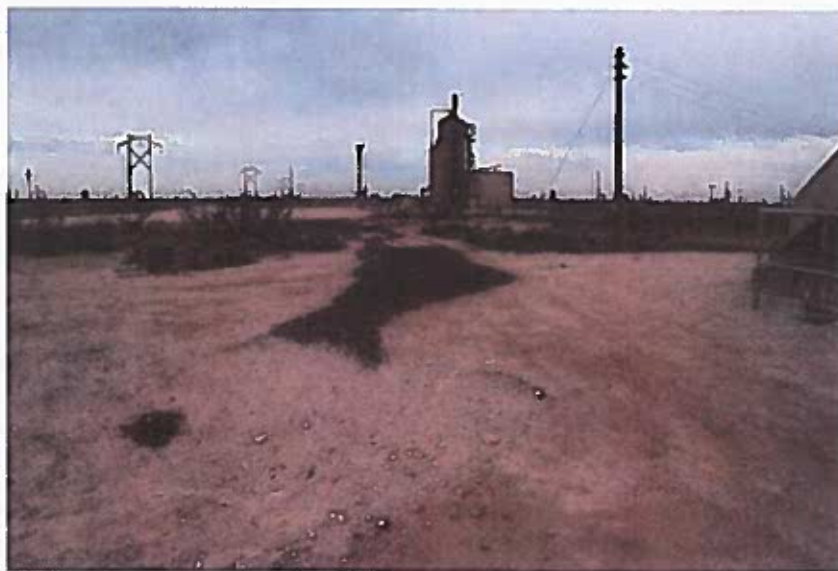
**Photograph: 2****Description:**  
Facing west viewing  
stain from fluid**Location:**  
Warn State A/C Battery**Photograph taken by:**  
Jennifer Van Curen**Date:** 10/24/2016

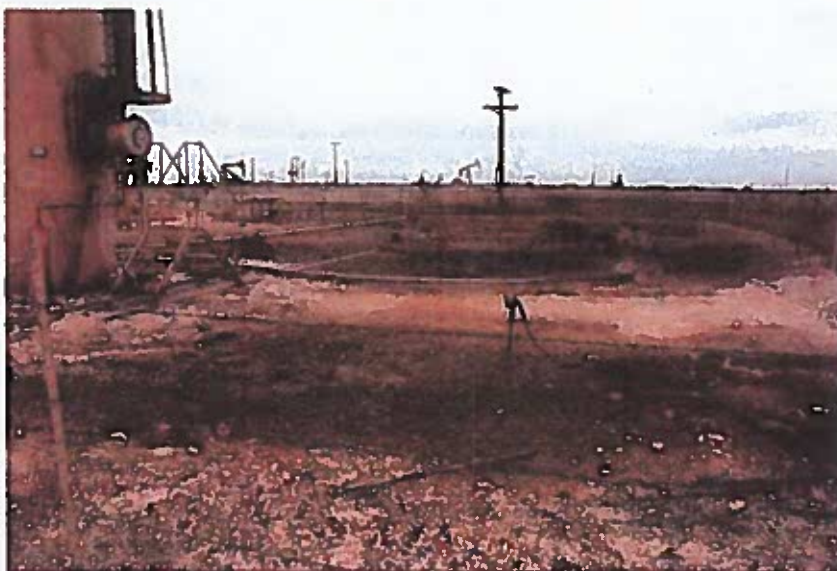
**Photograph: 5****Description:**  
Facing west viewing  
stain inside firewall**Location:**  
Warn State A/C Battery**Photograph taken by:**  
Jennifer Van Curen**Date:** 10/24/2016

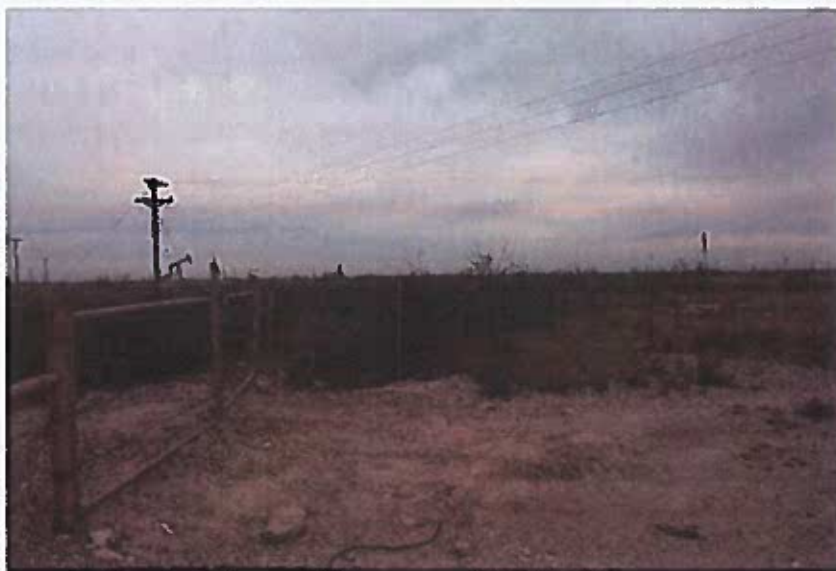
**Photograph: 6****Description:**  
Facing north viewing  
mist in pasture**Location:**  
Warn State A/C Battery**Photograph taken by:**  
Jennifer Van Curen**Date:** 10/24/2016

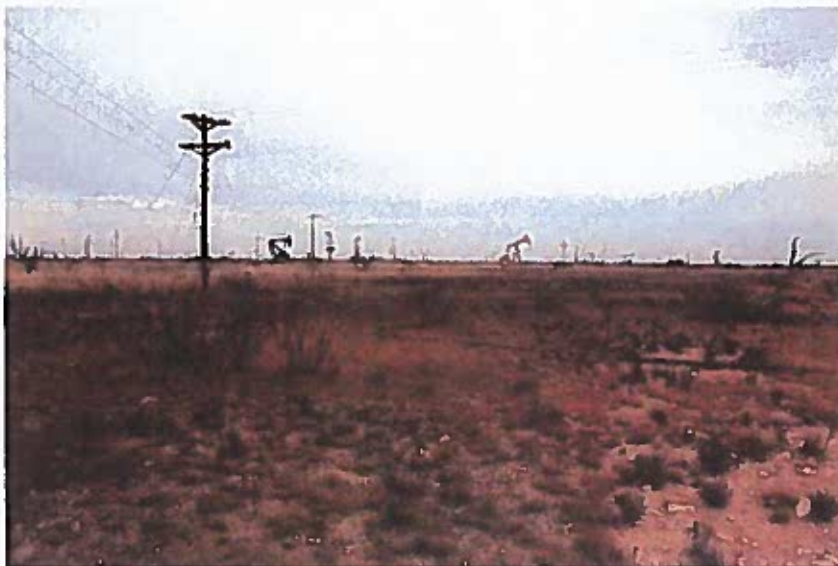
**Photograph: 7****Description:**  
Facing north viewing  
mist in pasture**Location:**  
Warn State A/C Battery**Photograph taken by:**  
Jennifer Van Curen**Date:** 10/24/2016
